**HURRICANE KATRINA:
WHY DID THE LEVEES FAIL?**

COMMITTEE ON
HOMELAND SECURITY AND
GOVERNMENTAL AFFAIRS
UNITED STATES SENATE

NOVEMBER 2, 2005

Chapters 2 through 5 of this report present a summary of observations and preliminary findings to date associated with protective levee system performance in the (2) Orleans East Bank, (3) Ninth Ward/St. Bernard Parish, (4) New Orleans East, and (5) Plaquemines Parish protected areas, respectively. Chapter 6 briefly addresses observations regarding pumping and dewatering systems, and other aspects of the overall regional flood protection system. Chapter 7 describes LIDAR imagery data sets taken to capture three-dimensional representations of detailed ground surface conditions and configurations at a number of key sites. Finally, Chapter 8 summarizes a number of preliminary overall observations and recommendations.

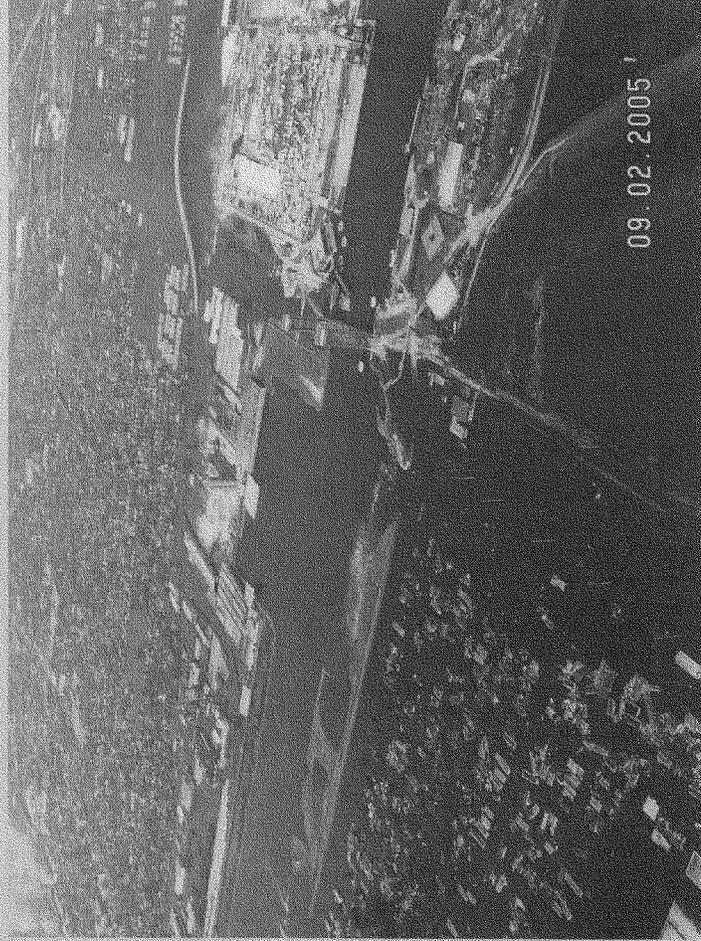
Levee Failure on East Side of Industrial Canal

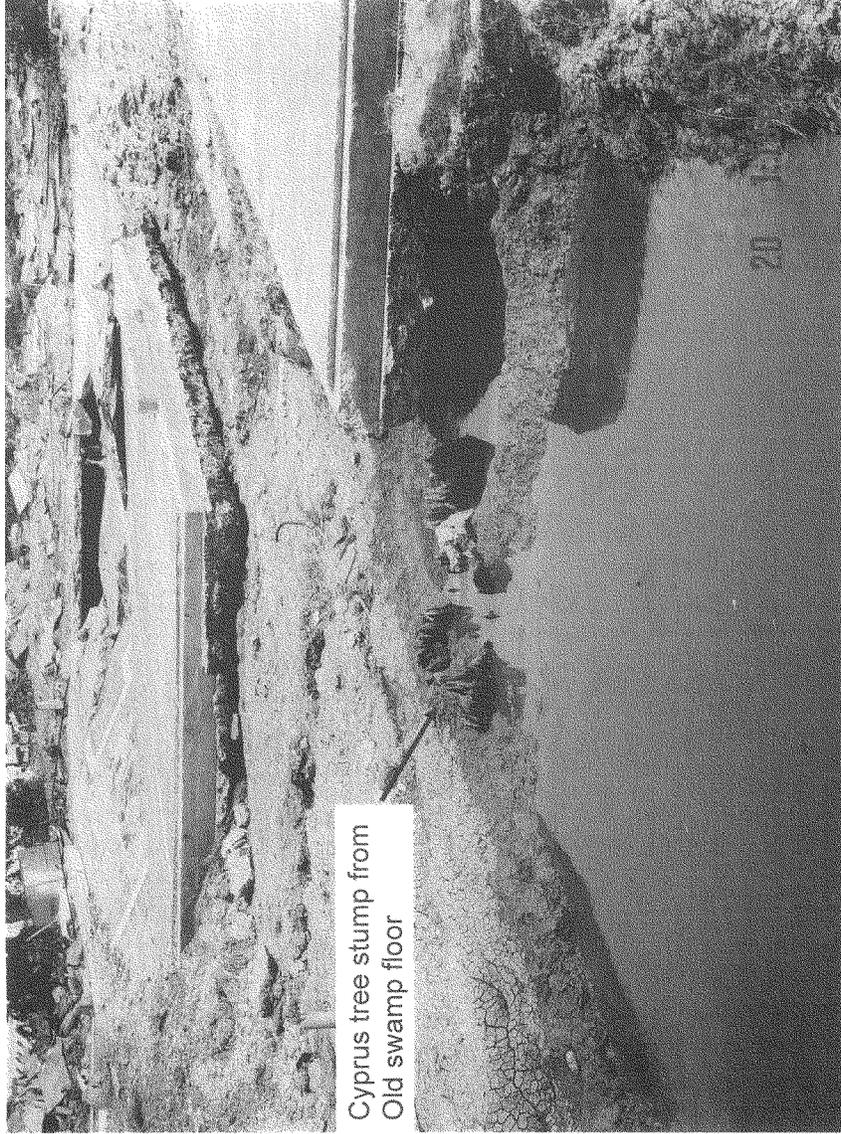
Levee wall tilted back.
Cracks and soil failure in
front of wall and development
of downward percolation holes

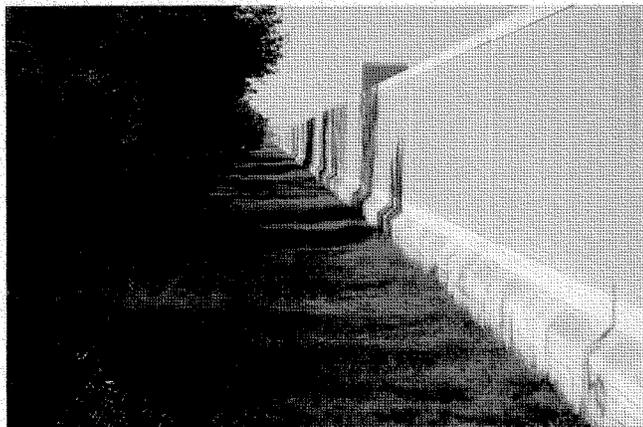
Figure 2.11: Typical conditions at the inboard side of floodwalls along the 17th Street Canal showing no scour of soil at the toe of the wall.

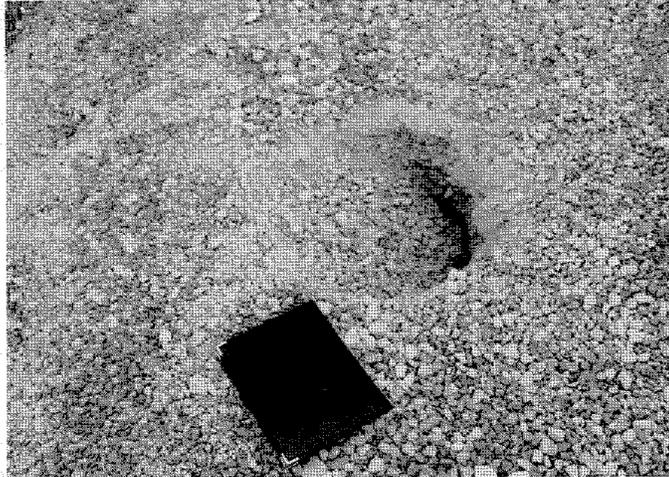
Figure 2.13: One of four sinkholes noted at the front lip of the crest of the temporary closure section embankment.

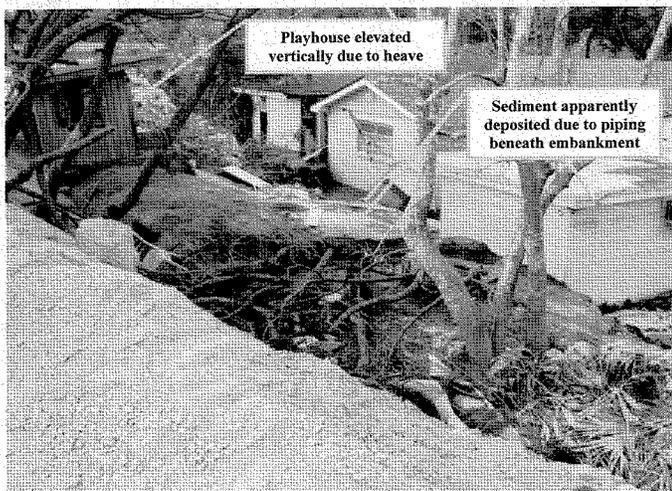
Figure 2.16: Conditions at the inboard toe of the London Avenue Canal (North) breach section.

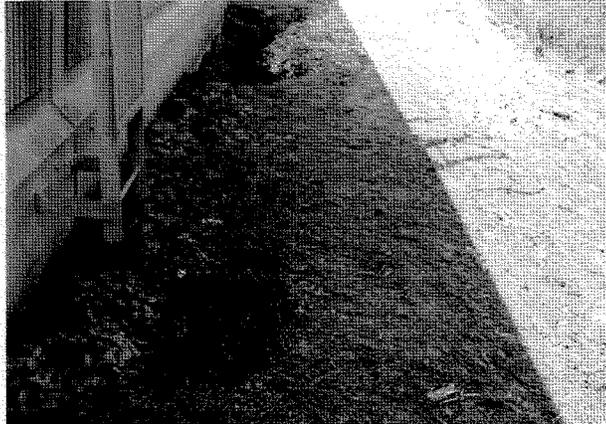
Figure 2.21: Closeup view of sinkholes at the inboard toe of the floodwall, at the location of the engineer wearing a red shirt in Figure 2.20.

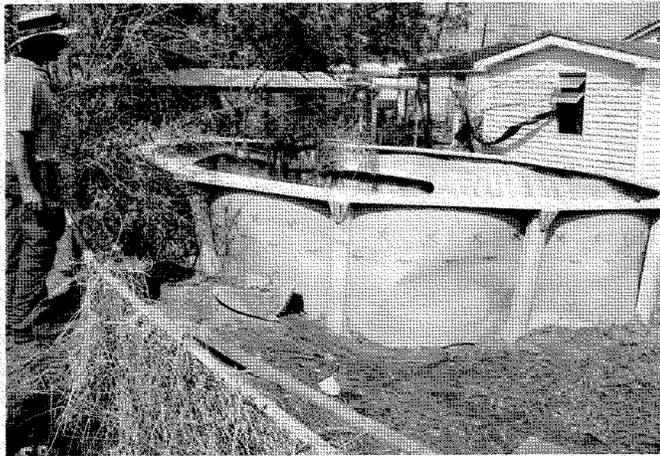
Figure 2.22: View of conditions at the inboard toe, immediately inboard of the locations shown previously in Figures 2.21 and 2.22. Note the bulged and hummocky ground, the laterally displaced chain link fence, and the piping boil ejecta.

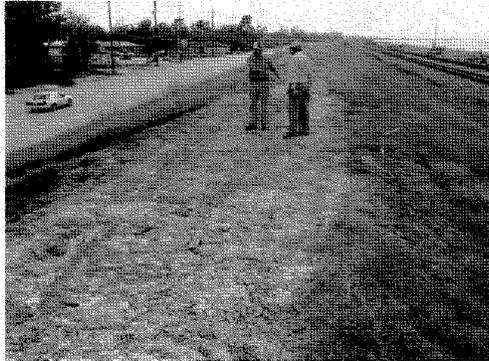
Figure 3.6: Wave overtopping of lakefront earthen levee at low spot in structure did not cause serious damage (N 30° 03' 47.8", W 89° 58' 13.1)

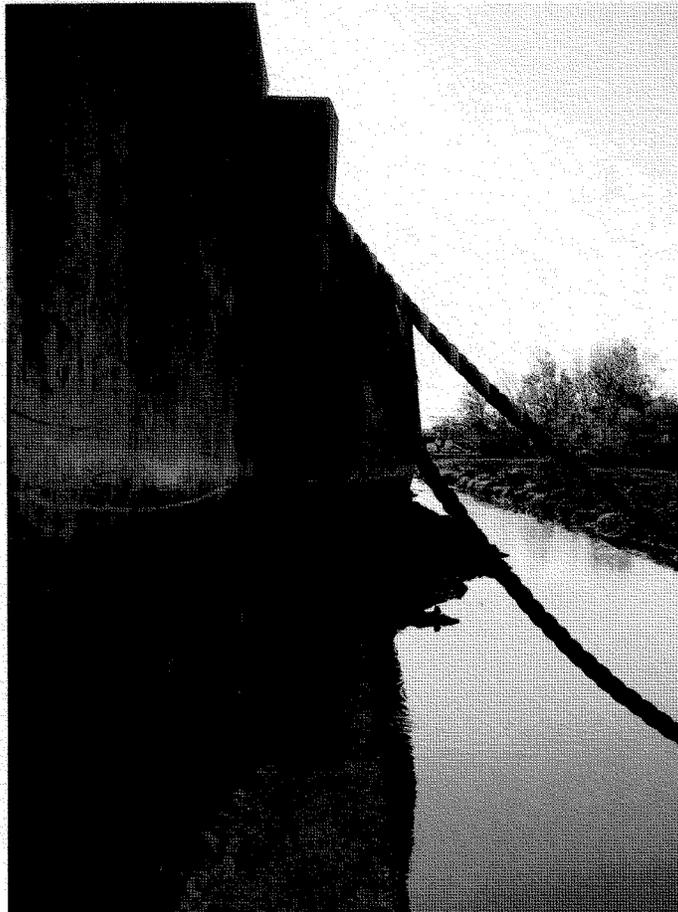
Figure 3.10: Undamaged T-wall in foreground and damaged I-wall in background along the IWW/MRGO. Severe scour on the landside and distress of the I-wall (N30.00030 W89.99459).

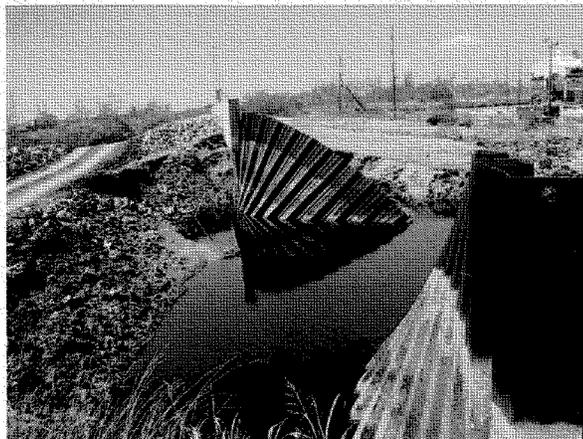
Figure 3.13 Failure of sheetpile wall adjacent to higher and stronger concrete topped I-wall on the north side of the IWW.

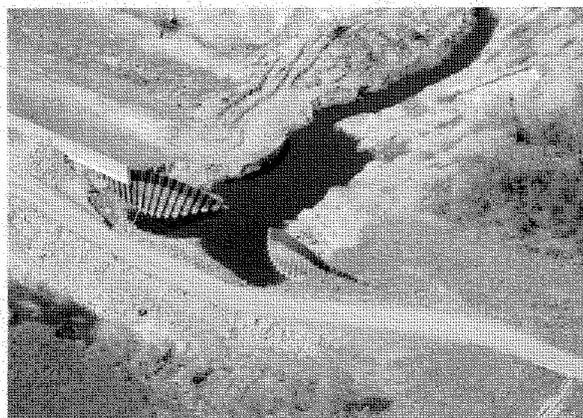
Figure 3.14: Aerial view of the failed wall section shown in Figure 3.14

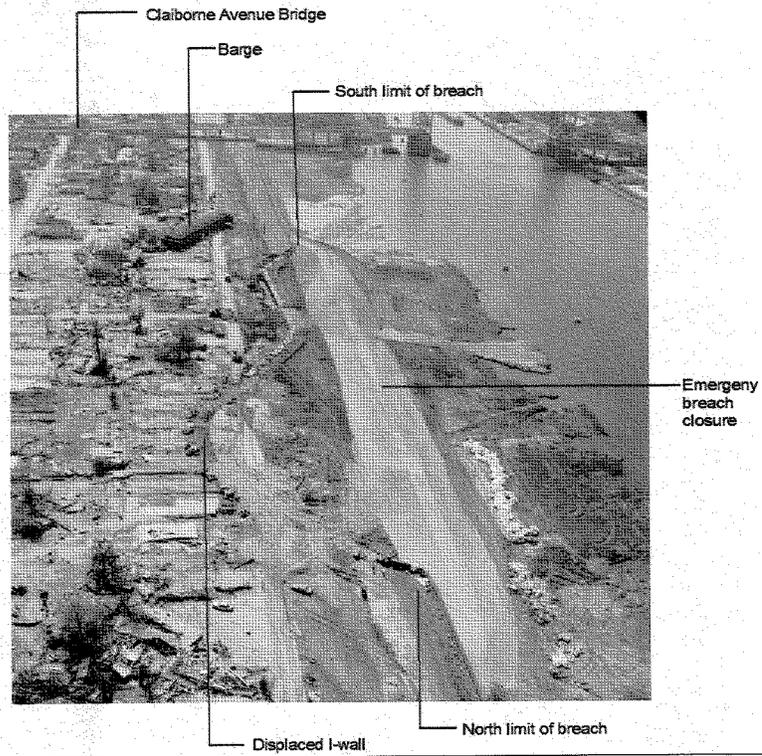
Figure 4.2: Aerial view of the south breach at the Lower Ninth Ward (L. Harder, October 14, 2005).

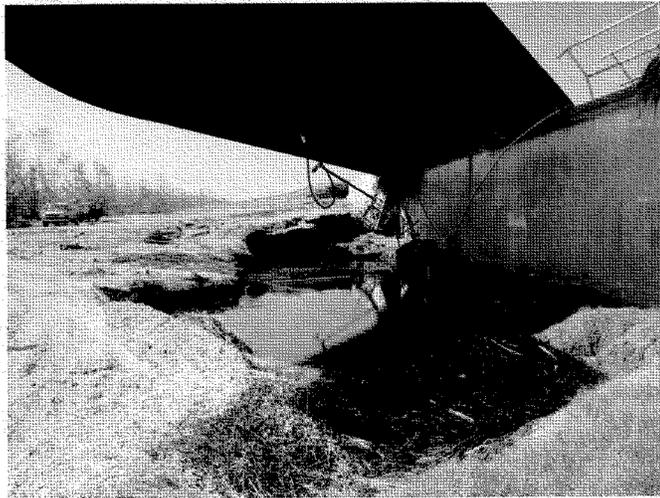
Figure 4.14: Scour near barge damage at the Bayou Bienvenue Gate site (J. Wartman, October 5, 2005).

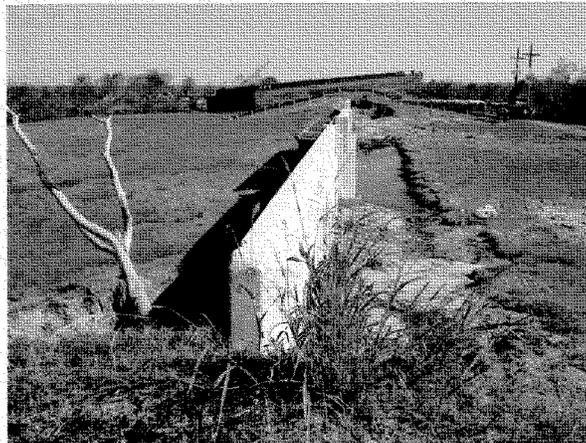
Figure 4.15: Scour near Bayou Bienvenue Gate site (L. Wooten, October 5, 2005).

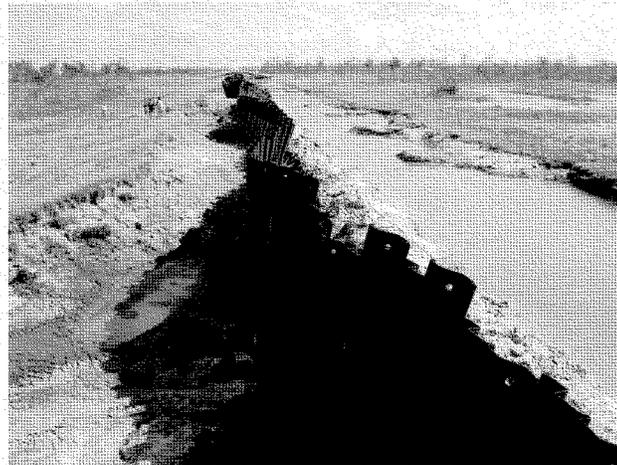
Figure 4.20: Failure of earth levee with steel sheetpile barrier on the southeast bank of the MRGO. Note severe erosion and scour (L. Wooten, October 6, 2005).

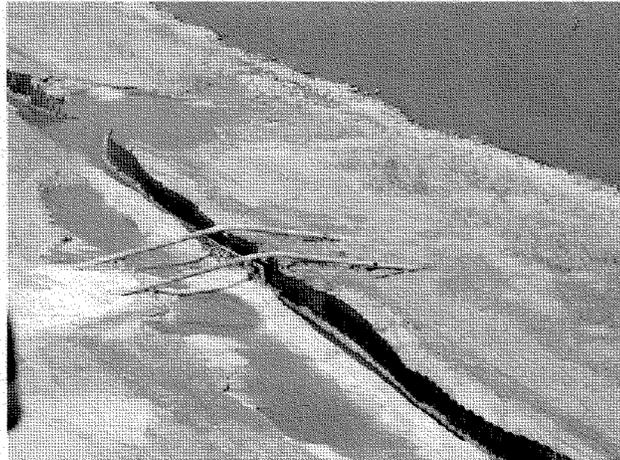
Figure 4.21: Levee failure on southwestern bank of MRGO between Bayou Bienvenue (where barge is aground on I-wall) and Bayou Dupree. Note severe erosion and scouring (L. Harder, October 14, 2005).

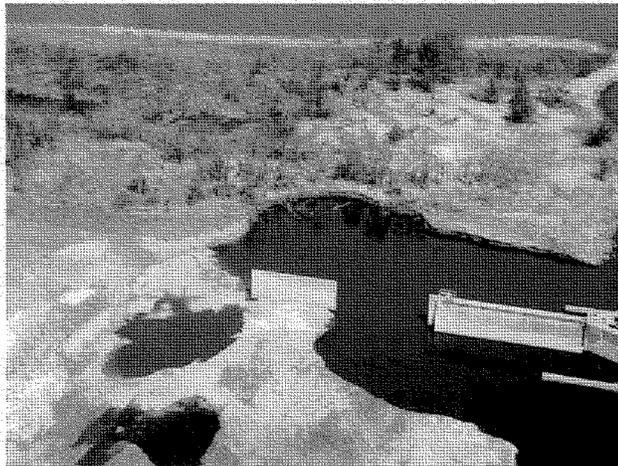
Figure 4.22: Levee failure on southwestern bank of MRGO at Bayou Dupree. Note concrete sheetpile and levee transition washouts (L. Harder, October 14, 2005).

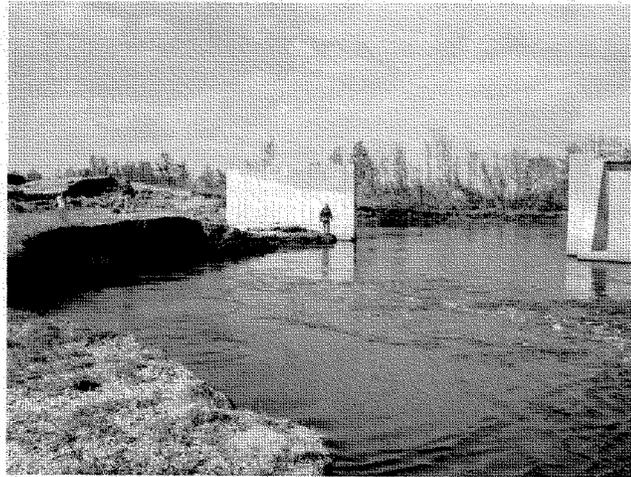
Figure 4.23: Ground perspective of Bayou Dupree gate abutment failure (L. Wooten, October 6, 2005).

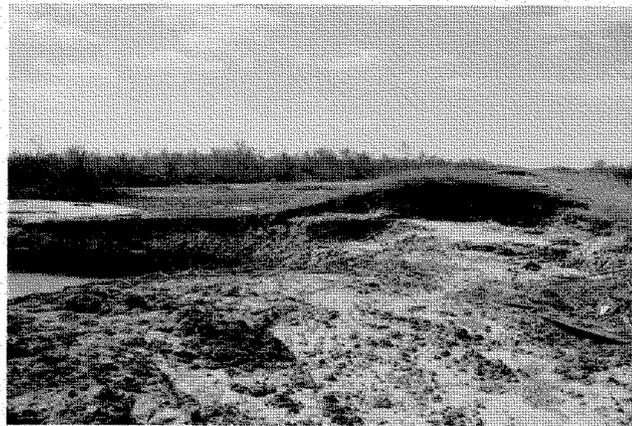
Figure 4.24: Failure of earth levee on southwest bank of MRGO adjacent to the Bayou Dupree gate (L. Wooten, October 6, 2005).

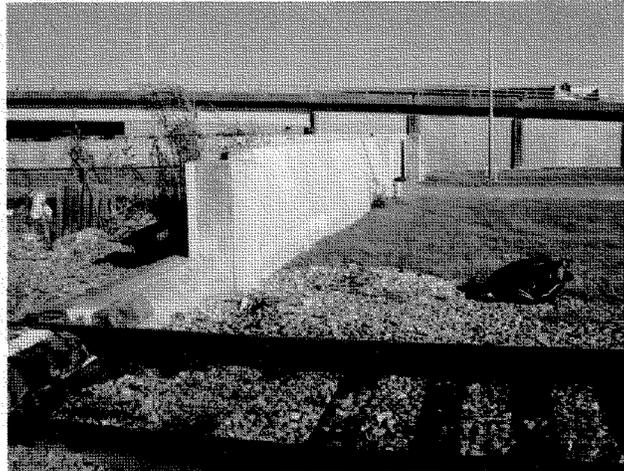
Figure 6.2: Lack of a floodgate at the railroad line crossing resulted in scour around the railroad tracks. No overtopping was observed the floodgate across the adjacent roadway.
