[Docket No. FAA-2015-3989; Directorate Identifier 2014-NM-250-AD; Amendment 39-18600; AD 2016-16-02]

#### Airworthiness Directives; Airbus Airplanes

**2016–16–02 Airbus:** Amendment 39–18600. Docket No. FAA–2015–3989; Directorate Identifier 2014–NM–250–AD.

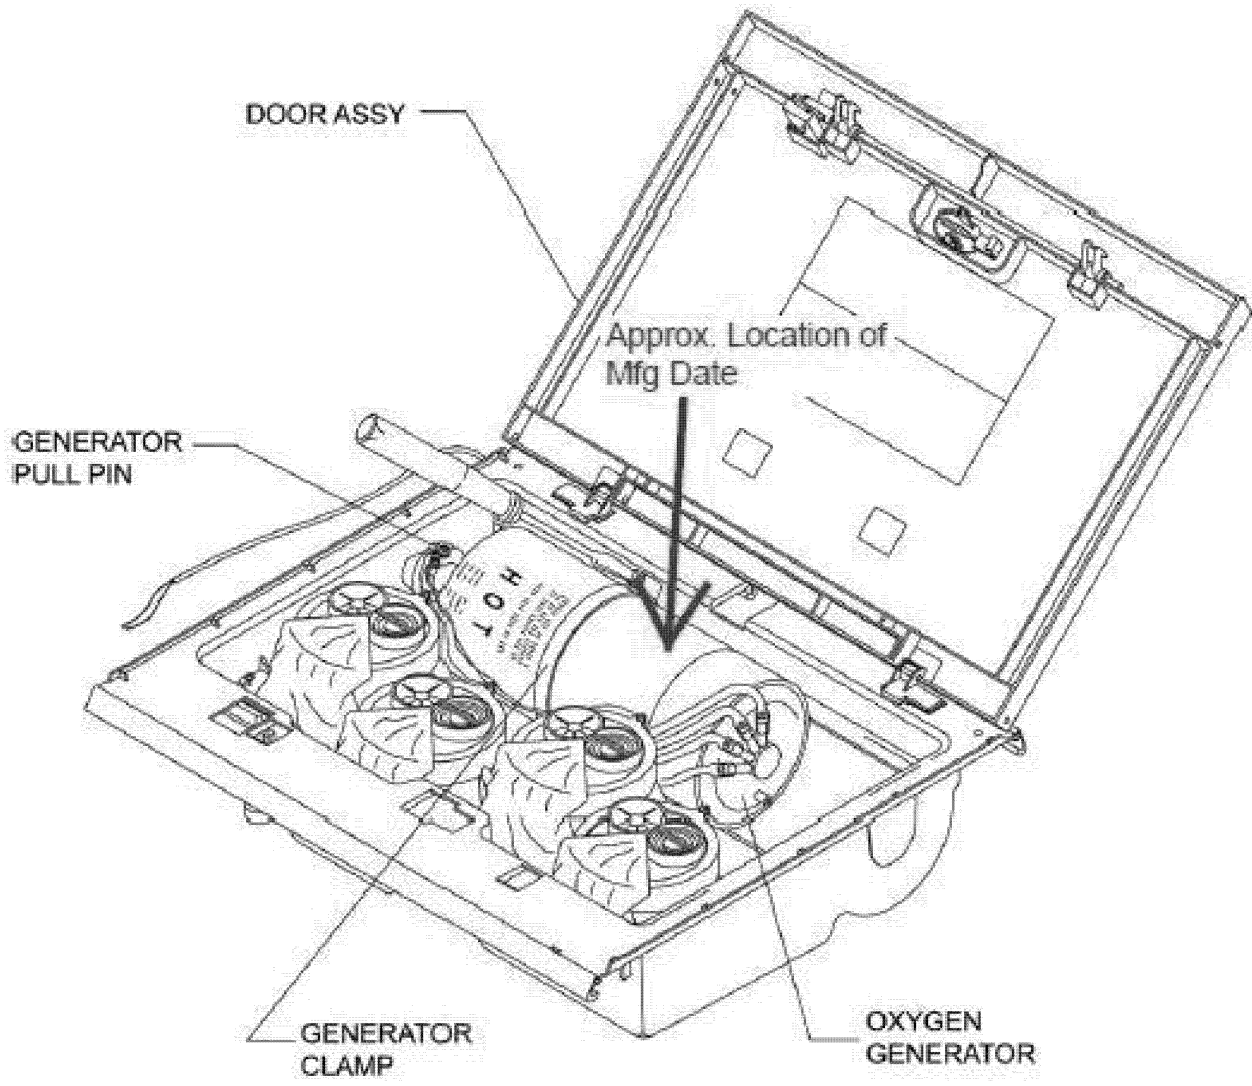
Figure 1 to Paragraph (g) of this AD - Location of Date (MM-YY)

Within 30 days after the effective date of this AD: Do a one-time inspection of passenger chemical oxygen generators, part numbers (P/N) 117042–02 (15 minutes (min)—2 masks), 117042–03 (15 min—3 masks), 117042–04 (15 min—4 masks), 117042–22 (22 min—2 masks), 117042–23 (22 min—3 masks), and 117042–24 (22 min—4 masks) to determine the date of manufacture as specified in Airbus Alert Operators Transmission (AOT) A35N006–14, dated December 10, 2014, including Appendix 1. Refer to figures 1 and 2 to paragraph (g) of this AD for the location of the date. A review of airplane maintenance records is acceptable for the inspection required by this paragraph, provided the date of manufacture can be conclusively determined by that review.
