[Docket No. FAA-2015-8463; Directorate Identifier 2014-NM-226-AD; Amendment 39-18612; AD 2016-16-14]

Airworthiness Directives; Airbus Airplanes

2016–16–14 Airbus: Amendment 39–18612; Docket No. FAA–2015–8463; Directorate Identifier 2014–NM–226–AD.

Air Transport Association (ATA) of America Code 35, Oxygen.

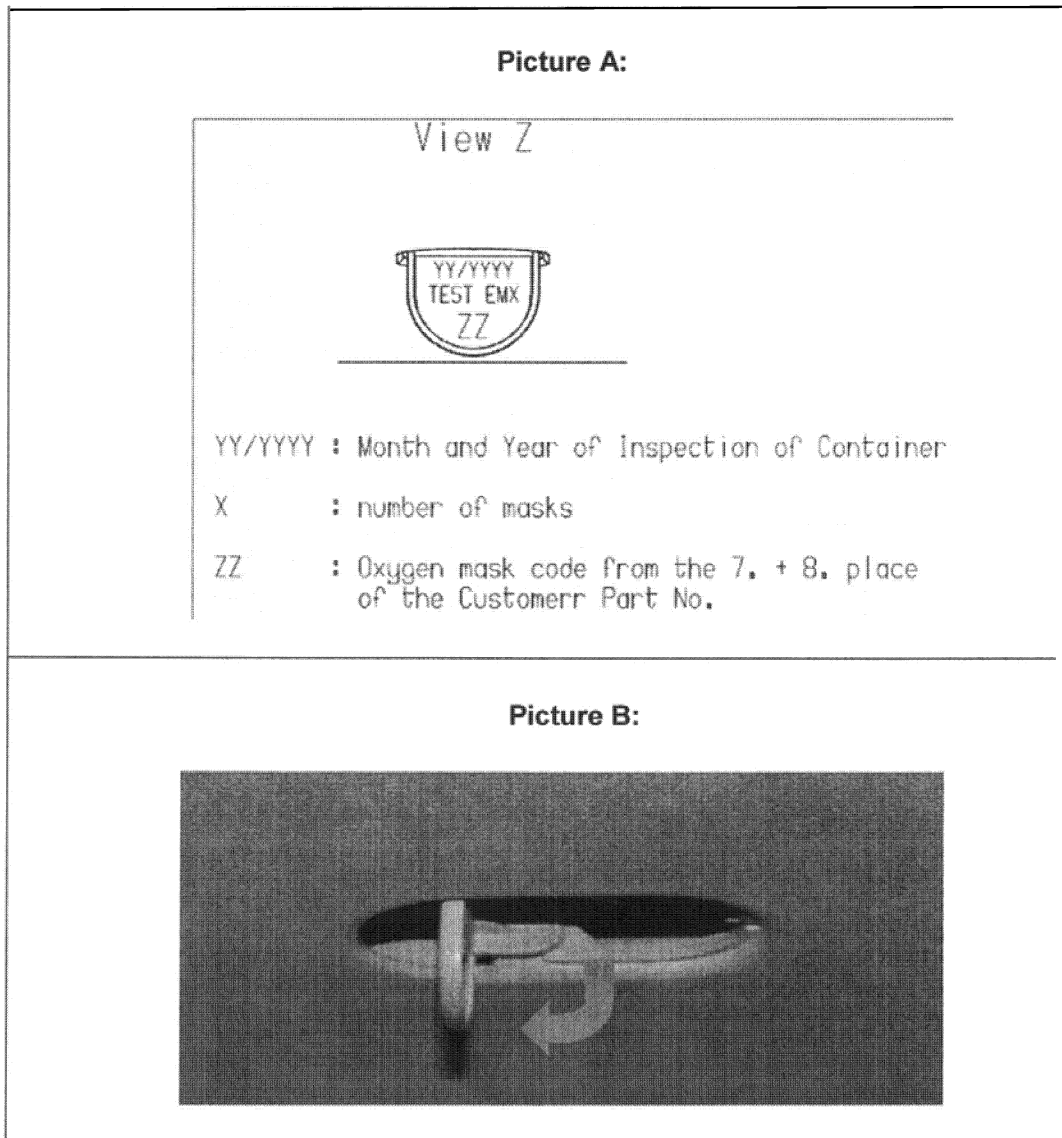
Figure 1 to Paragraph (l)(4) of this AD – Design A of the Passenger Oxygen Containers

(4) Airplanes on which the design of the passenger oxygen container is not Design A, as defined in figure 1 to paragraph (l)(4) of this AD, are excluded from the requirements of paragraph (i) of this AD for that passenger oxygen container.

Note 2 to paragraph (l)(4) of this AD: For "Design A," the placard on the passenger oxygen container test button is as described in "Picture A" in figure 1 to paragraph (l)(4) of this AD. The mask configuration ("ZZ" in "Picture A") is a number, and the test button is as shown in "Picture B."
