**[Docket No. FAA-2016-4228; Directorate Identifier 2015-NM-107-AD; Amendment 39-18734; AD 2016-25-08]**

#### Airworthiness Directives; Airbus Airplanes

**2016–25–08 Airbus:** Amendment 39–18734; Docket No. FAA–2016–4228; Directorate Identifier 2015–NM–107–AD.

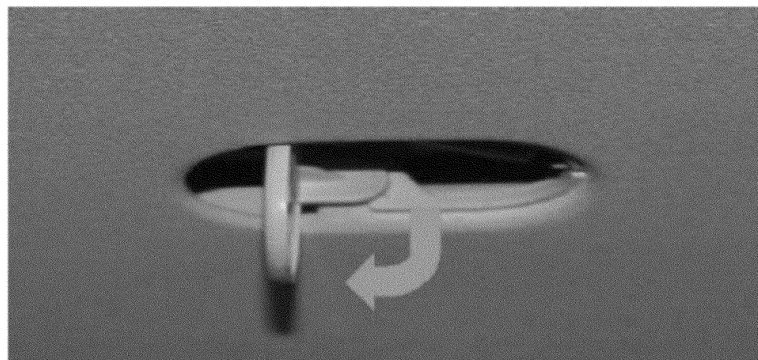
Figure 1 to Paragraph (i)(7) of this AD – Design A of the Passenger Oxygen Containers Affected by this AD

**Design A:** The placard on the passenger oxygen container test button is as described in Picture A of Appendix 1 of this AD. The Mask configuration ("ZZ" in Picture A) is a number and the test button is as shown in Picture B.

**Note 2 to figure 1 to paragraph (i)(7) of this AD:** For "Design A," the placard on the passenger oxygen container test button is as described in "Picture A" in figure 1 to paragraph (i)(7) of this AD. The mask configuration ("ZZ" in "Picture A") is a number, and the test button is as shown in "Picture B."
