Federal Aviation Administration

[Docket No. FAA-2017-0288; Directorate Identifier 2017-CE-007-AD]

Airworthiness Directives; Textron Aviation Inc. Airplanes

ACTION: Notice of proposed rulemaking (NPRM).

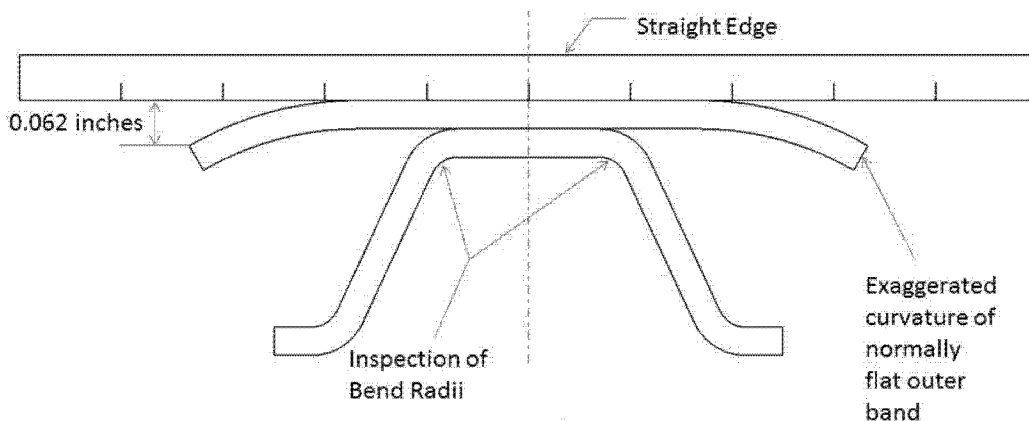
Figure 1 to paragraphs (h)(1)(iii) and (v) of this AD: Cross section of v-band coupling

(iii) Visually inspect the flatness of the outer band using a straight edge. Lay the straight edge across the width of the outer band. The gap must be less than 0.062 inches. See figure 1 to paragraphs (h)(1)(iii) and (v) of this AD. If the gap exceeds 0.062 inches between the outer band and the straight edge, do not re-install the v-band coupling. Before further flight, you must install a new v-band coupling and restart the hours TIS for the repetitive replacement of the v-band coupling.

(v) Visually inspect the bend radii of the coupling v-retainer coupling segments for cracks. Inspect the radii throughout the length of the segment. See figure 1 to paragraphs (h)(1)(iii) and (v) of this AD. If any cracks are found, do not re-install the v-band coupling. Before further flight, you must install a new v-band coupling and restart the hours TIS for the repetitive replacement of the v-band coupling.
