NTSB/SS-91/01

# NATIONAL TRANSPORTATION SAFETY BOARD

## SAFETY STUDY

### TRANSPORT OF HAZARDOUS MATERIALS BY RAIL

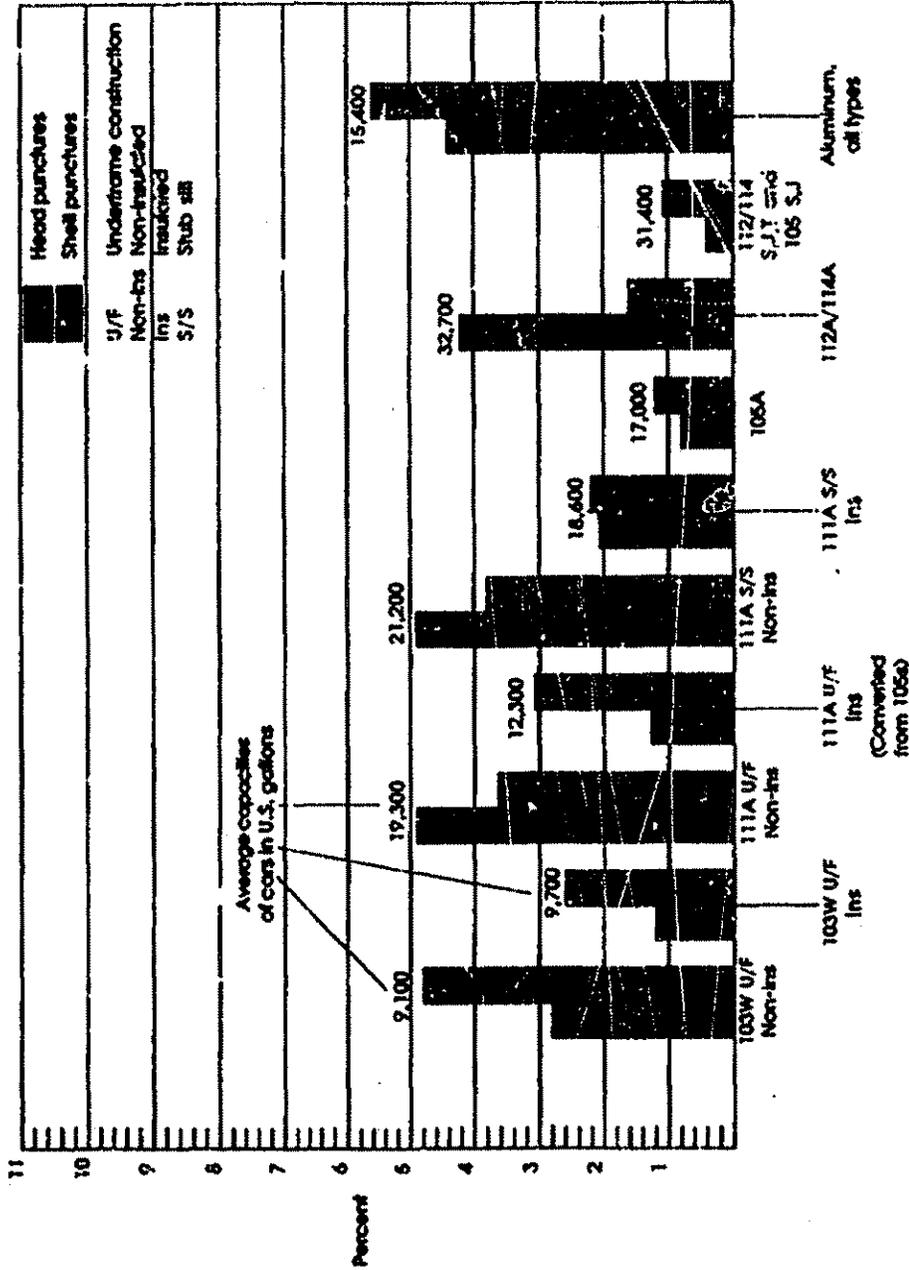
Figure 1.--Incidence of head and shell punctures to total number of tank cars damaged in accidents, 1965-86. (Source: Railway Progress Institute and Association of American Railroads 1990a.)

The RPI and AAR, in their 1990 study that analyzed the performance of the DOT-111A tank cars and other tank cars (RPI and AAR 1990a), reported a greater incidence of head and shell punctures in DOT-111A (insulated and non-insulated), DOT-112A/114A, and aluminum tank cars (fig. 1)--none of which have the improved tank head resistance protection and/or thermal protection as required for the DOT-112S, J, and T tank cars, the DOT-114S, J, and T tank cars, and for the DOT-105S, J, and T tank cars (see footnote 5). The incidence of head and shell punctures in tank cars damaged in accidents to the total number of tank cars damaged in accidents during a 22-year period (1965-86) is also shown in figure 1.
