michigan's  
demonstration  
erosion control  
program

update evaluation report - august, 1975

Prepared by  
The University of Michigan

Coastal Zone Laboratory

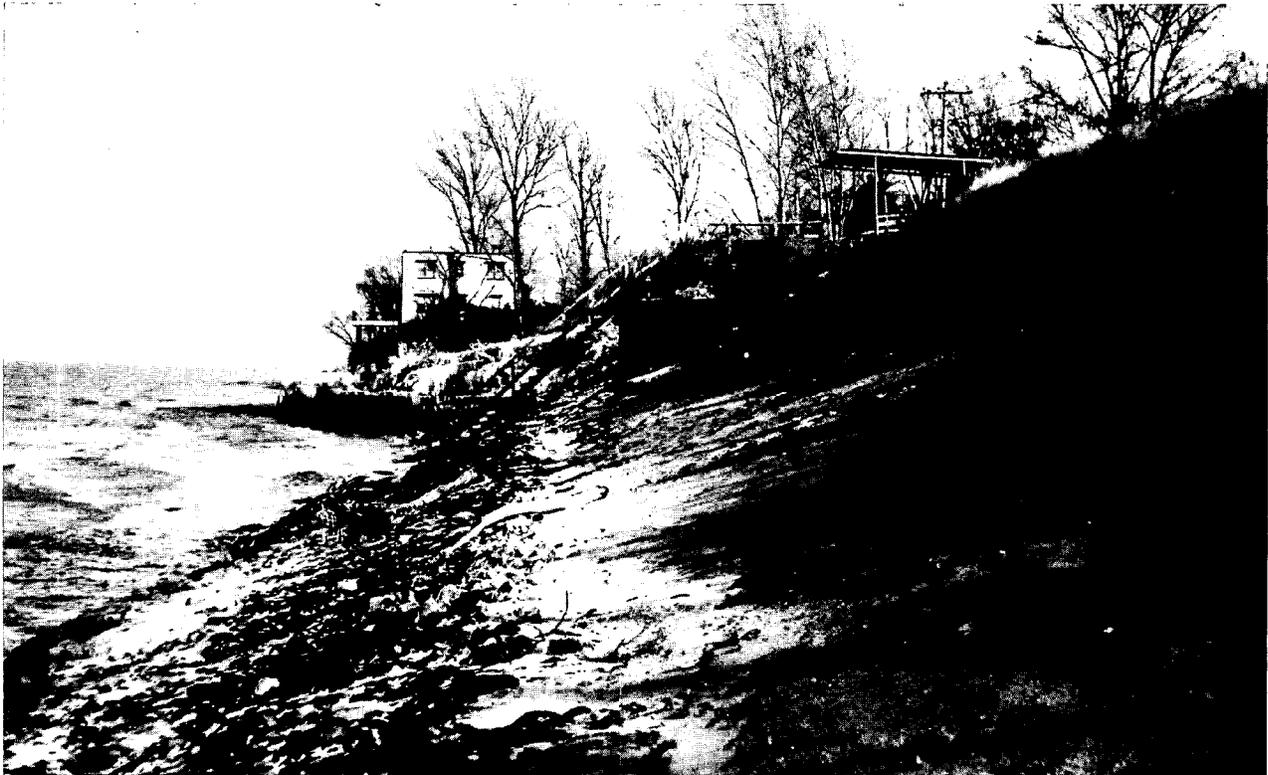
Photo #1 December 10, 1974

Condition. Diagram #1 shows the condition of the structure at this site on December 10, 1974. The first sign of problems with the structure appeared in the fall of 1974 when undermining of the toe of the revetment occurred in a few small areas. At that time it was also evident that surface runoff from the roads was concentrating at one or two locations, causing local undermining. A survey made after a fairly heavy November storm showed that the revetment had settled in some places. Photo #1 illustrates the condition of the revetment after the November storm. After the snow and ice disappeared in the spring of 1975, however, the revetment was still in quite good condition. Settlement had lowered the top edge about a foot in some places.

There is evidence that the steel wall which projects out from the shore adjacent to the north end of this project may have caused reflections which increased the destructive force of the waves in that area. The 75 feet of revetment immediately adjacent to the steel wall has suffered severe slumping, whereas the next 75 feet is virtually undamaged.

Maintenance. The revetment is beyond repair at this point in time; it would cost as much to repair the structure as it would to rebuild it entirely. After the damage experienced in the fall of 1974, the structure could have been repaired by replacing and regrading lost sand and by placing additional rock and asphalt mastic in those areas where the revetment had begun to collapse.

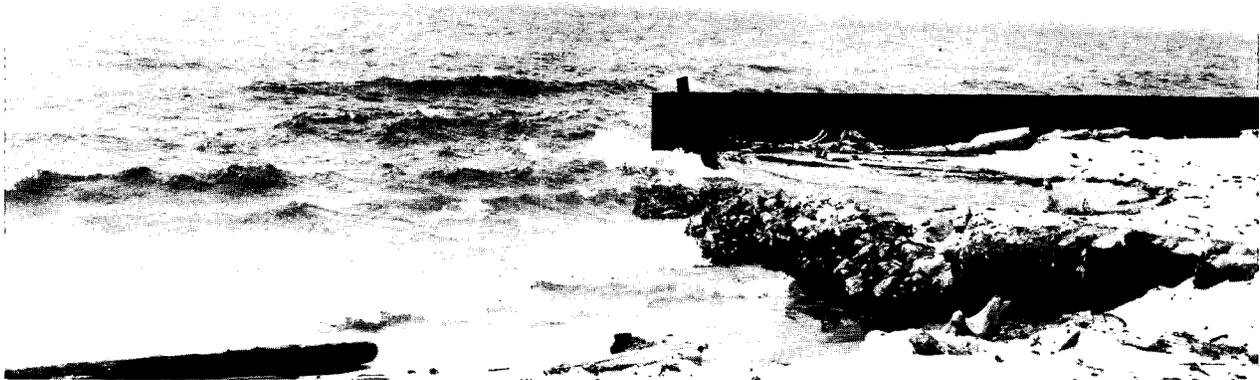
The gabion return wall in the south has failed. The backfill material has been washed out from behind the wall. The gabion cut-off walls have been flanked, and some further bluff recession appears to have taken place.

Photo #4 May 19, 1975  
Condition of the gabion return wall after several months of service.

Maintenance. A number of repairs must be made at this site to enable these structures to prevent further damage. The center cut-off wall needs to be extended further back into the existing bluff, while the gabion return wall in the south needs to be replaced in its entirety. The tie-backs installed next to the existing seawall need to be secured to pilings, and the backfill material needs to be replaced.

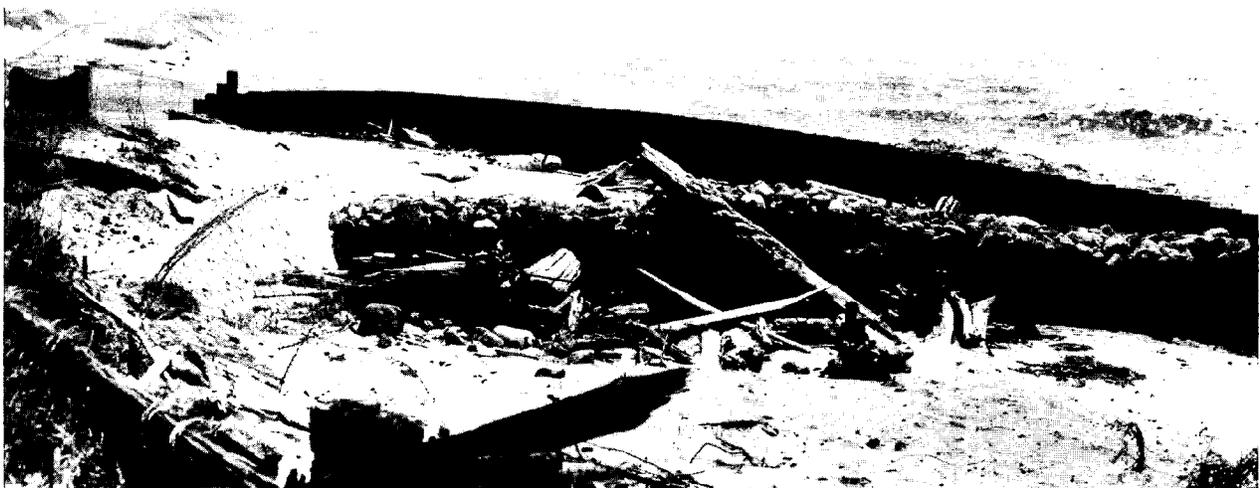
Analysis. The south groin was poorly constructed and failed, while the center groin, also poorly constructed, was too short to be functional. As a result, severe overtopping by waves has washed out about half of the backfill. Removal of the backfill also revealed that the tie-backs had not been completed properly. On June 5, 1975 the water in front of the steel wall was 8 feet deep, but the wall had not failed.

Photo #5 May 19, 1975  
Damage to gabion return wall by winter storms. Gabion cut off walls were flanked and backfill washed out from behind wall. Improper tie-back usage is evident.

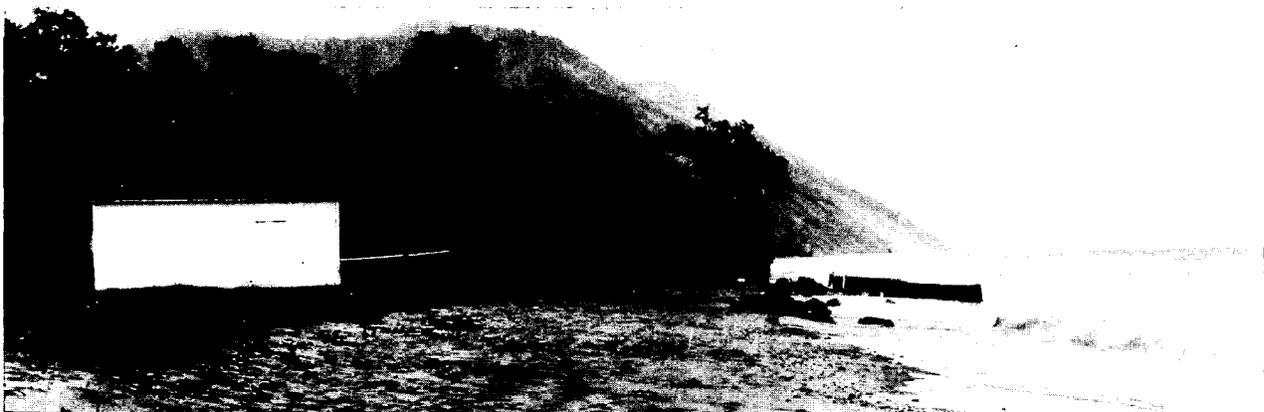
Photo #6 October 6, 1974  
Only a few remaining fragments of the Longard tube structure can be seen.  
Bluff recession was 25 feet during the year of study.

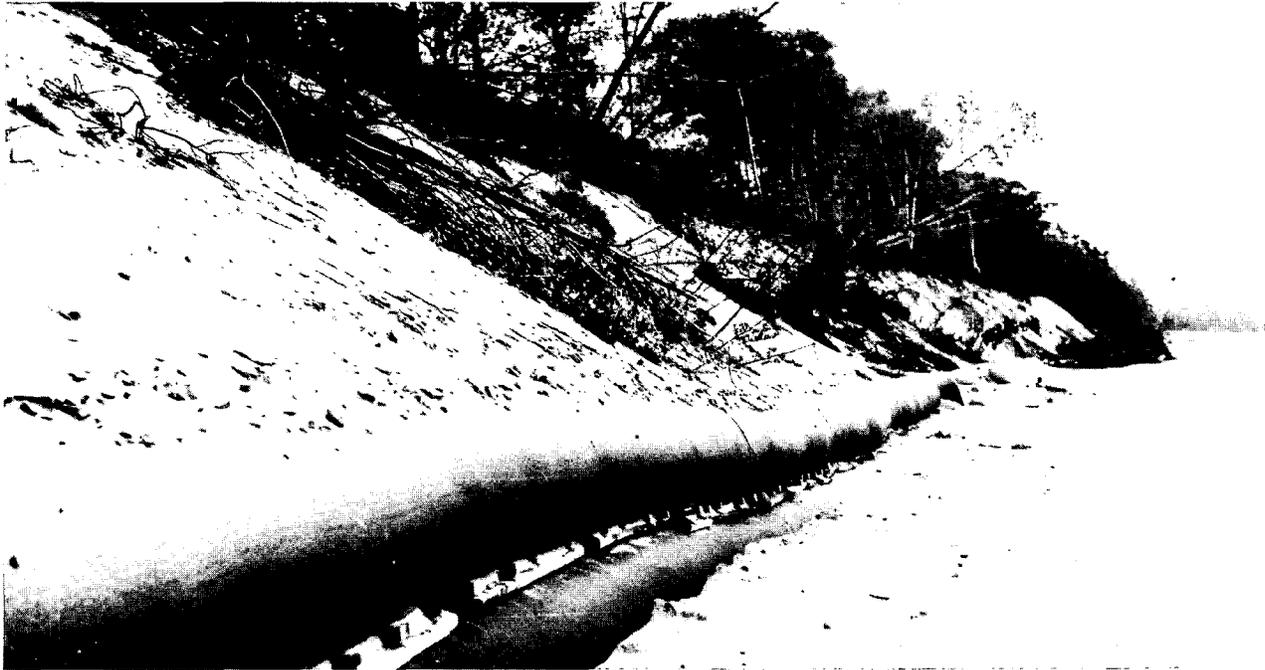
Photo #7 October 5, 1974  
Shims were added to help hold the top tube in place against the back pressure of the slumping bank.

Maintenance. The top Longgard tube has been shimmed with wooden wedges to increase its stability. Some additional shims may be required to help hold the top tube in place. A number of missing sand bags should be replaced.

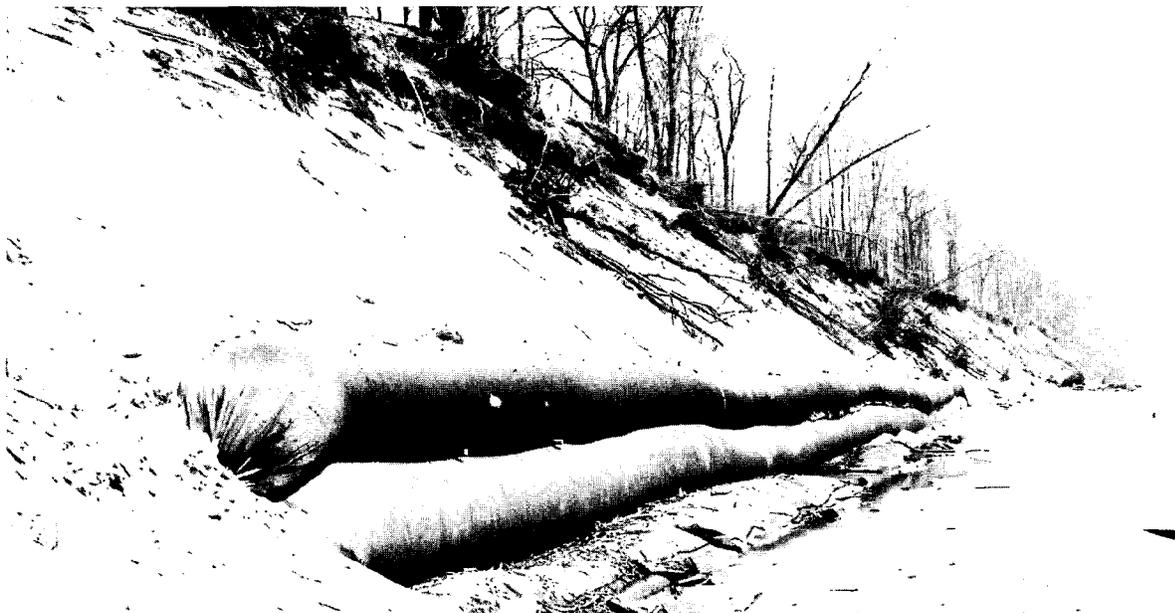
Photo #8 May 18, 1975  
Lost shims have not prevented the tubes from remaining relatively stable.

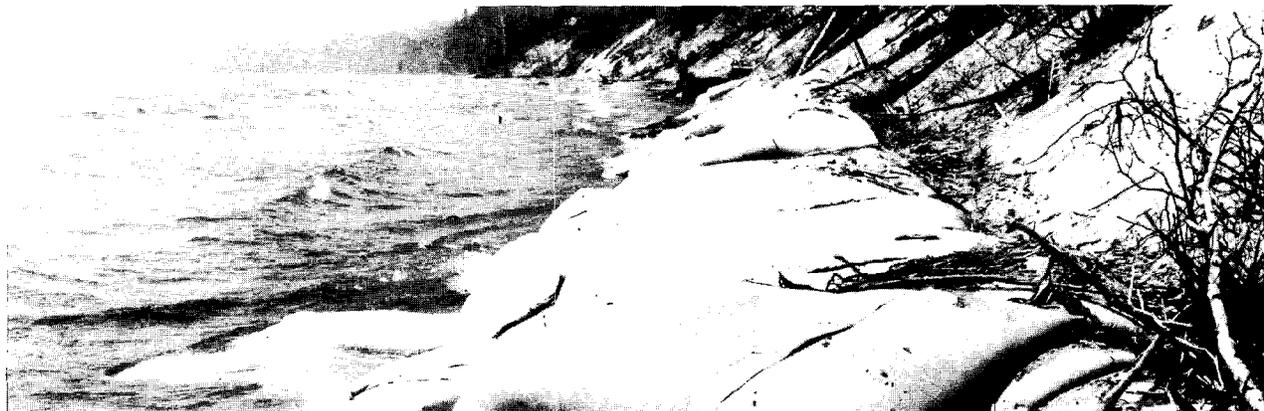
Photo #10 May 18, 1975  
 Winter storms caused some sand bags to shift and others to be lost.

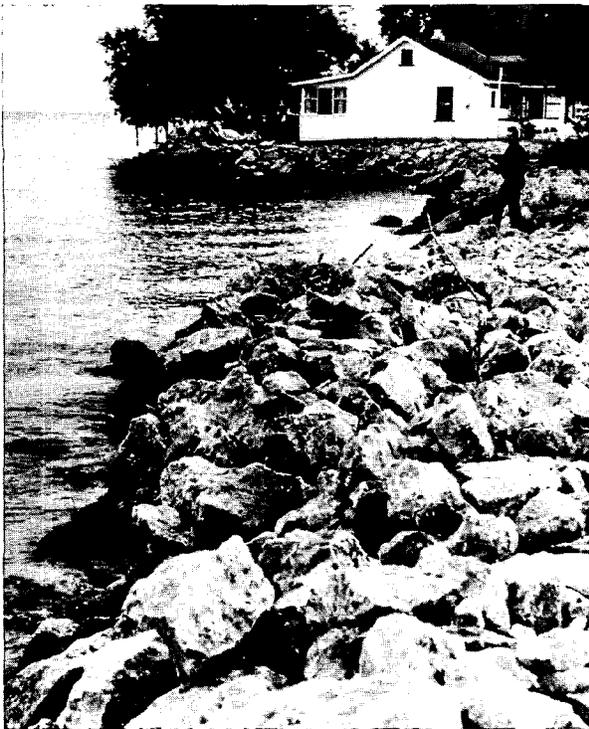
Photo #11 July 30, 1974  
This photograph was taken shortly after completion of the project.

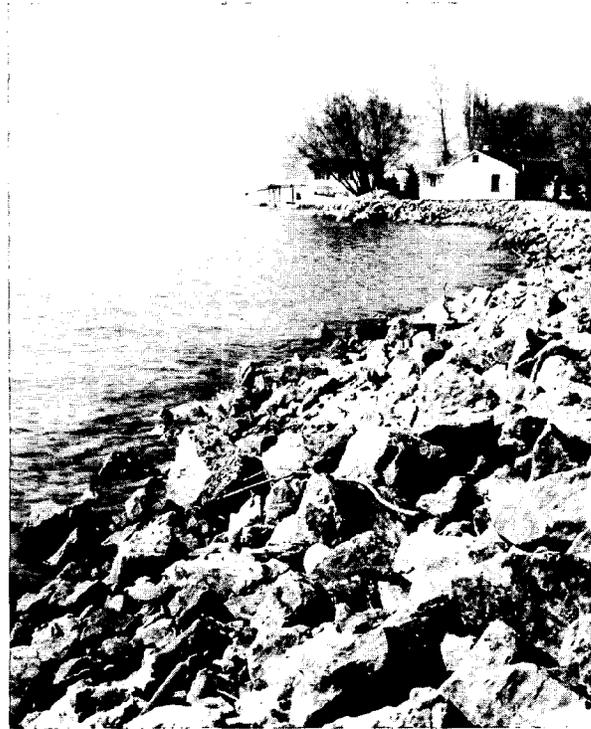
Condition. Diagrams #7 and #8 and Photos #11 and #12 show the condition of the site. No further erosion or recession of the bluff has occurred to date. Some of the rock has begun to slump and slide toward the lake, although this movement has been minimal to date. It should be noted that further storm activity may cause additional shifting.

Photo #12 May 17, 1975  
After the first storm season, minor rock shifts are noted.

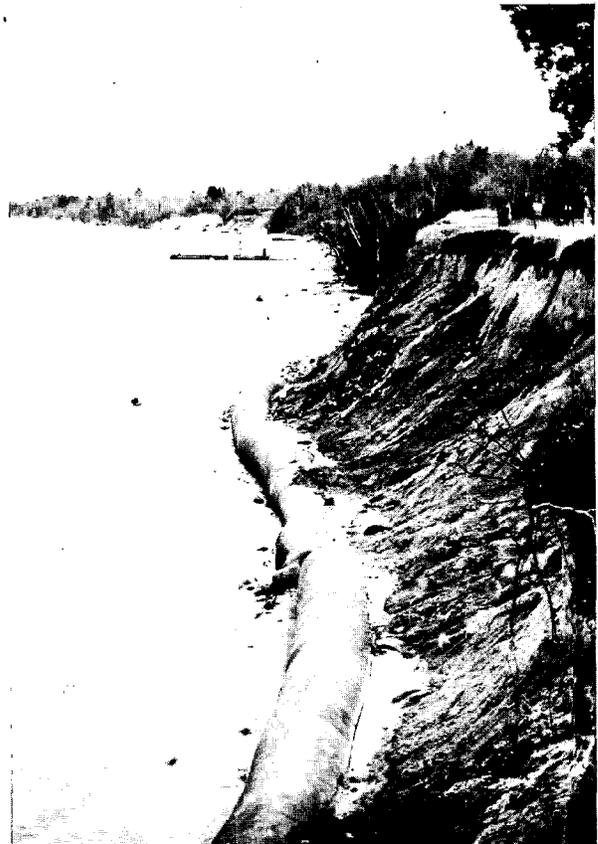
Condition. Diagrams #9 and #10 and Photos #13 and #14 show the condition of the site. The field surveys show no substantial movement of the tubes in either a vertical or horizontal direction. Some minor slumping has been detected which can probably be attributed to terrestrial processes. One critical storm has been experienced at this site since installation, and the tubes appear to be performing satisfactorily.

Photo #14 April 29, 1975  
The tubes have remained stable although bluff slumping is evident.

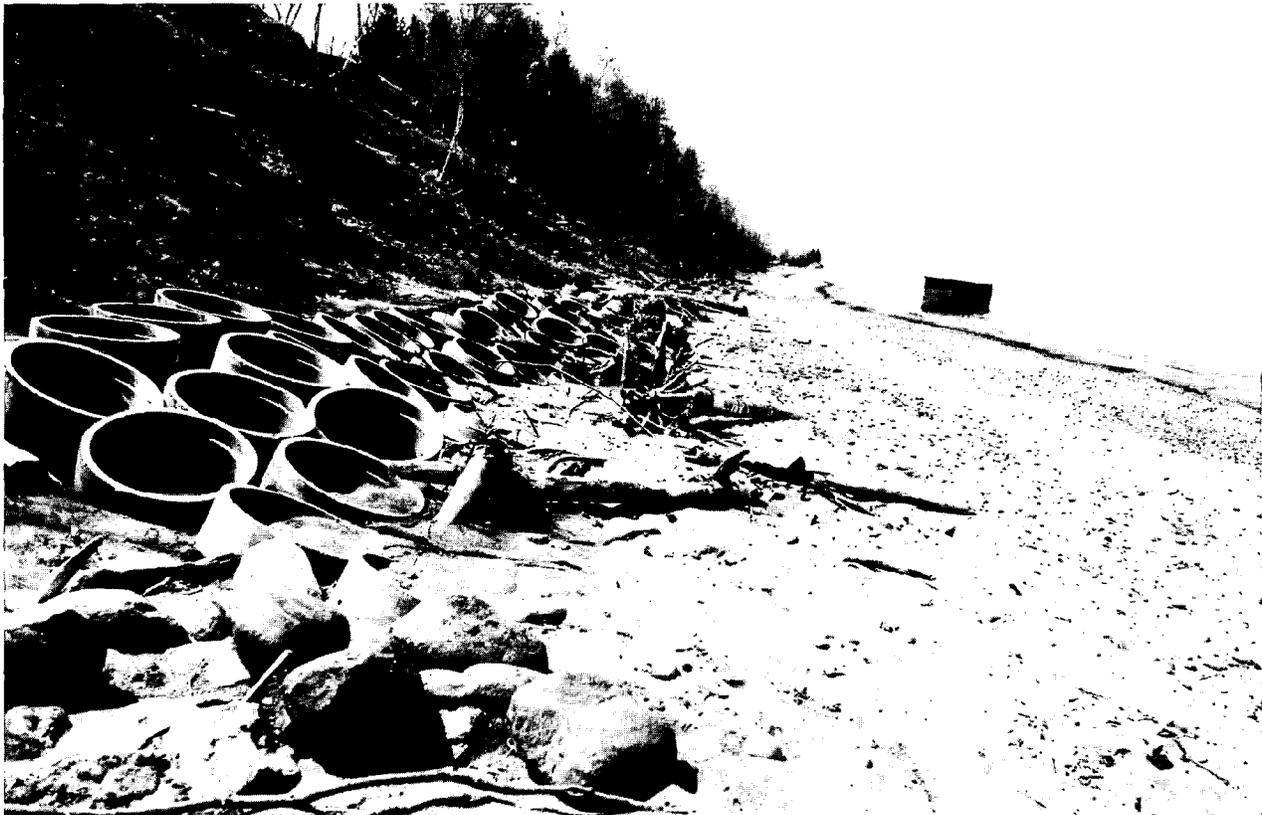
Condition and Analysis. Some of the lower rows have been covered with beach sand and most of the other rings are nearly filled with sand. This appears to be due to wave action. The eastern portion of the revetment, which was placed on a rock foundation without tie rods, has been forced upward along its landward edge by clay sliding from the bluff. The slide appeared to be due to unstable conditions which occurred when the steep bluff was very wet during the spring. The upper rows of rings were moved about quite a bit, as shown in Photo #16. Wave action may have contributed somewhat to the movement of the rings. However, a local observer reported that no major northerly storm has occurred since the ice went out. This is borne out by the fact that there has been little toe erosion this spring at the unprotected bluffs to the east and west of the revetment. Some of the movement of the rings could have been caused by ice piling up on the shore.

Photo #16 May 21, 1975  
The Nami Rings have shifted and filled with sand.

Design Modifications. The revetment has not been tested sufficiently to indicate specific design changes. If the bluff behind the revetment had been cut back to a 2 to 1 slope, much of the sliding which caused the displacement could have been avoided.

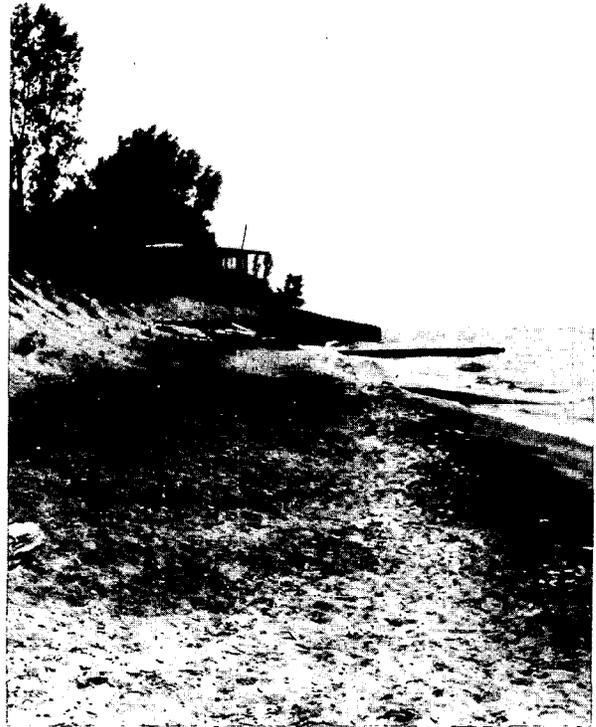
Condition. Diagrams #11 and #12 and Photo #17 show the condition of the tube. It has continued to settle, but its rate of settlement has dropped off substantially. In spite of total settlement (which has amounted to as much as 3 feet at the outer end since installation) the tube is still trapping sand and offering protection. The rip in the structure which was observed earlier does not seem to have caused much loss of sand.

Photo #17 July 18, 1974  
A typical example of conditions  
at this site. Both groins  
are providing shore protection.

Maintenance. The rip in the tube needs to be repaired. An attempt was made previously to repair the tube by sewing the hole together, placing patching material over the entire area and sealing the repair work with roofing cement. This method proved to be ineffective as the hole reopened soon afterward. In all likelihood, grouting this tube with portland cement concrete would probably be the best way to repair it. This would not only seal the hole, but would also hold the remaining sand in place and offer substantial resistance to further damage.

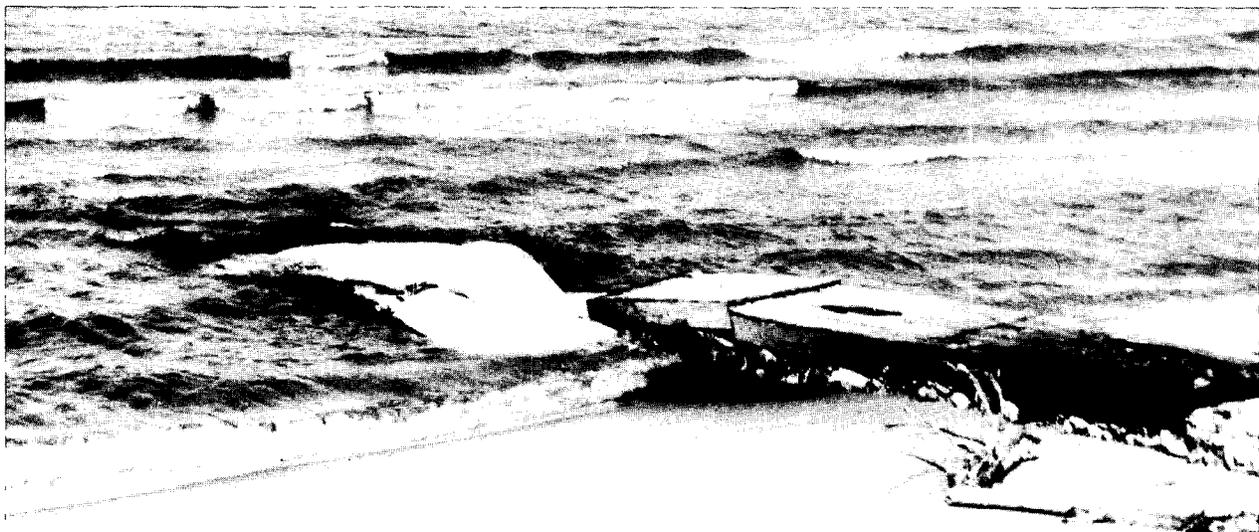
Photo #18 October 20, 1974  
The sand bag-gabion arrangement is shown here. Some bags have lost sand and have shifted.

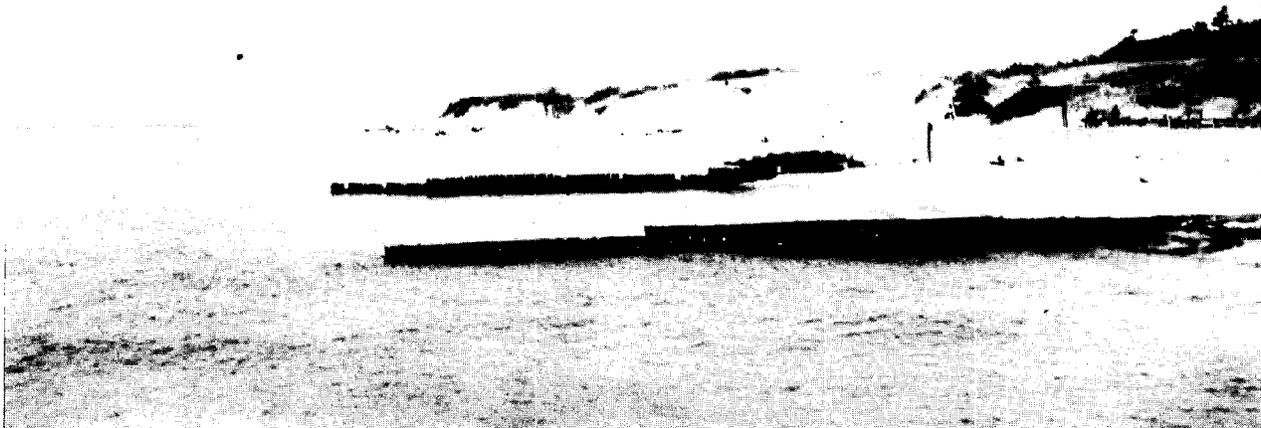
Photo #20 October 20, 1974  
The groins at this site have required continual maintenance. A third groin (shown in background), which was built last and is not a part of the project, has fallen over.

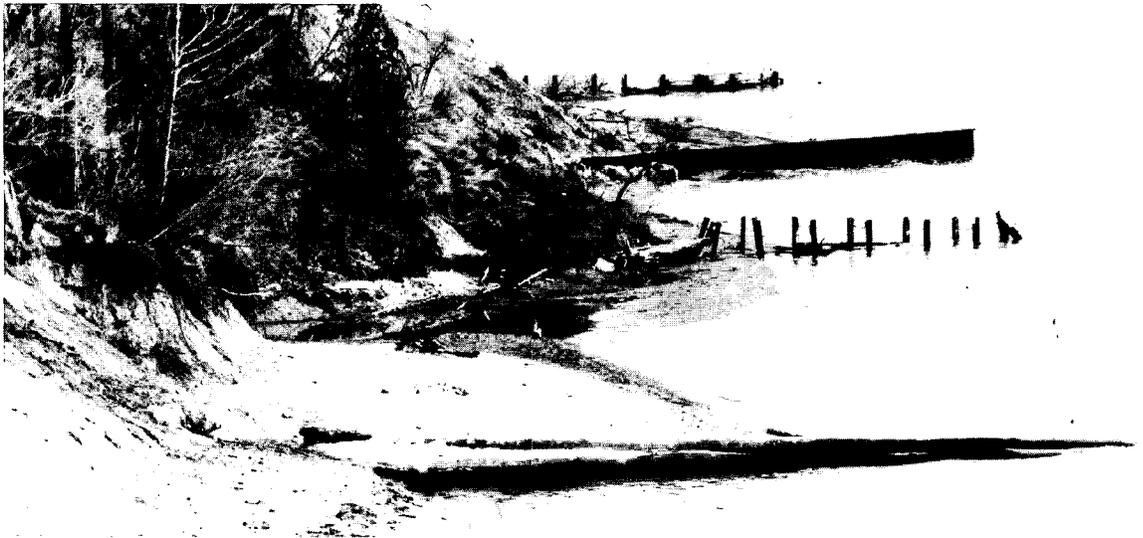
Photo #22 April 27, 1975  
Settlement in the south tube is evident here. The groin is still effectively trapping sand.

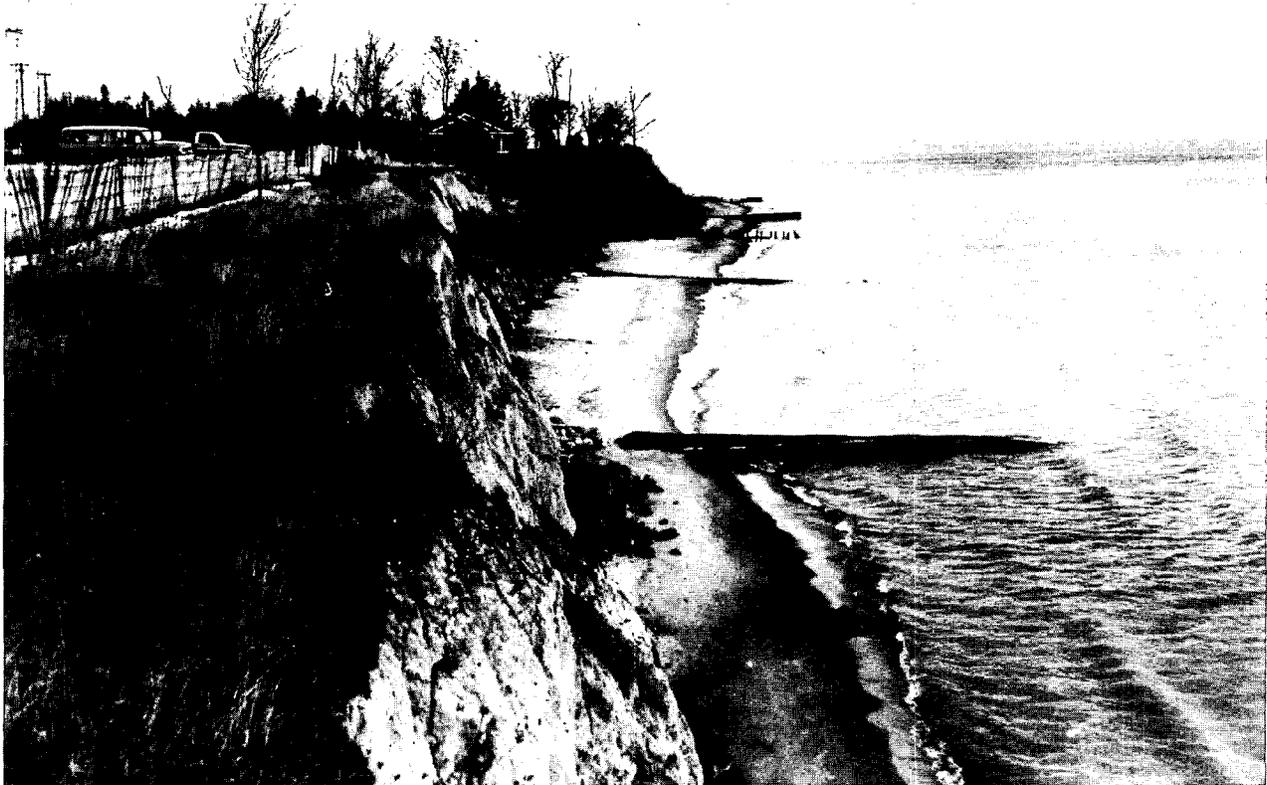
Photo #23 November 17, 1974  
The condition of the 69'' diameter Longard tube has remained relatively stable since installation. Note the other Longard tube in the background.

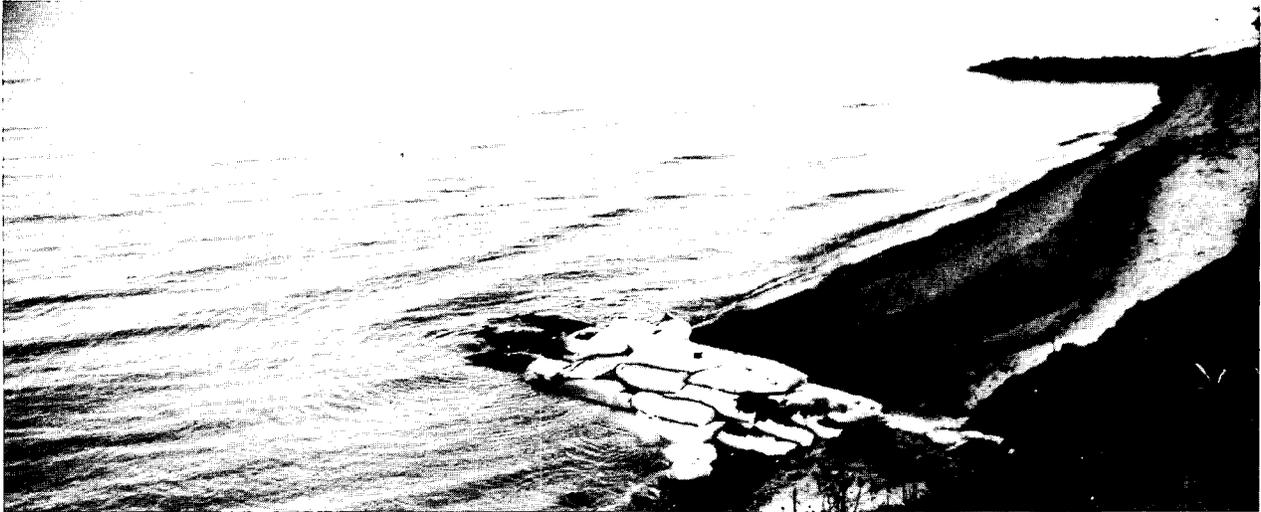
Photo #24 November 17, 1974  
The groin at this site has lost a number of bags, but is still trapping sand and helping to build a beach.

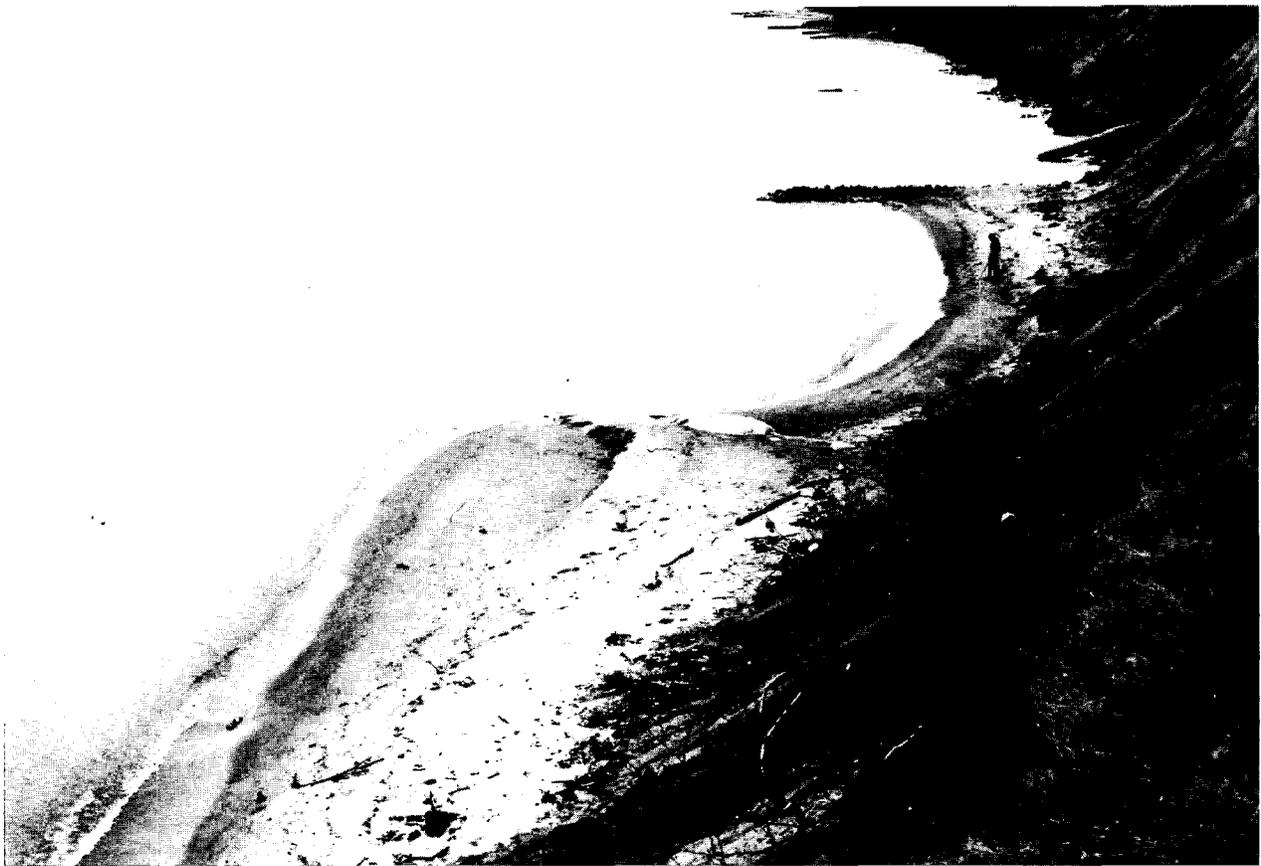
Photo #25 April 27, 1975  
Both the sand bag (which has lost many bags) and the rock mastic groin are shown here.

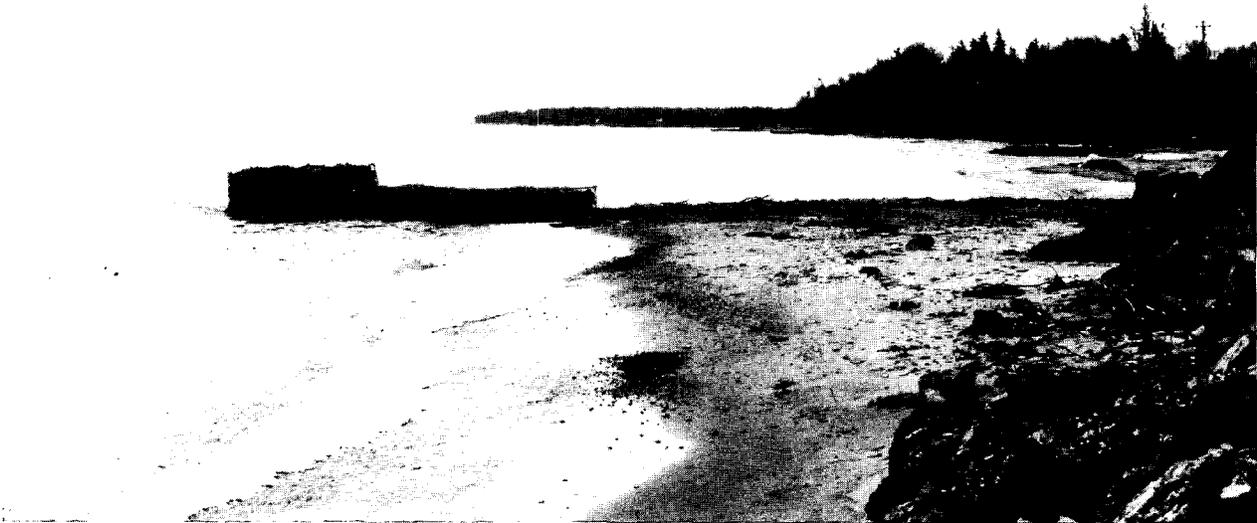
Photo #27 April 27, 1975  
This gabion groin is already building a beach. Note the sand bag installation and the rock mastic groin in the background.

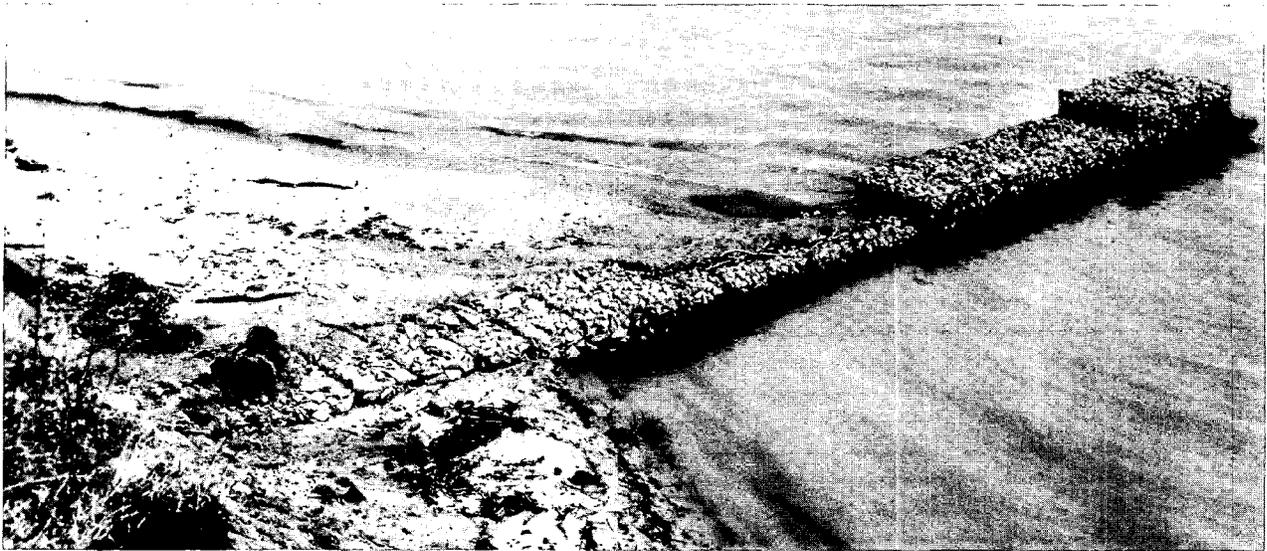
Photo #28 April 27, 1975  
 Another view of the gabion groin shows its "stepped" configuration.

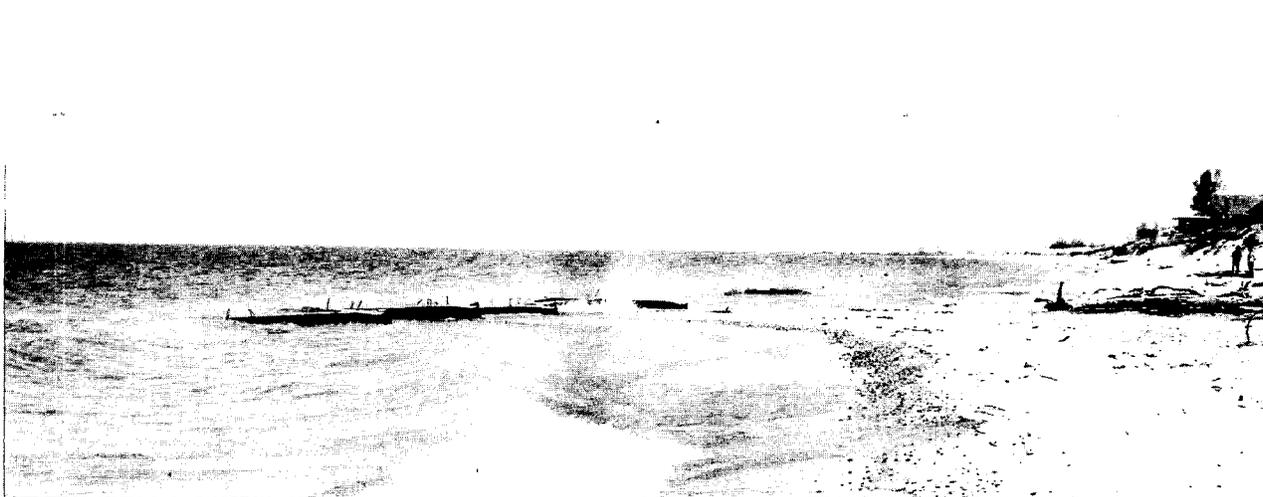
Photo #30 May 19, 1975

The north breakwater, which was only 56' long, seemed to experience the most damage. The longer sections (70' long) were not damaged as much, thus indicating that short sections may be more vulnerable.

The center and north panels are shown here; both have settled.

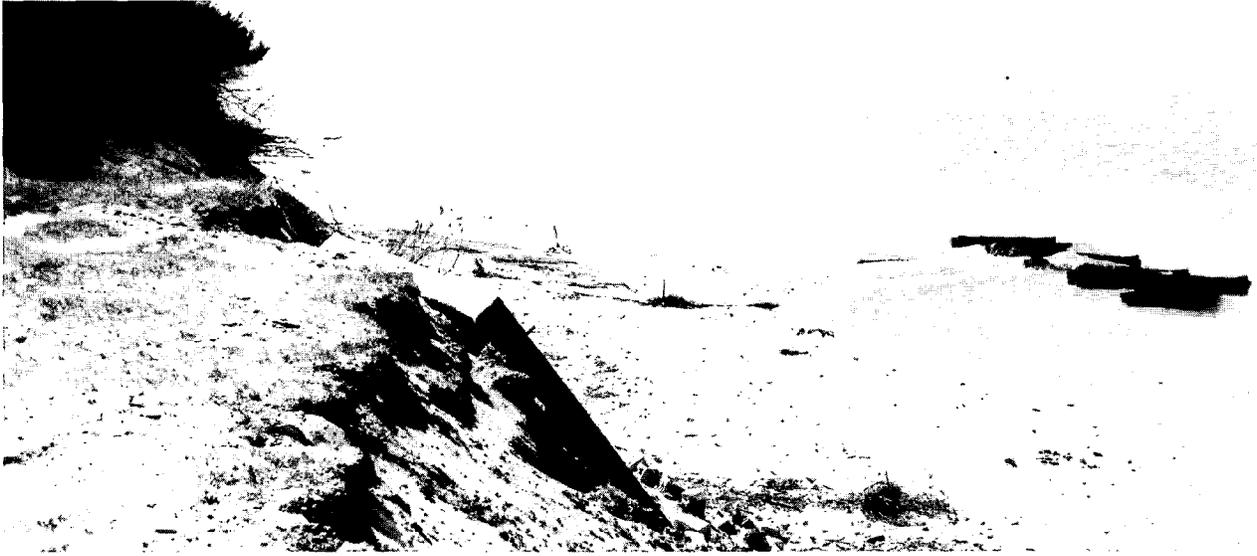
Photo #33 May 19, 1975  
These are the remains of the bathhouse. The foundation slab is lying in a litter of blocks.

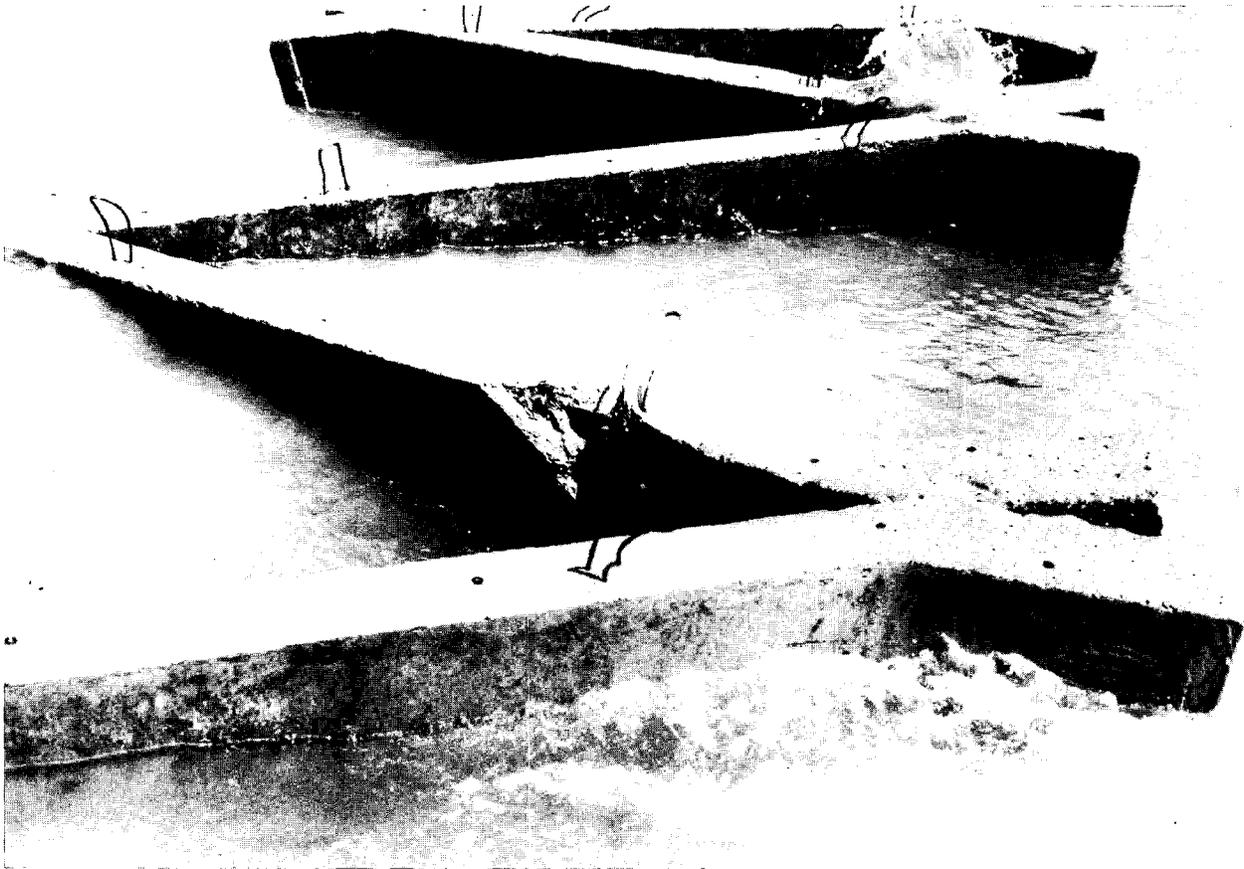
Photo #34 May 19, 1975  
The force of the water was great enough to crack and break up portions of these concrete panels.

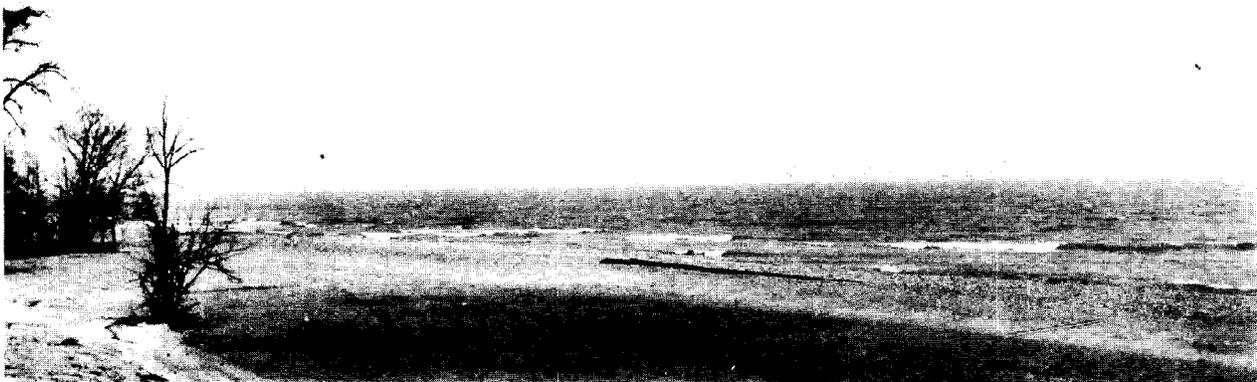
Photo #35 May 6, 1975  
Sand has covered all but small portions of the tube. The structure is no longer needed and is not functioning as a shore protection device.

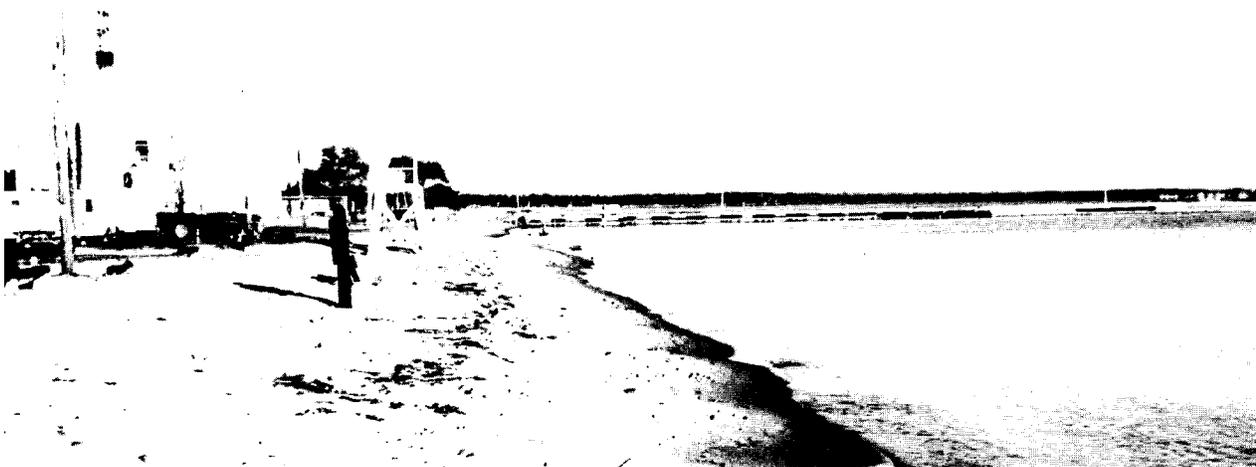
Photo #39 October 20, 1975  
Although the sand fill has shifted, it still offers shore protection.

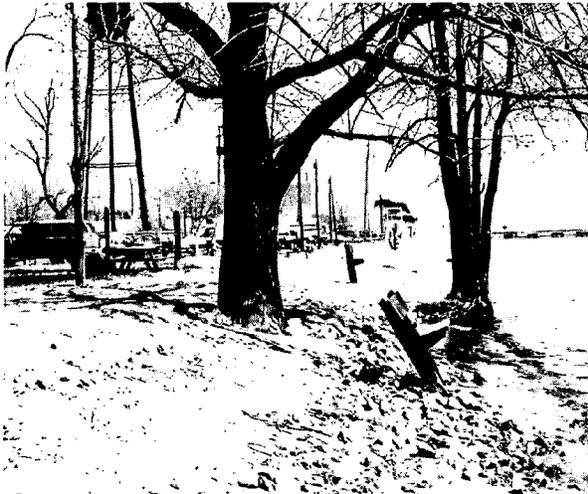
Photo #40 May 17, 1975  
 During the winter some of the small rock revetment was displaced and more sand was moved.
