[Docket No. 94-NM-231-AD; Amendment 39-9116; AD 95-01-05]

Airworthiness Directives; Boeing Model 757 Equipped With Pratt & Whitney Model PW2000 Series Engines

95-01-05 Boeing: Amendment 39-9116. Docket 94-NM-231-AD.

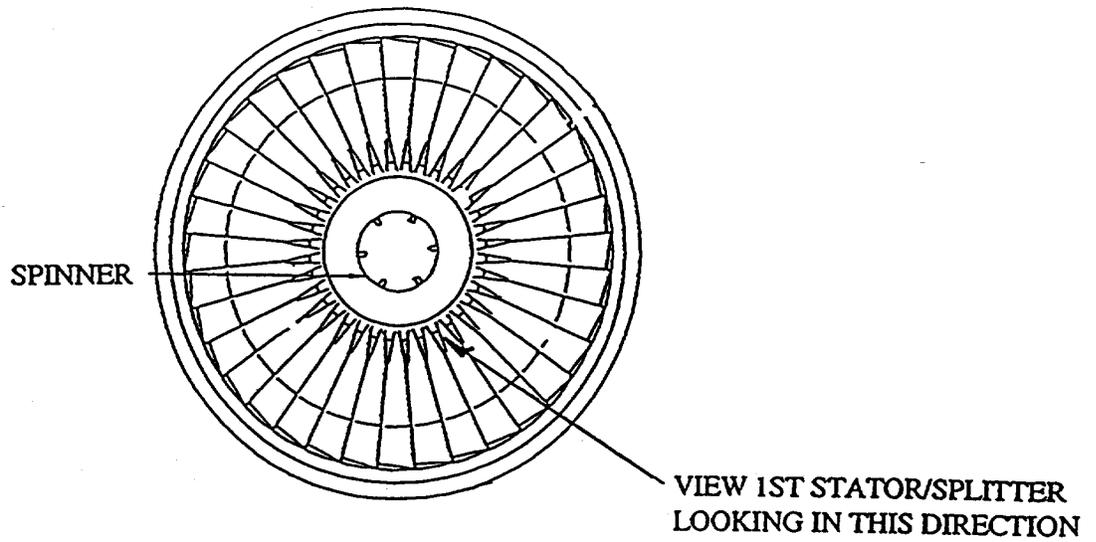
FIGURE 1

(1) Use adequate lighting to illuminate the first stage of the LPC stator. This stator can be viewed by standing at ground level, off to the side of the centerline of the engine, and viewing through the opening between the fan blades. (See Appendix 1, Figure 1 of this AD.) If ice is present, it will be seen to build up on the leading edge of the first stage of the LPC stator or the lip of the splitter. (See Appendix 1, Figure 2.)

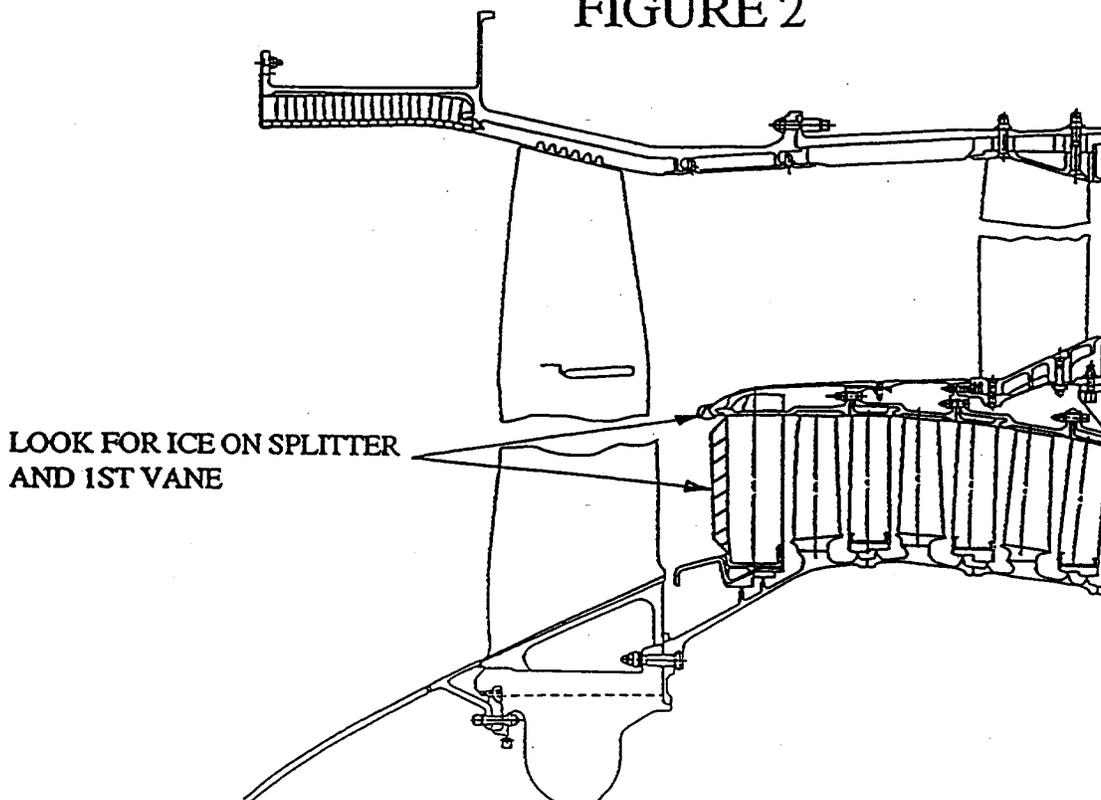
FIGURE 2

(c) If any ice is detected on the first stage of the LPC stator (see Appendix 1, Figure 2) during the visual check required by paragraph (b) of this AD, it must be removed prior to dispatch of the aircraft, in accordance with the procedures specified in paragraph (c)(1) or (c)(2) of this AD, as applicable.

(2) If the total ground operating time since the last run-up to 50 percent N_1 is greater than 30 minutes, and the engine has been visually checked and it has been determined that ice has accumulated on the leading edge of the first stage of the LPC stator, the following "Ice Removal" (hot air de-icing) method must be used. Do not use hot water or aircraft de-icing fluids.

De-ice the leading edge of the first stage of the LPC stator with the use of a suitable hot

air source (e.g., heating cart). At no time should the temperature of the air supplied exceed 175 degrees Fahrenheit. Direct the air past the fan blades toward the first stage of the LPC stator. Continue hot air de-icing this LPC stator until all of the ice has been melted. Melted ice and ice chunks, which have been dislodged, should not be allowed to accumulate at the bottom of the fan duct where they could refreeze and become ingested into the engine during the next engine run-up.
