[Docket No. 94-SW-27-AD; Amendment 39-9276; AD 95-06-03]

Airworthiness Directives; Robinson Helicopter Company Model R22 Helicopters

95-06-03 Robinson Helicopter Company: Amendment 39-9276. Docket No. 94-SW-27-AD.

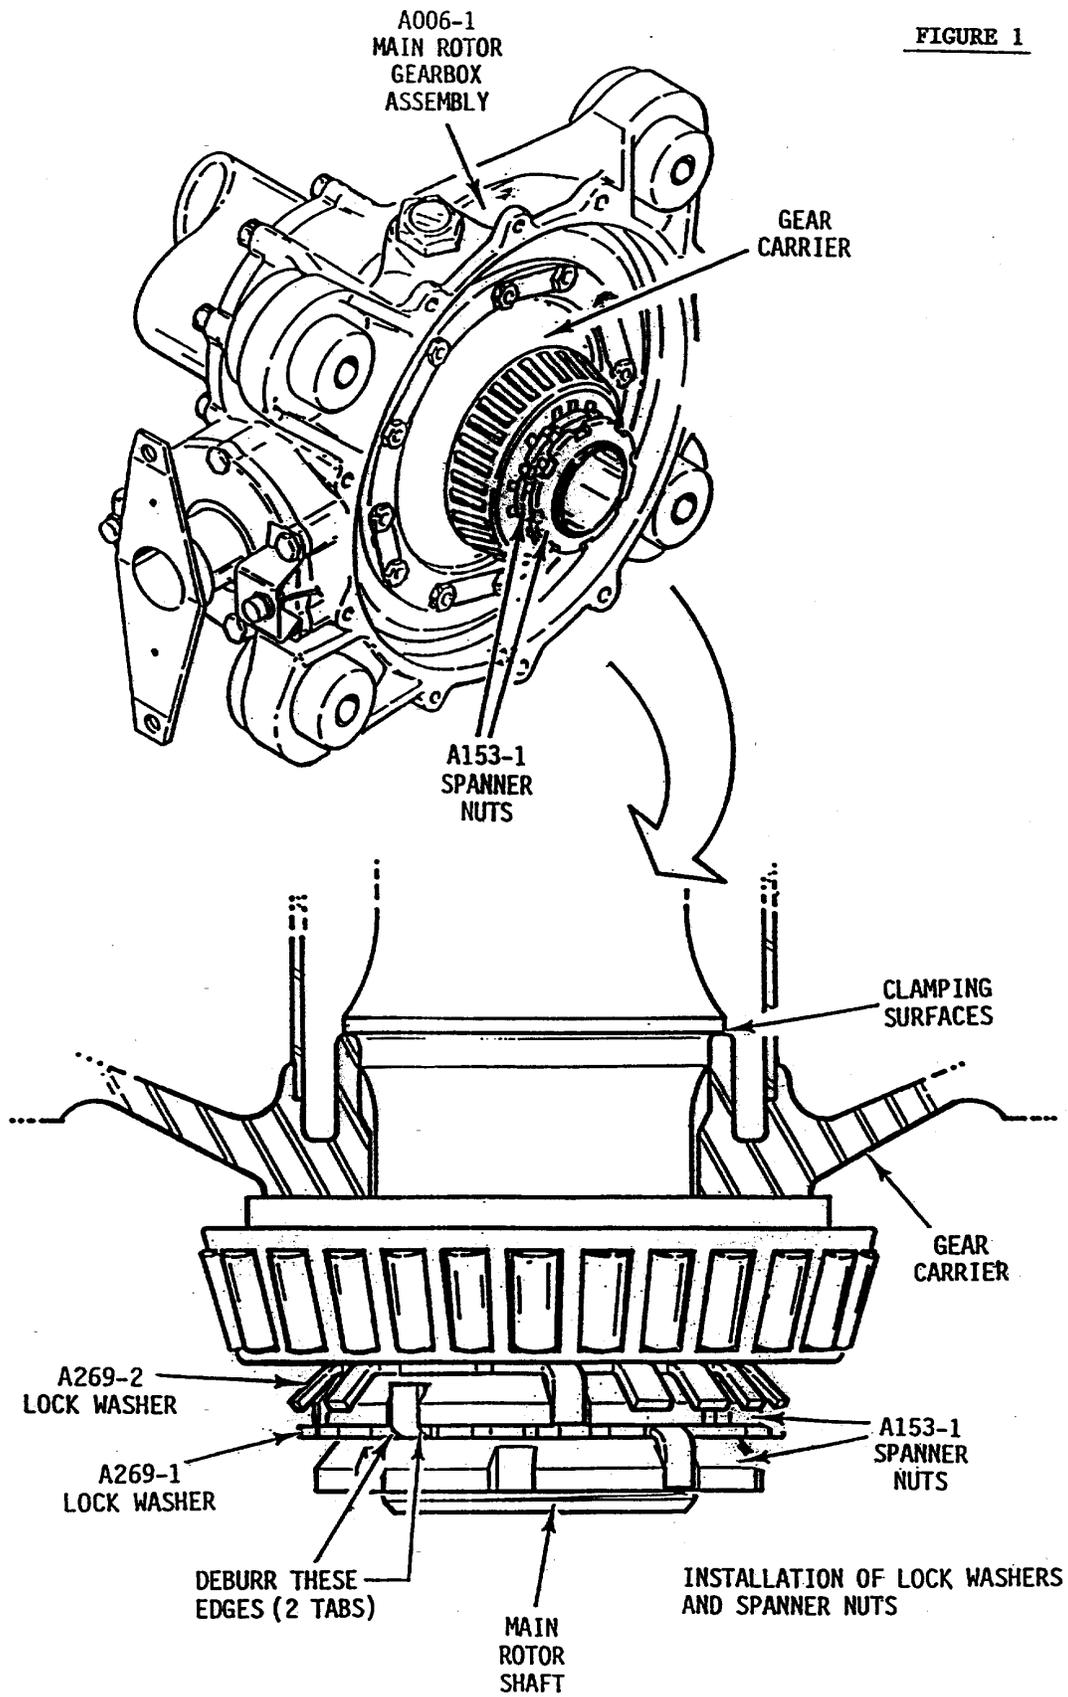
FIGURE 1

(viii) Before installing the lock washer, P/N A269-1, note that the edges are sharp on one side and rounded on the other. De-burr the sharp edges on two opposite tabs (see figure 1). This will reduce the chance of cracking when these tabs are bent up. Install the lock washer with the rounded edges toward the installed nut.

(ix) Apply anti-seize, P/N A257-9, to the chamfered-side face and threads of the lower nut. Align the two de-burred tabs with the upper nut and install the lower nut with the chamfered side against the lock washer. Hand-tighten the nut to hold the washer in place. Bend the two de-burred tabs up to lock with the upper nut. Torque the lower nut to between 90 and 120 ft.-lb., as required to align the two additional tabs. Do not untorque the nut to align the lock washer tabs with the nut. For the two tabs that are aligned with the recessed areas, bend down the tabs into the recessed areas of the nut to lock the lower nut.

(x) Verify that all six bent tabs properly engage the nuts (four tabs to the upper nut and two to the lower nut), and inspect the edges of the bent tabs for cracks. Replace any cracked lock washers. Remove excess anti-seize compound.
