[Docket No. 98-NM-323-AD]

Airworthiness Directives; Boeing Model 757-200, -200PF, and -200CB Series Airplanes Powered by Rolls-Royce RB211-535C/E4/E4B Turbofan Engines

ACTION: Supplemental notice of proposed rulemaking; reopening of comment period.

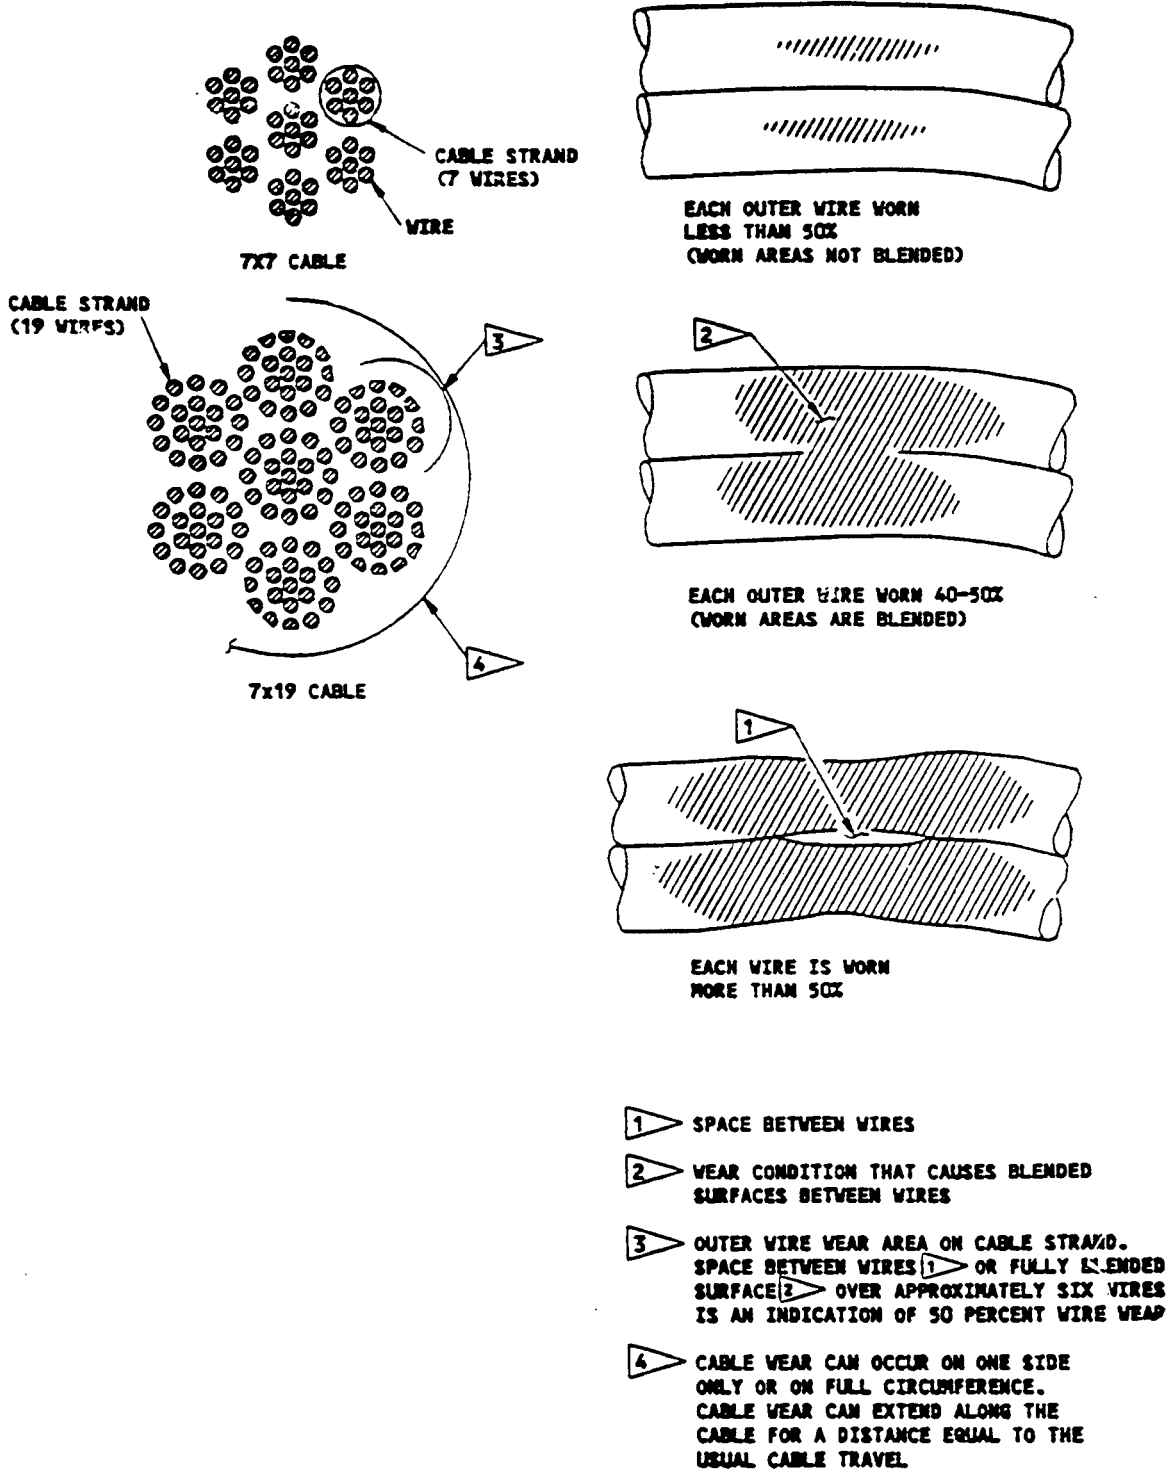
FIGURE 1

(1) One cable strand had worn wires where one wire cross section is decreased by more than 40 percent (see Figure 1),

B. Perform a detailed visual inspection of the cable runs to detect incorrect routing, kinks in the wire rope, or other damage. Replace the cable assembly if:
