SUMMARY: This amendment supersedes Airworthiness Directive (AD) 75-23-08 R5, which currently requires repetitively inspecting and replacing or repairing the exhaust system on certain Cessna Aircraft Company (Cessna) 300 and 400 series airplanes. The requirements of this AD replace the inspections and replacements that are required by AD 75-23-08 R5 with inspections and replacements containing new simplified procedures for all 300 and 400 series airplanes (models affected by the current AD plus additional models). This AD also revises the inspection intervals and requires replacing certain unserviceable parts and removing the exhaust system for a detailed inspection. This AD is the result of numerous incidents and accidents relating to the exhaust systems on Cessna 300 and 400 series airplanes dating from the middle 1970's to the present, including six incidents since issuance of AD 75-23-08 R5 where exhaust problems were cited. The actions specified by this AD are intended to detect and correct cracks and corrosion in the exhaust system, which could result in exhaust system failure and a possible uncontrollable in-flight fire with pilot and/or passenger injury.

Appendix to Docket

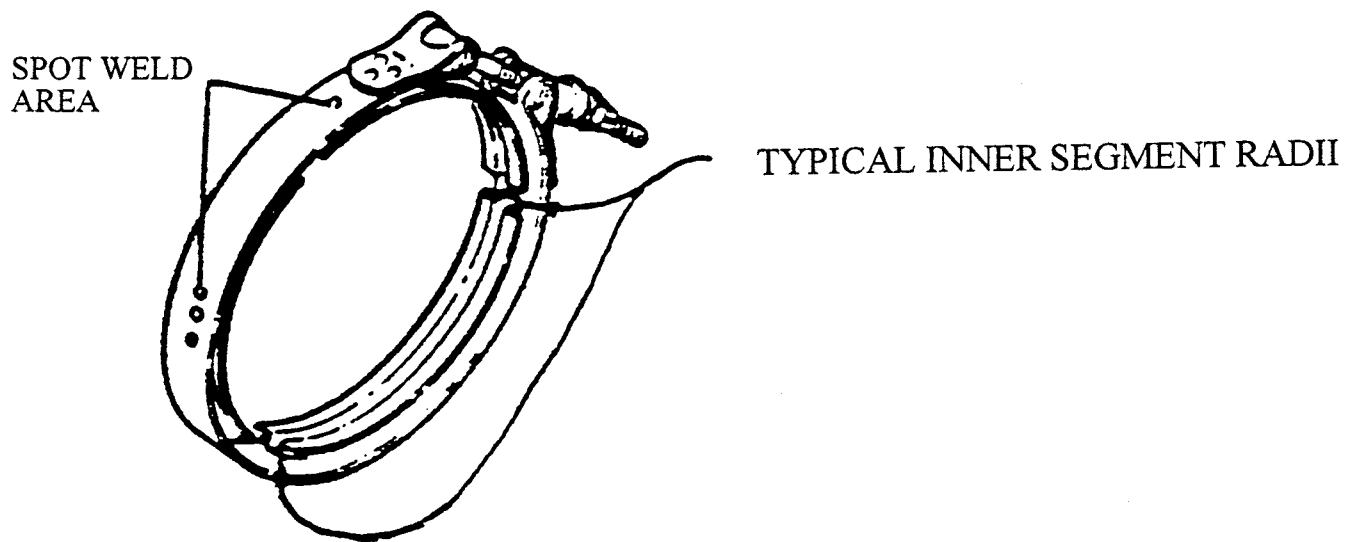
FIGURE 3 to the Appendix

Multi-Segment "V" Band Clamp

The FAA’s intent was to maintain the V-band replacements from AD 75–23–08 R5. Based on this and after evaluating all the comments and information on this subject, the FAA has revised the proposal to only require replacement of the multi-band V-clamps at 500-hour TIS intervals. Inspection of the other V-band clamps is part of the exhaust system inspections required by this AD.
