Airworthiness Directives; Schweizer Aircraft Corporation Model 269A, 269A-1, 269B, 269C, and TH-55A Helicopters

2001-25-52 Schweizer Aircraft

Corporation: Amendment 39-12726.

Docket No. 2001-SW-58-AD.

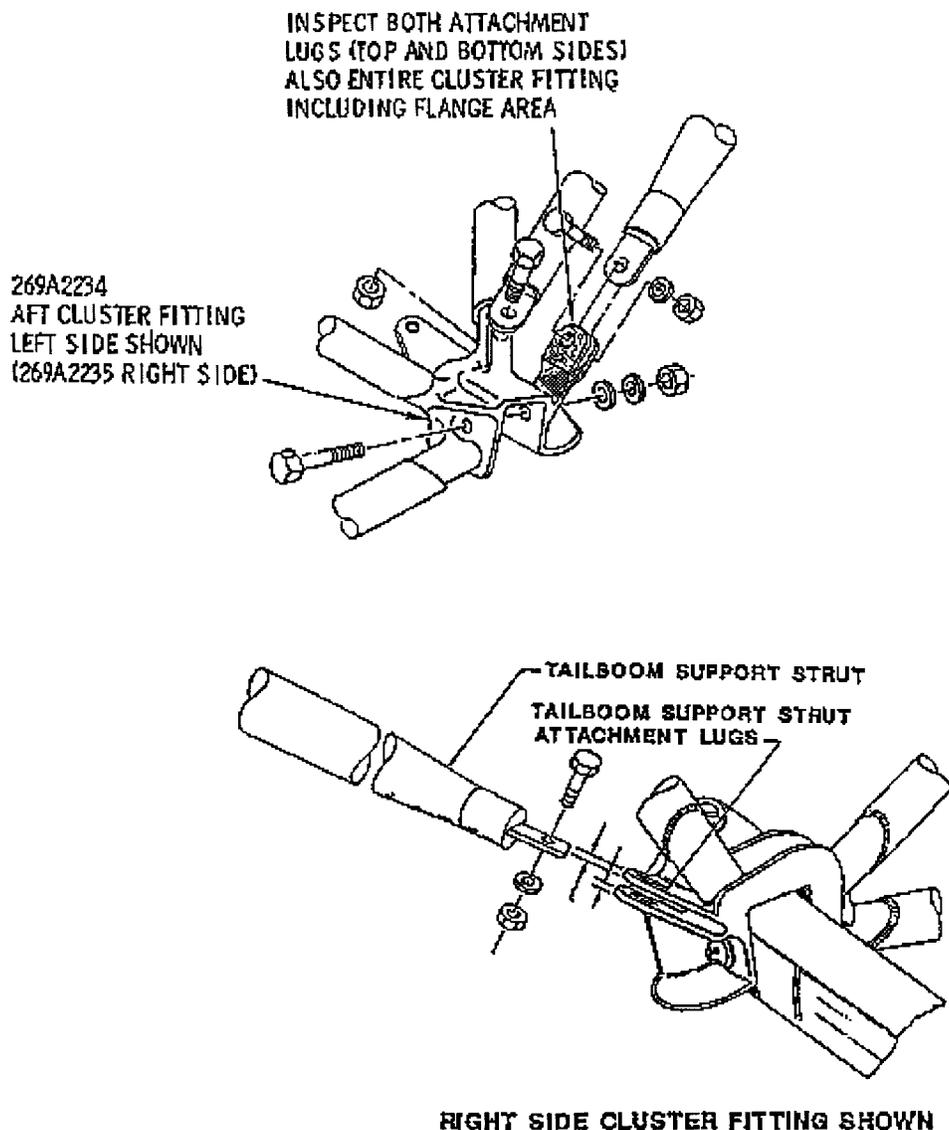
Figure 1

To prevent failure of a strut clevis lug (lug) on a center frame aft cluster fitting (cluster fitting), rotation of a tailboom into the main rotor blades, and subsequent loss of control of the helicopter, accomplish the following:

(2) Dye-penetrant inspect the lugs on each aft cluster fitting. See Figure 1.

(3) If a crack is found, before further flight, replace the cracked cluster fitting with an airworthy cluster fitting. Cluster fittings, P/N 269A2234 and 269A2235, are not eligible to replace a cracked cluster fitting.
