[Docket No. 2002-SW-38-AD; Amendment 39-12935; AD 2002-22-10]

Airworthiness Directives; Bell Helicopter Textron Canada Limited Model 407 Helicopters

2002-22-10 Bell Helicopter Textron

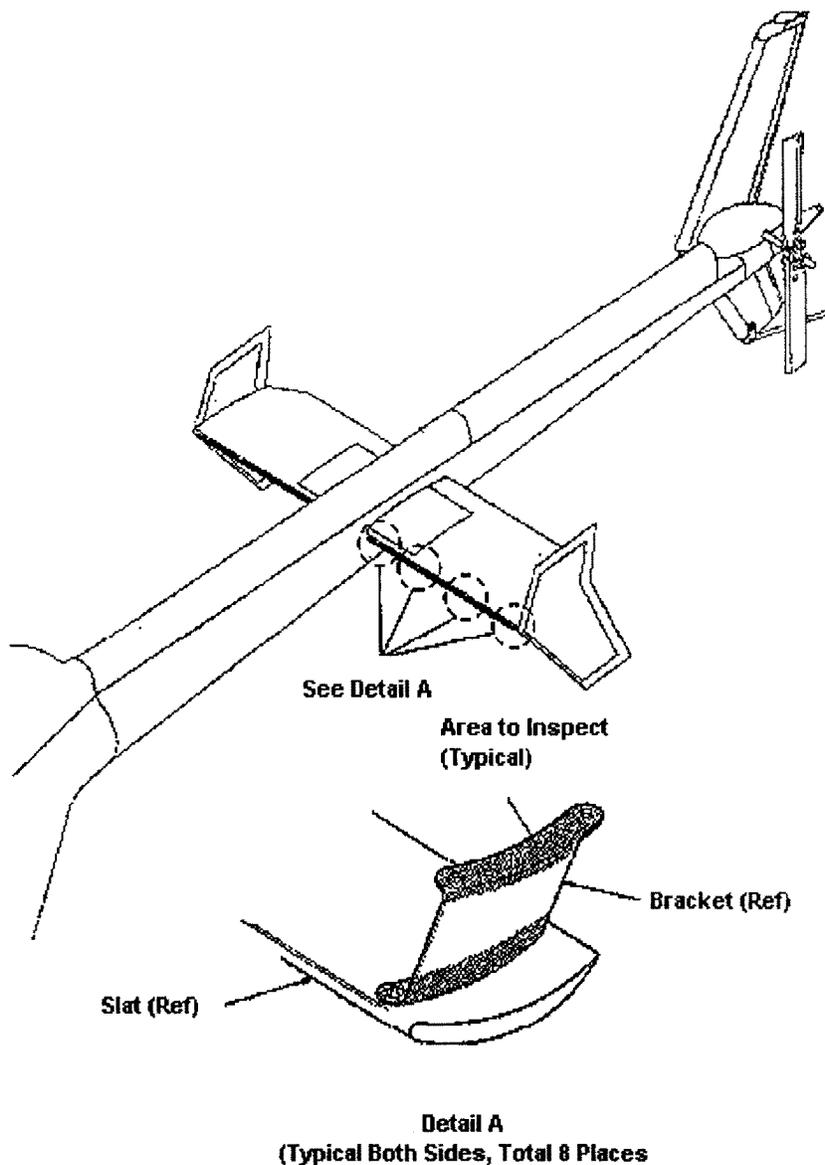
Since issuing that AD and since installing the newly designed slat assembly, part number (P/N) 407-023-001-101 on affected helicopters, two additional cracked slat brackets have been reported. These occurrences are attributed to a design flaw and improper installation of the slat assembly.

(1) Within 10 hours time-in-service (TIS) and thereafter before the first flight of each day, check each slat for a crack at the radius

of each bracket, part numbers (P/N) 206-023-119-109, -110 or 407-023-801-127, -128, or

407-023-001-119, -120, or -121, as shown in Figure 1 of this AD:

Figure 1. Pre-Flight check of brackets, horizontal stabilizer slats.

(3) If a crack is found, before further flight, replace slat assembly, P/N 407-023-002-117 or 407-023-001-101, with an airworthy, segmented slat assembly, P/N 407-023-001-103.

(1) For helicopters, S/N 53000 through 53498, replace slat assembly, P/N 407-023-002-117 and 407-023-001-101, with an airworthy, segmented slat assembly, P/N 407-023-001-103, in accordance with the Accomplishment Instructions, Part II, Bell Helicopter Textron Alert Service Bulletin 407-02-52, dated March 20, 2002 (ASB).
