[Docket No. 2002-SW-55-AD; Amendment 39-13060; AD 2002-25-51]

Airworthiness Directives; Agusta S.p.A. Model A109E Helicopters

2002-25-51 Agusta S.p.A (Agusta): Docket No. 2002-SW-55-AD. Supersedes AD 2002-17-51, Amendment 39-12936, Docket No. 2002-SW-42-AD.

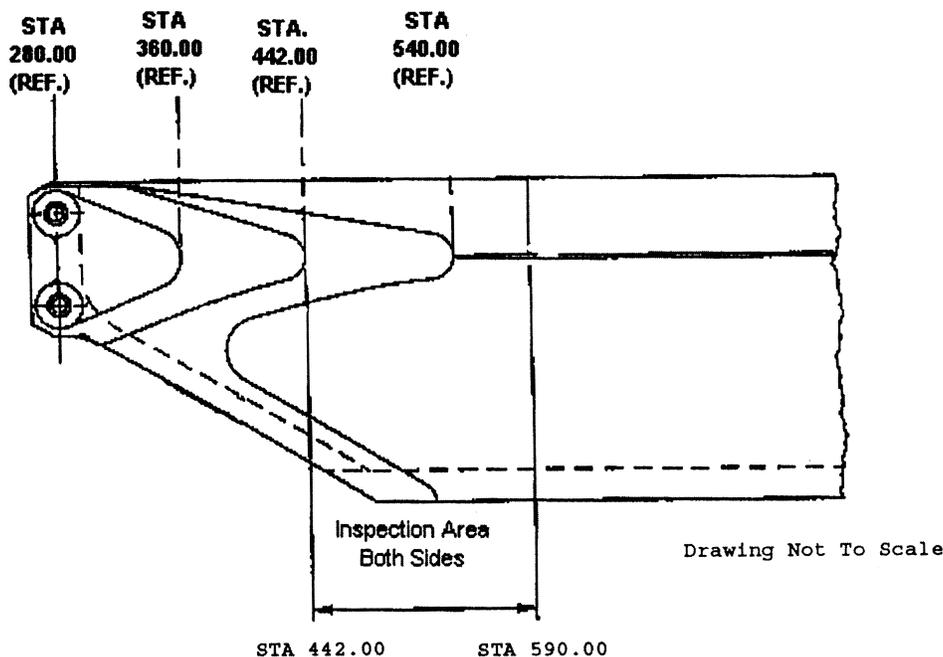
FIGURE 1

(b) Before each start of the helicopter engines, visually check both sides of each tail rotor blade for a crack in the area depicted in Figure 1 of this AD. An owner/operator (pilot) holding at least a private pilot certificate may perform this visual check and must enter compliance with this paragraph into the aircraft maintenance records in accordance with 14 CFR 43.11 and 91.417(a)(2)(v). See Figure 1:

Part Number 109-8132-01-111 Tail Rotor Blade

rotor blade for a crack in the area depicted in Figure 1 of this AD. An owner/operator (pilot) holding at least a private pilot certificate may perform this visual check and must enter compliance with this paragraph into the aircraft maintenance records in accordance with 14 CFR 43.11 and 91.417(a)(2)(v). See Figure 1.

(d) Before further flight, replace any unairworthy T/R blade with an airworthy blade.

(j) Before further flight, replace any unairworthy T/R blade with an airworthy blade.
