**DEPARTMENT OF TRANSPORTATION****Federal Aviation Administration****14 CFR Part 39**

[Docket No. 2003-SW-20-AD; Amendment 39-13181; AD 2003-08-53]

**Airworthiness Directives; Eurocopter France Model SA-365N1, AS365-N2, AS 365 N3, and SA-366G1 Helicopters**

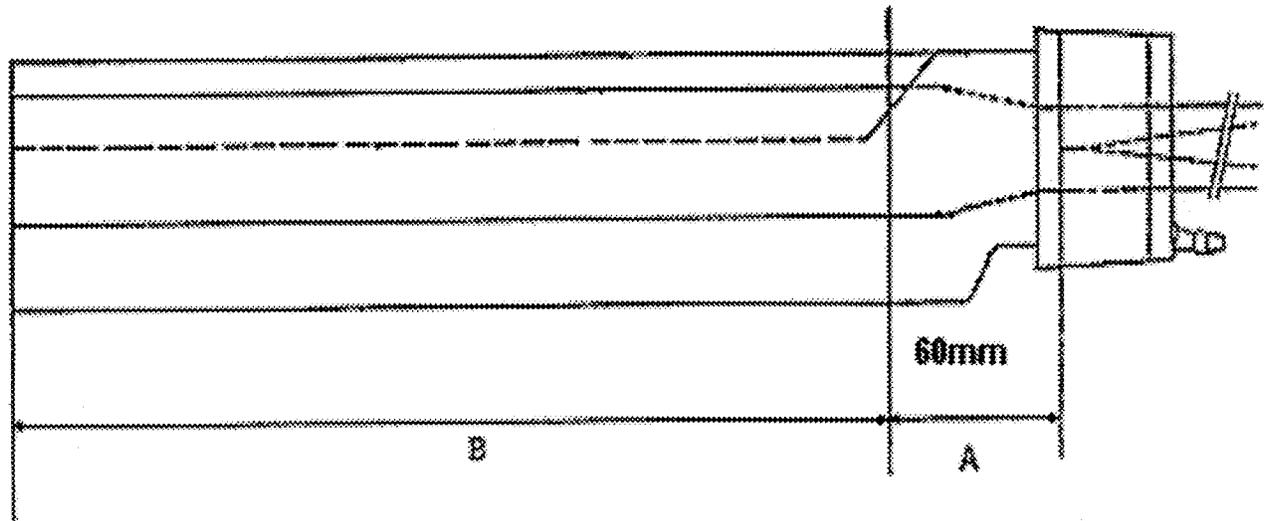
(a) Within 10 hours time-in-service (TIS) and thereafter before the first flight of each day, visually check each blade for a crack, blister, or wrinkling. An owner/operator (pilot), holding at least a private pilot certificate, may perform the visual check and must enter compliance into the aircraft maintenance records in accordance with 14 CFR sections 43.11 and 91.417(a)(2)(v)). See Figure 1 as follows:

(1) Zone A: If a blister is detected on the blade suction face, conduct a tapping test inspection on the whole blade for bonding separation.

(2) Zone B: If a crack, wrinkling, or a blister is found, replace the blade with an airworthy blade before further flight.

(2) Thereafter, at intervals not to exceed 25 hours TIS, conduct a tapping test inspection for bonding separation on blades, P/N 365A12-0020-02 or 365A12-0020-03, in Zone A as depicted in Figure 1 of this AD.

(3) Thereafter, at intervals not to exceed 100 hours TIS or 200 cycles, whichever occurs first, conduct a tapping test inspection for bonding separation on blades, P/N 365A12-0020-02 or 365A12-0020-03, in Zone B as depicted in Figure 1 of this AD. If a crack, wrinkling, or a blister is found, replace the blade with an airworthy blade before further flight.

(i) For blades, P/N 365A33-2131-all dash numbers, 365A12-0010-all dash numbers, and 365A12-0020-00, and -01, if bonding separation or a crack is found, replace the blade with an airworthy blade before further flight.

(ii) For blades, P/N 365A12-0020-02, and -03, if bonding separation exceeds 900 mm<sup>2</sup> in a 30 x 30 mm square or if there is a crack, replace the blade with an airworthy blade before further flight.
