Airworthiness Directives; Great Lakes Aircraft Company, LLC, Models 2T-1A-1 and 2T-1A-2 Airplanes

2004-25-22 Great Lakes Aircraft

Company, LLC: Amendment 39-13910; Docket No. FAA-2004-18744; Directorate Identifier 2004-CE-24-AD; Supersedes AD 79-20-08; Amendment 39-3580.

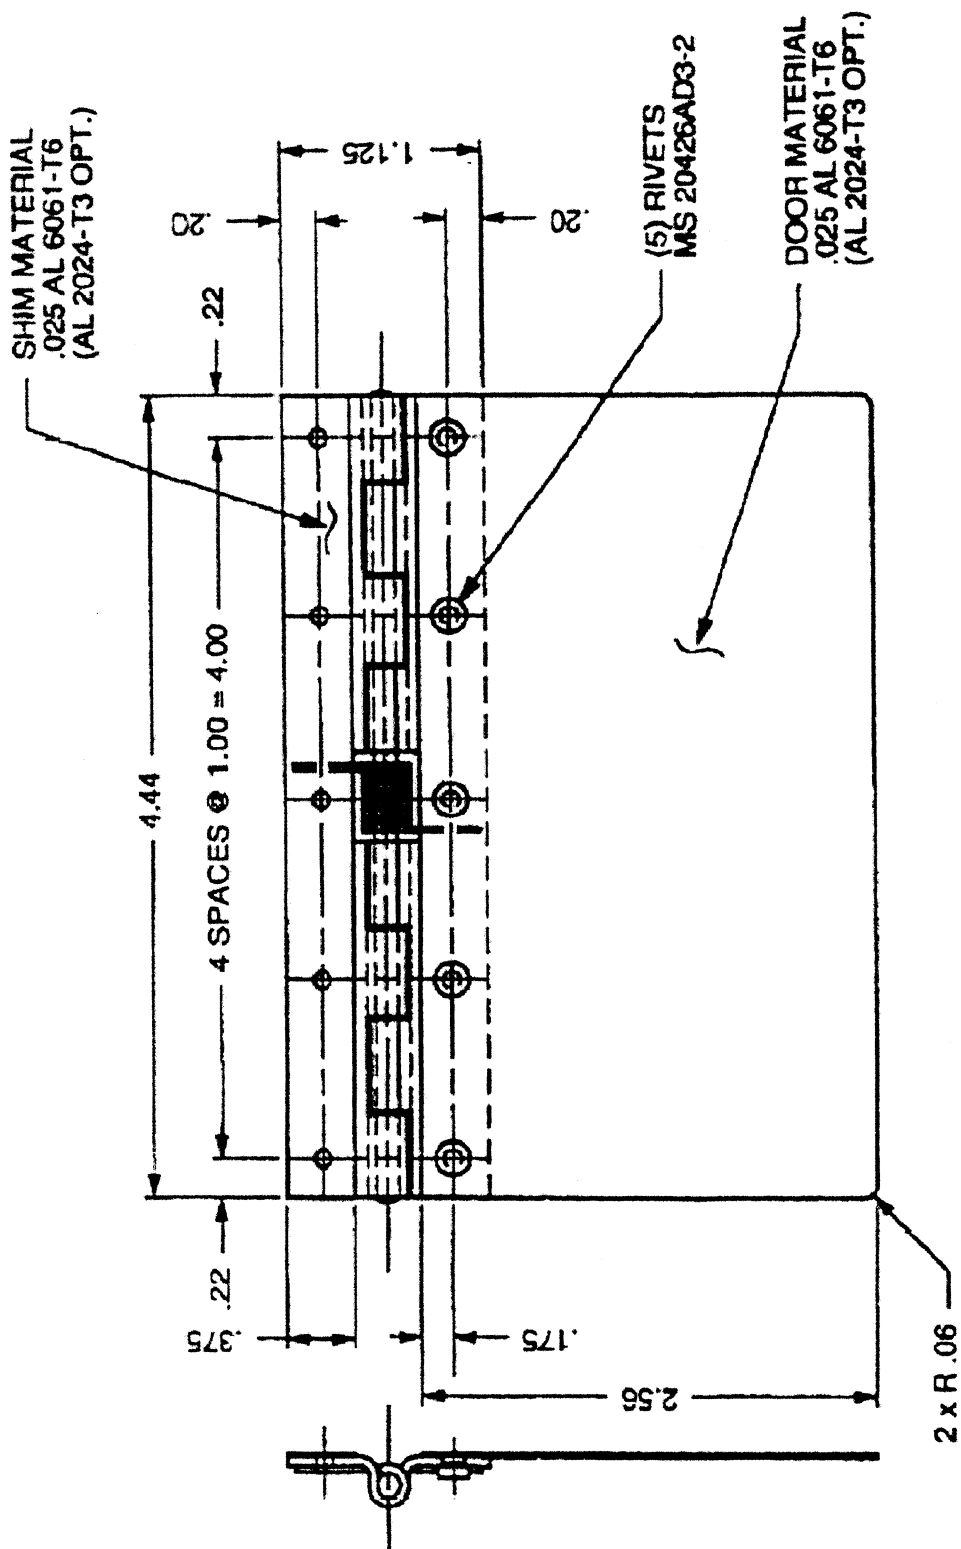
Figure 2

GREAT LAKES AIRCRAFT, TYPES 2T-1A-1 AND 2T-1A-2
ENGINE INDUCTION SYSTEM AD 79-20-08
ALTERNATE AIR DOOR FABRICATION DETAIL
FULL SCALE

Actions	Compliance	Procedures
(2) Visually inspect the alternate air door for distortion, heat damage, and cracks. If any damage is found, repair or fabricate a new door following Figure 1, Figure 2, and Figure 3 in this AD.	<i>For airplanes previously affected by AD 79-20-08:</i> Initially inspect at the next scheduled inspection required by AD 79-20-08 or within the next 25 hours TIS after January 28, 2005 (the effective date of this AD), whichever occurs later. Repetitively inspect thereafter at intervals not to exceed 100 hours TIS. <i>For airplanes not previously affected by AD 79-20-08:</i> Inspect within the next 25 hours TIS after January 28, 2005 (the effective date of this AD). Repetitively inspect thereafter at intervals not to exceed 100 hours TIS. <i>For all affected airplanes:</i> After each inspection, if damage is found during any inspection, before further flight, repair, replace the damaged alternate air door.	Not applicable.

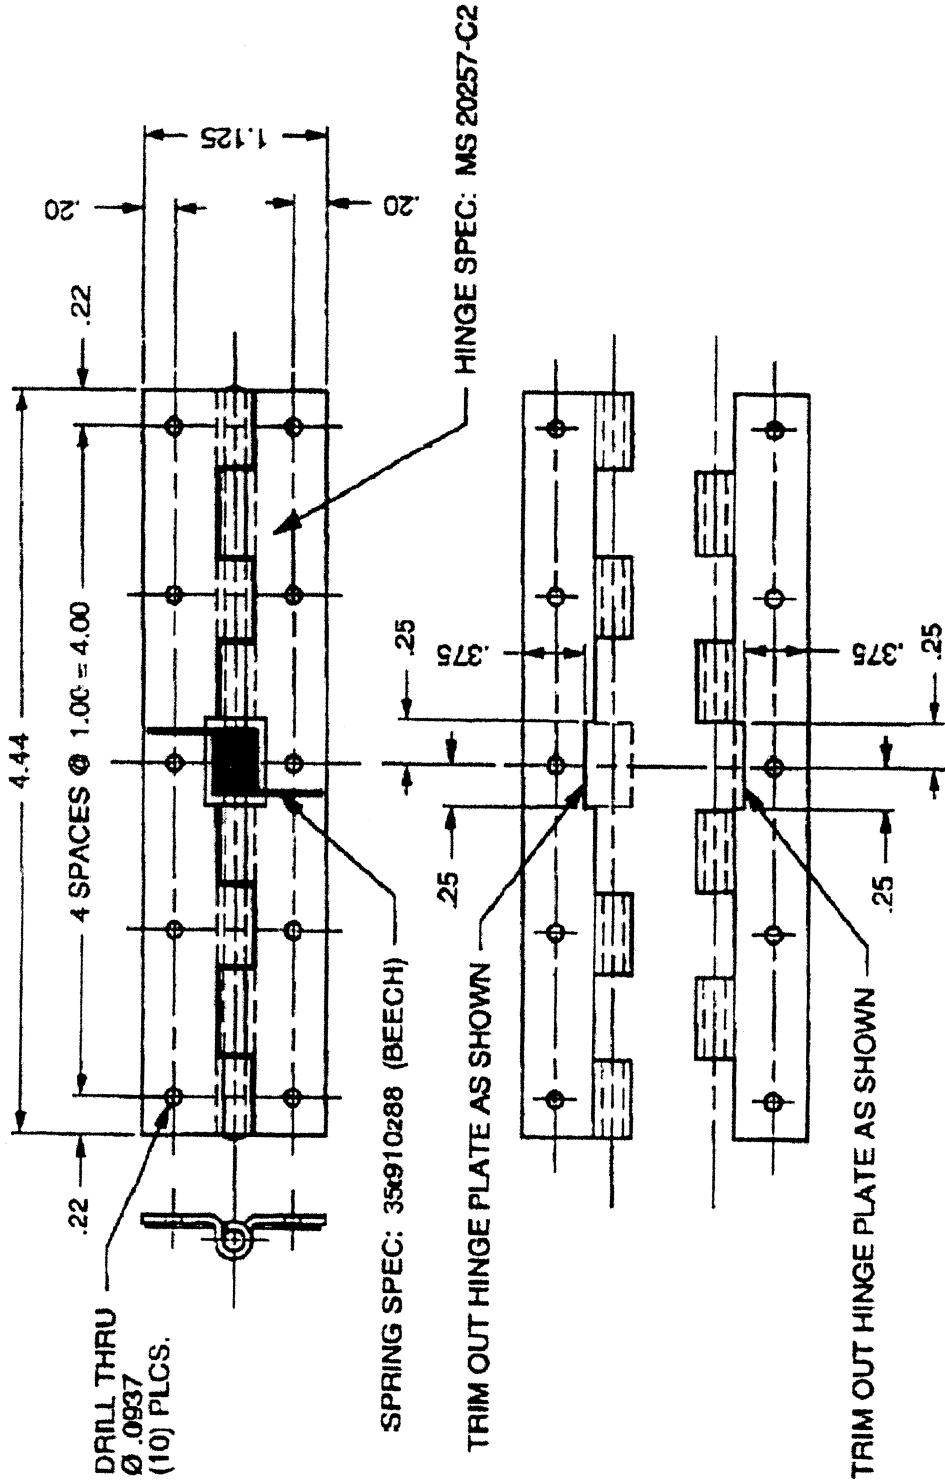
Figure 3

GREAT LAKES AIRCRAFT, TYPES 2T-1A-1 AND 2T-1A-2
ENGINE INDUCTION SYSTEM AD 79-20-08
ALTERNATE AIR DOOR HINGE DETAIL
FULL SCALE
