[Docket No. FAA-2004-19960; Directorate Identifier 2004-CE-47-AD; Amendment 39-14153; AD 2005-13-16]

Airworthiness Directives; The New Piper Aircraft, Inc. PA-34 Series Airplanes

ACTION: Final rule.

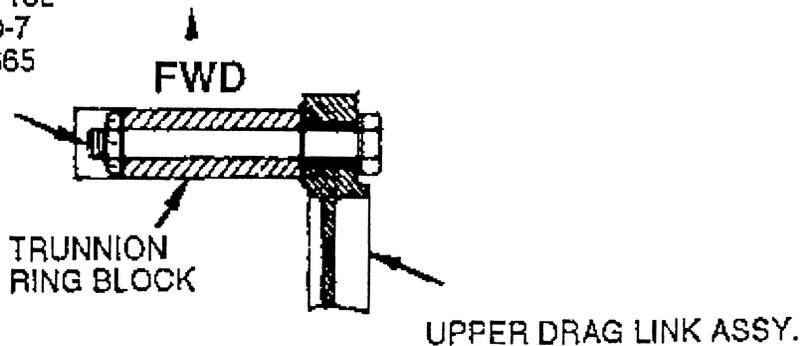
Figure 1.

What events have caused this AD?
Several incidents where the nose landing gear (NLG) on The New Piper Aircraft, Inc. (Piper) PA-34 series airplanes collapsed caused us to issue AD 93-24-14, Amendment 39-8762 (58 FR 65115, December 13, 1993). AD 93-24-14 currently requires the repetitive replacement of the bolt and stack up that connect the upper drag link to the nose gear trunnion on all Piper PA-34 series airplanes.

AN7-35
AN960-716
OR
AN960-716L
AN320-7
MS24665

SECTION B-B
"UPPER" DRAG LINK - TO -
GEAR CONNECTION

Actions	Compliance	Procedures
<p>(1) Replace the bolt and stack up that connects the upper drag link to the nose gear trunnion with new parts (or FAA-approved equivalent part numbers (P/N)) of the following:</p> <ul style="list-style-type: none"> (i) Piper P/N 400 274 (AN7-35) bolt; (ii) Piper P/N 407 591 (AN960-716L) washer, as applicable; (iii) Piper P/N 407 568 (AN960-716); (iv) Piper P/N 404 396 (AN320-7) nut; and (v) Piper P/N 424 085 cotter pin. <p>(2) Do the inspections, replacements, and other corrective actions specified in Table 1 "Specified Maintenance" of Piper Service Bulletin No. 1123A, dated November 30, 2004.</p> <p>(3) Do any necessary corrective actions as a result of the actions specified in Table 1 "Specified Maintenance" of Piper Service Bulletin No. 1123A, dated November 30, 2004.</p>	<p>Within the next 100 hours time-in-service (TIS) after January 28, 1994 (the effective date of AD 93-24-14), unless already done within the last 400 hours TIS before January 28, 1994 (compliance with AD 93-24-14). Repetitively replace thereafter at intervals not to exceed 500 hours TIS. Continue to repetitively replace until the actions in paragraphs (e)(2) and (e)(3) of this AD begin.</p> <p>Within the next 100 hours TIS after August 8, 2005 (the effective date of this AD), unless already done. Repetitively inspect thereafter at the intervals referenced in the Inspection Time column of the <i>INSTRUCTIONS</i> paragraph in Piper Service Bulletin No. 1123A, dated November 30, 2004.</p> <p>Before further flight after any action required by paragraph (e)(2) of this AD.</p>	<p>Follow Figure 1 of this AD.</p> <p>Follow The New Piper Aircraft, Inc. Service Bulletin No. 1123A, dated November 30, 2004.</p> <p>Follow The New Piper Aircraft, Inc. Service Bulletin No. 1123A, dated November 30, 2004.</p>
