**[Docket No. FAA-2012-0704; Directorate Identifier 2012-SW-040-AD; Amendment 39-17113; AD 2012-13-11]**

#### **Airworthiness Directives; Eurocopter Deutschland GmbH Helicopters**

**SUMMARY:** We are adopting a new airworthiness directive (AD) for Eurocopter Deutschland GmbH (ECD) Model MBB-BK 117 (all versions) and BO-105LS A-3 helicopters. This AD requires inspecting the tail rotor pitch link spherical bearing for proper swaging. This AD is prompted by a report of a tail rotor pitch link with a spherical bearing that had migrated out of the bearing bore. The actions specified by this AD are intended to prevent failure of the tail rotor pitch link and subsequent loss of control of the helicopter.

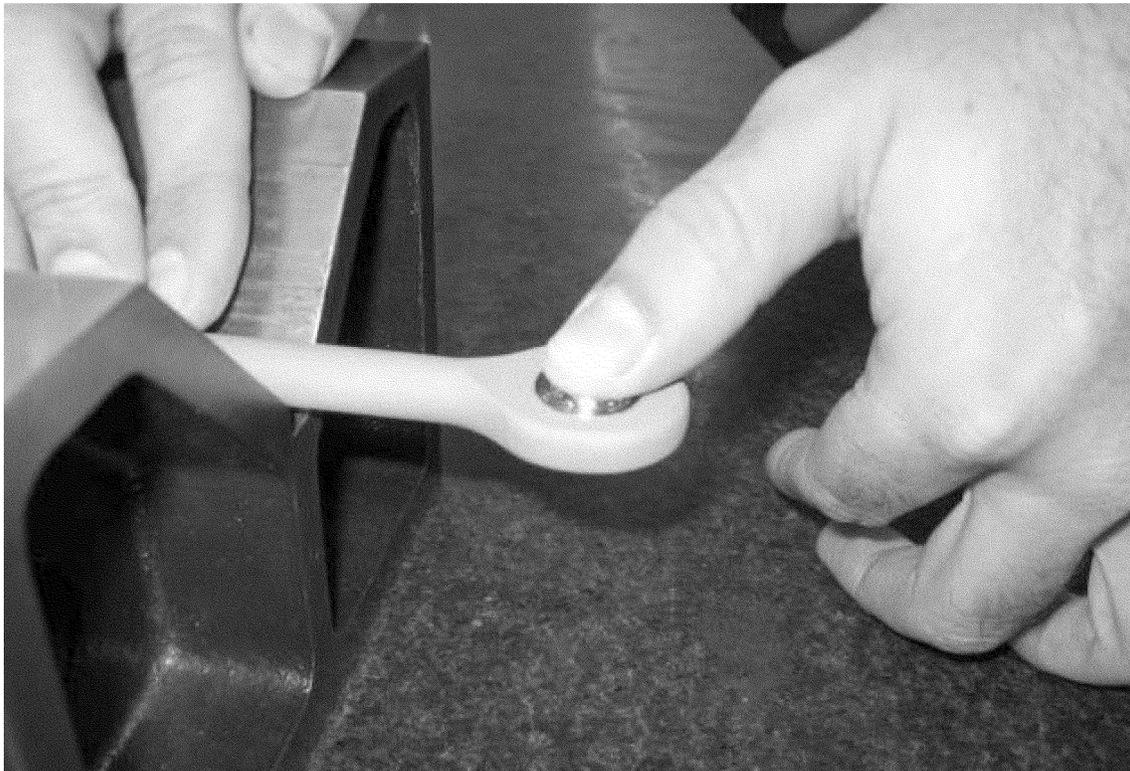
- (1) Remove the pitch link.
- (2) Clean the area around the spherical bearings and pitch link bearing bore chamfer.
- (3) Apply axial hand pressure to the faces of both spherical bearings as shown in Figure 1 to Paragraph (e) of this AD.

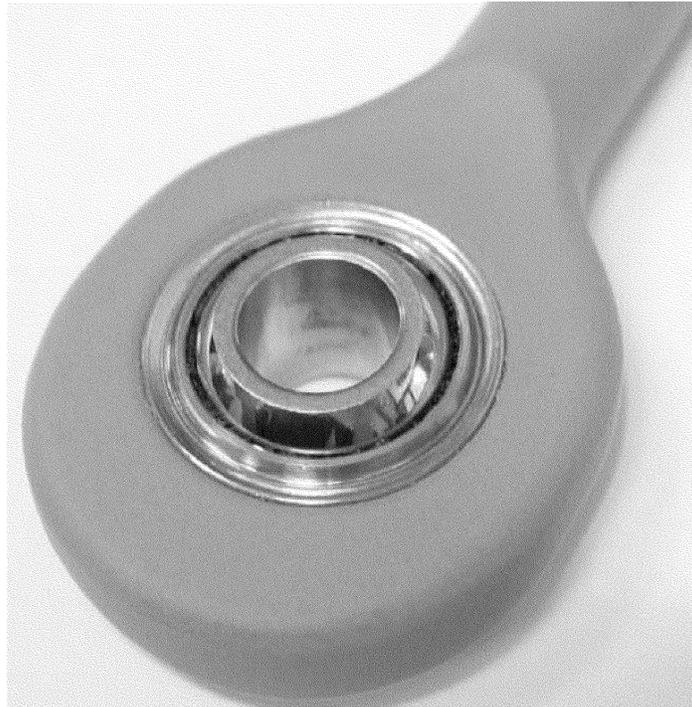
(4) Using an 8X or higher power magnifying glass, inspect the boundaries between the bearing and the bearing bore

chamfer surface. Determine that the bearings have been completely swaged and there is no gap between the edge of the bearing and the

chamfer as shown in Figure 2 to Paragraph (e) of this AD.

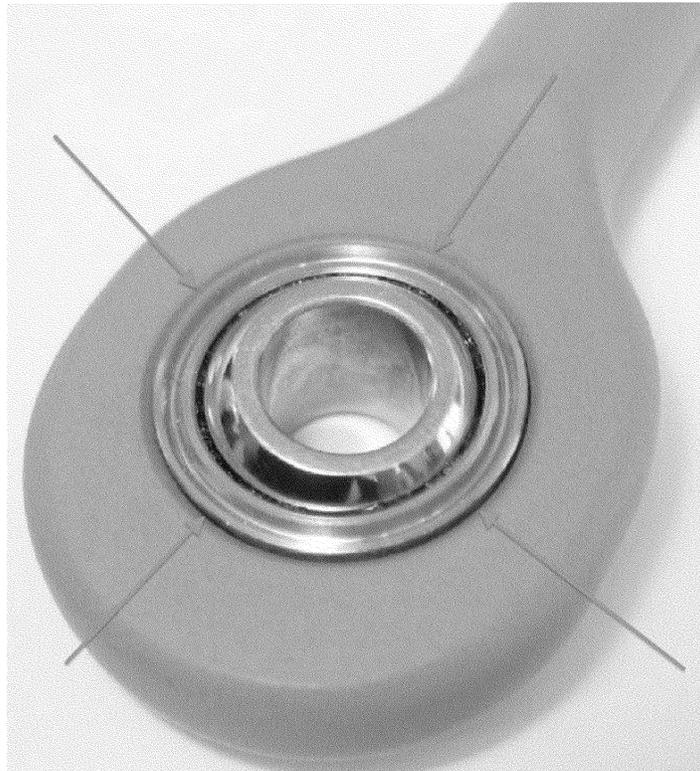
Able Engineering & Component Services (Able) received a report of a tail rotor pitch link with a spherical bearing that had migrated out of the bearing bore. Investigation by Able revealed that the migration resulted from the spherical bearing being improperly swaged during a repair process and that the affected parts were limited to those repaired after January 1, 2011. Able determined that an inspection of other tail rotor pitch links repaired after that date is necessary to determine their airworthiness and issued Alert Service Bulletin (ASB) No.: 2012-001, Revision IR, dated March 7, 2012 (Able ASB).

This AD defines the unsafe condition as an improperly swaged spherical bearing on the pitch link, which could result in loss of tail rotor control and subsequent loss of control of the helicopter.

(5) If a bearing is not completely swaged or there is a gap between the edge of the

bearing and the chamfer, as shown in Figure

3 to Paragraph (e) of this AD, replace the pitch link with an airworthy pitch link.
