[Docket No. FAA-2018-0479; Product Identifier 2016-NE-23-AD]

Airworthiness Directives; Honeywell International Inc. Turboprop and Turboshift Engines

ACTION: Notice of proposed rulemaking (NPRM).

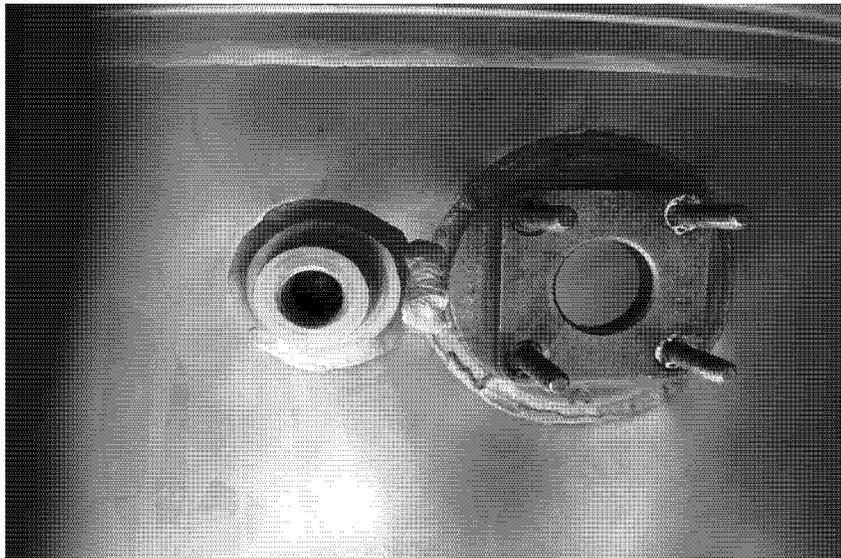
Figure 1 to Paragraph (h) of this AD. Combustion Chamber Case Assembly Without the One-Piece Bleed Pad with P3 Boss

(2) Figures 1 and 2 to paragraph (h) of this AD illustrate the appearance of combustion chamber case assembly, P/N 893973–5, without and with, respectively, the one-piece bleed pad with the P3 boss.

After the effective date of this AD, do not install a combustion chamber case assembly, P/N 869728-1, 869728-3, or 893973-5, in TPE331-3U, -3UW, -5, -5A, -5AB, -5B, -6, and -6A engine models or in TPE331-1, -2, and -2UA engine models modified by National Flight Services, Inc., STC SE383CH, unless the combustion chamber case assembly has a one-piece bleed pad with P3 boss.
