NBSIR 77-1292 R

Examination of Failed Six Inch Cast Iron Pipe Natural Gas Main, Public Service Electric and Gas Company, Fairview, New Jersey

June 1977

Failure Analysis Report

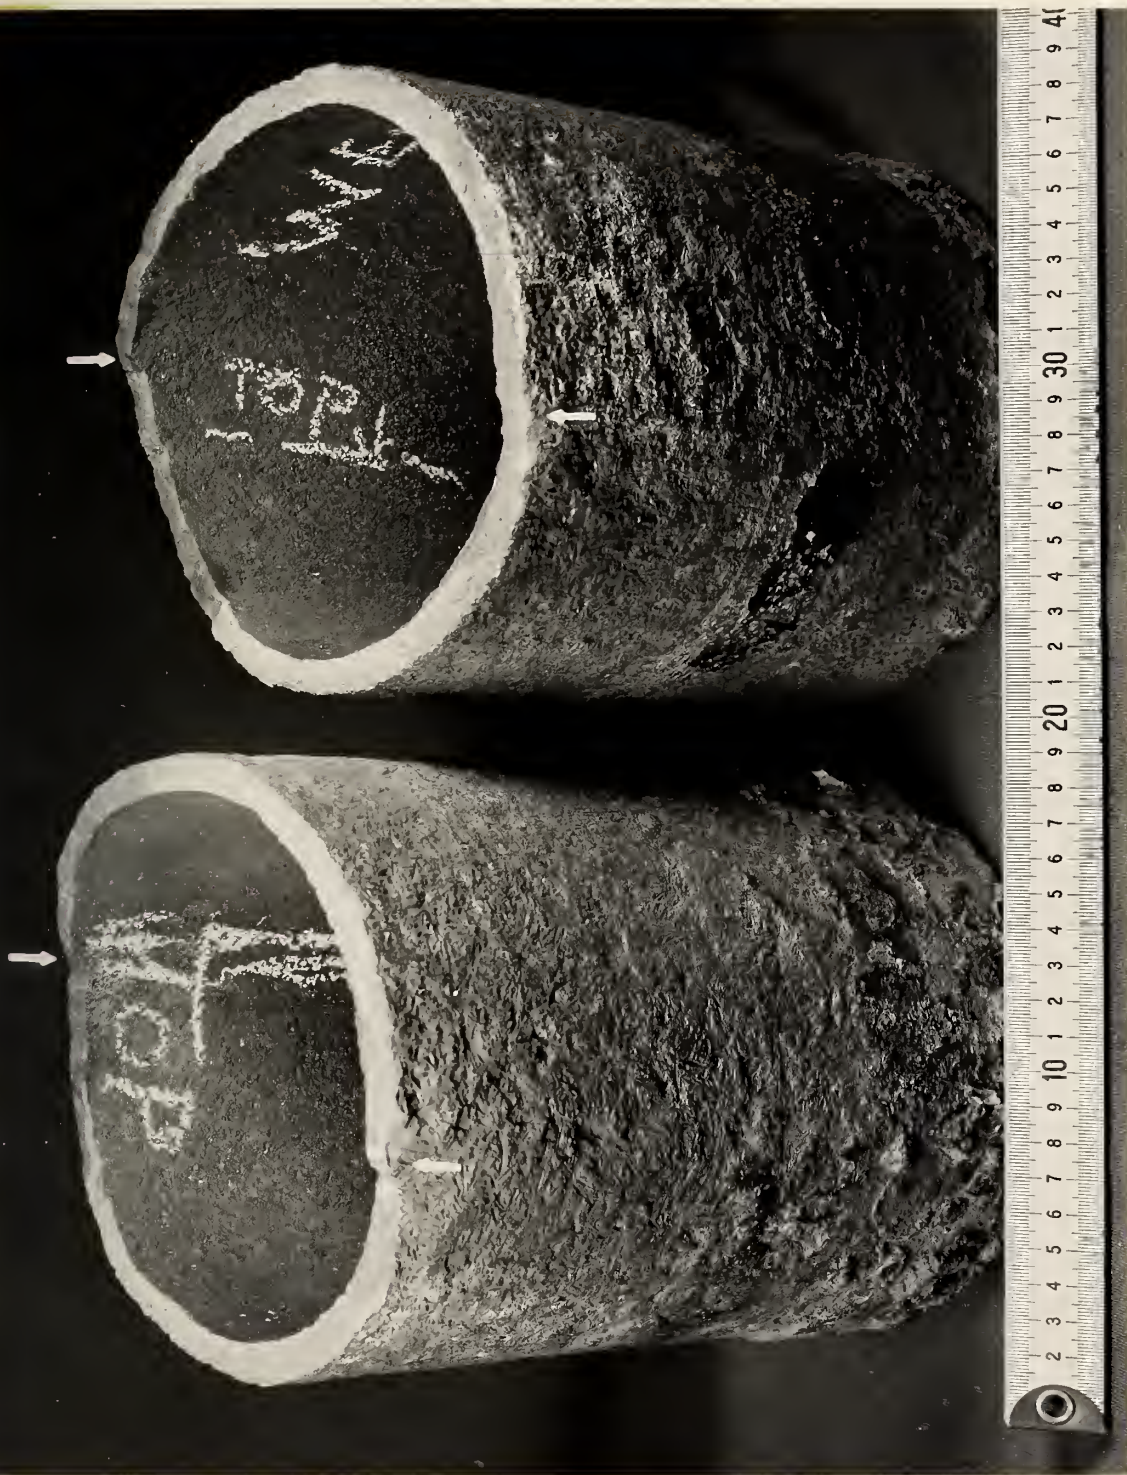
Two pieces of the failed six inch diameter cast iron pipe were submitted to the NBS Mechanical Properties Section for examination. The nominal wall thickness was 3/8-inch. Each piece contained one of the two mating fracture faces. The two pieces, designated E and W before being received at NBS, measured approximately 9 1/2 and 9 inches, respectively, in length. The piece designated W was used for most of this examination. The piece designated E was not cleaned or sectioned. Both pieces were marked before being submitted to NBS to indicate the top of the pipe as it had been oriented in service. The parts are shown in figure 1 as they were received at NBS.

There were slight jogs in the fracture path at both the top and bottom of the pipe as it reportedly had been oriented in service. The mating fracture surfaces can be seen in figure 1. The jogs are indicated in the figure by arrows.

Figure 1. The two pieces of pipe showing the fracture surfaces as received at NBS from the NTSB. The piece labeled E is at the left and the piece labeled W is at the right. Arrows indicate jogs in the fracture path near the top and bottom of the pipe. X 1/2

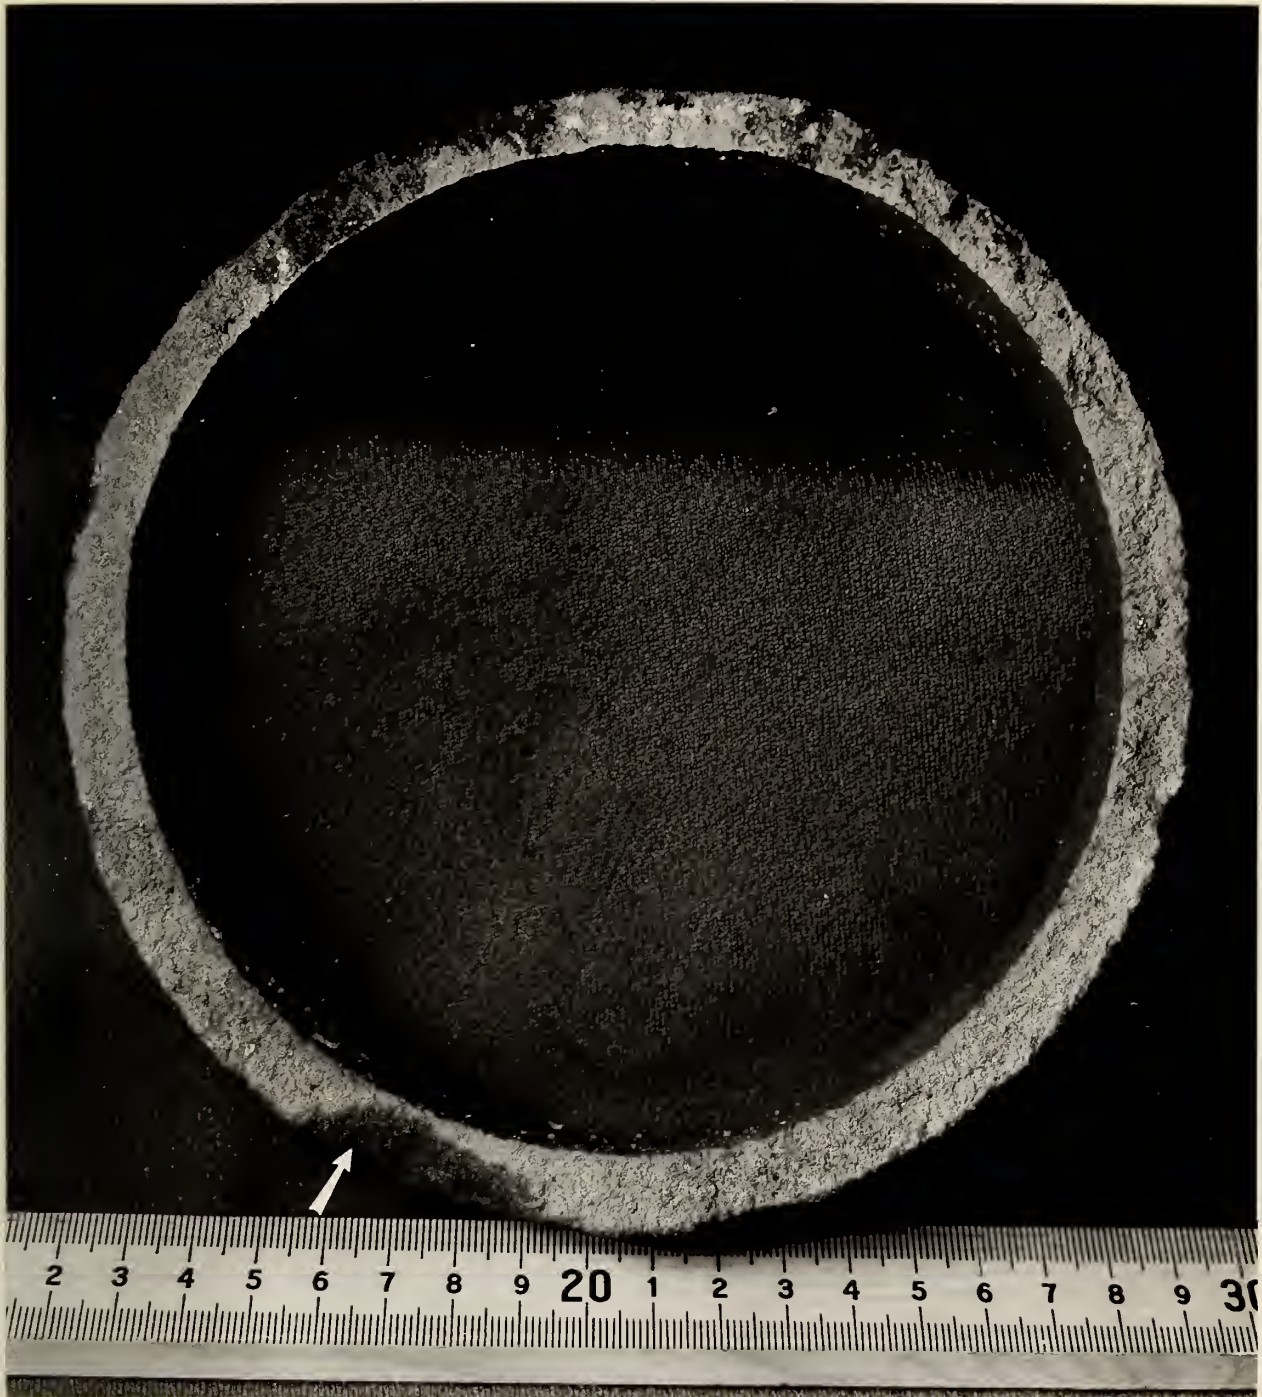
Cleaning revealed the features over most of the fracture surface. There was, however, no fractographic evidence revealed to indicate the site of fracture initiation.

The fracture surface designated W is shown before and after cleaning in figures 2 and 3, respectively. The cleaning operation revealed one region of graphitization at the fracture near the bottom of the pipe (dark region indicated by the arrow in figure 3). The dark appearing regions near the top of the pipe are areas where the oily deposit had not been removed during the cleaning procedure.

Figure 3. Fracture surface designated W after ultrasonic cleaning. The designated top of the pipe is at the top in the photograph. The arrow indicates the region of graphitization near the bottom of the fracture. The dark regions near the top are deposits that were not removed by the cleaning procedure. X 1

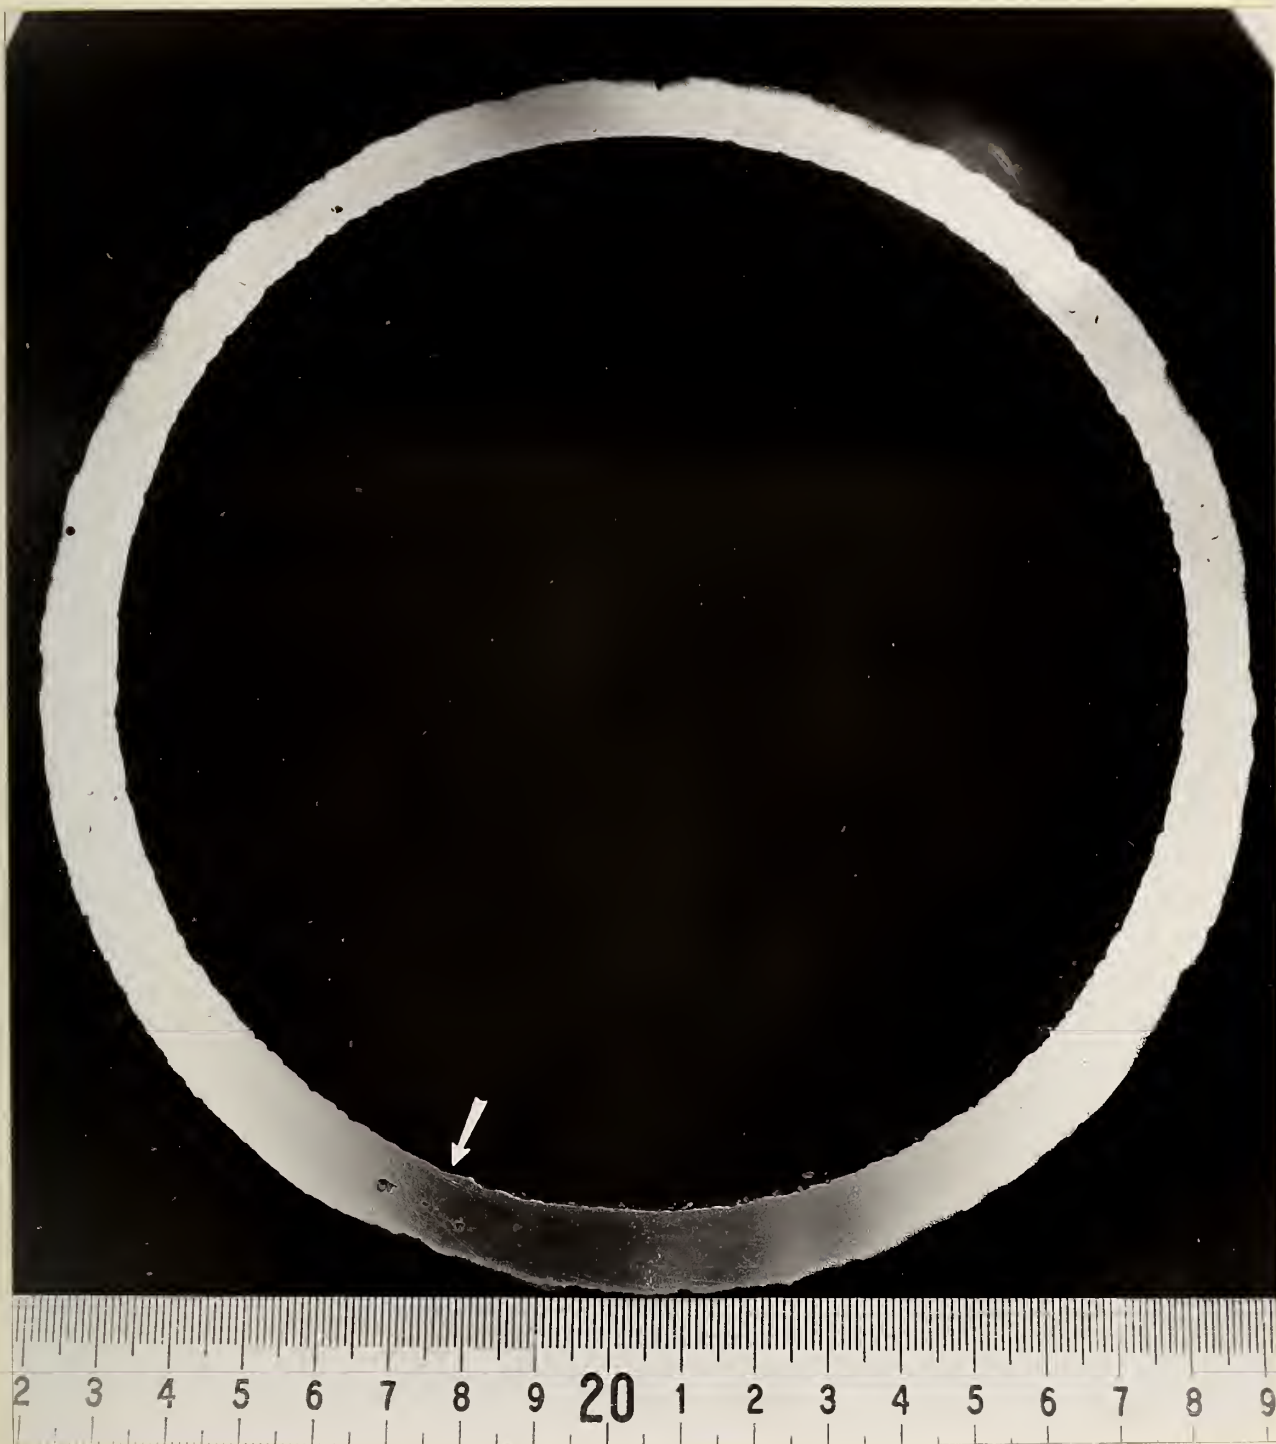
A transverse section was taken through the length of pipe designated W about one inch from the fracture. As shown in figure 4, no evidence of graphitization was found at that section location. There was, however, a small amount of porosity in that section in the region indicated by the arrow.

Figure 4. Transverse section through the piece of pipe designated W one inch from the fracture. The top of the pipe is at the top of the photograph. (The notch appearing at the top was put in with a file in order to identify the orientation.) The arrow indicates a region of porosity. X 1

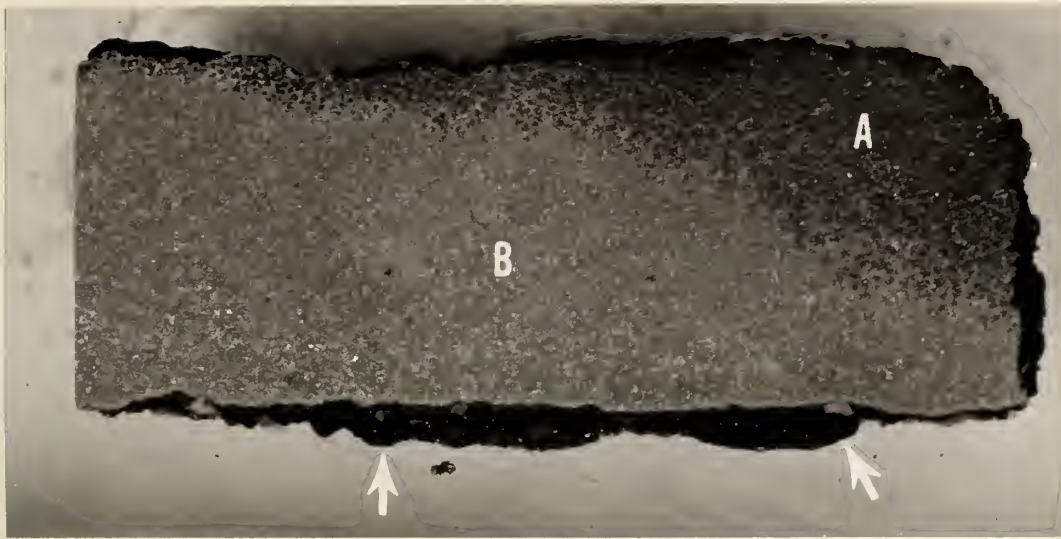
A longitudinal section intersecting the fracture at the location of the deepest penetration of graphitization was taken through the pipe. This section is shown in figure 5. The fracture profile is vertical at the right in the figure. At the location of maximum depth, graphitization had penetrated about 75% of the wall thickness of the pipe. A gradient of graphitization was found across the pipe wall, with the most severe graphitization at the outside.

The submitted six inch diameter cast iron pipe had completely fractured transversely. Because of the low operating pressure of the pipeline (0.25 psig) it would appear likely that failure occurred as a result of stresses from an external source and not from stresses generated internally. There was one region of graphitization at the fracture near the bottom of the pipe. Maximum penetration of graphitization was about 75% of the approximately 3/8 inch wall thickness. The graphitization was most severe at the outside surface of the pipe and became less severe with distance from the outside surface.

Figure 5. Longitudinal section through pipe intersecting fracture at location of deepest penetration of graphitization. Fracture profile is vertical at the right. The outside surface of the pipe is horizontal at the top. Region A has been graphitized, whereas region B has not. The very dark areas indicated by arrows are deposits on the inside surface of the pipe.
Etchant: 1% nital
