NISTIR 7809

Metallurgical Investigations into Corrosion Damage in Homes Constructed with Problem Drywall

R. E. Ricker
D. J. Pitchure
M. E. Williams
S. A. Claggett

Report prepared for the
U.S. Consumer Product Safety Commission
Directorate for Engineering Sciences
Bethesda, MD 20814

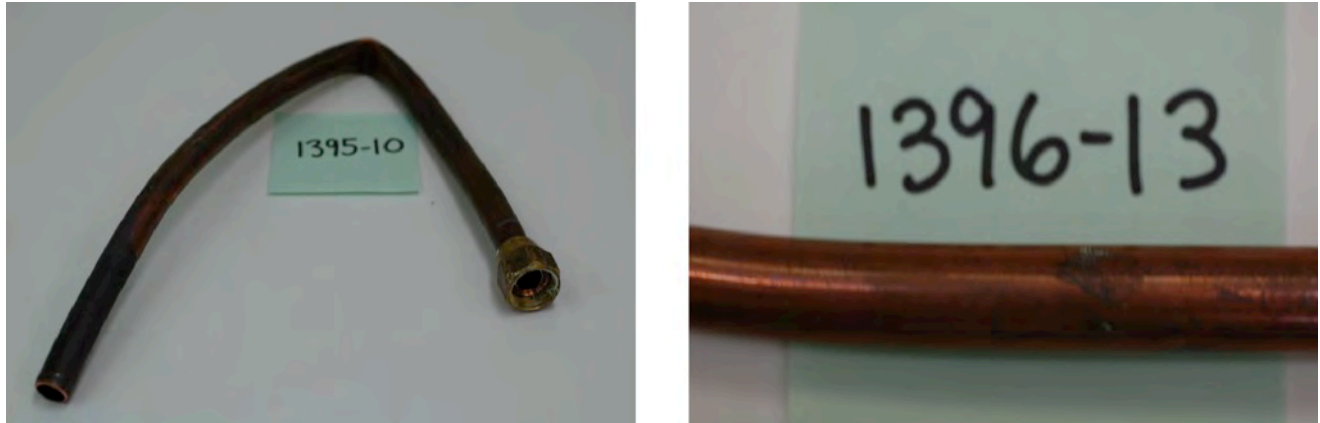
The lengths of copper tubing were discolored to varying degrees. This discoloration, which is illustrated in Figure 1, was found to be due to the presence of a thin, adherent layer of a black substance. This is clearly illustrated in Figure 2, where the sample number has been scribed into the sample exposing fresh bare copper. While this black film adhered to the surface, physical contact would result in the transfer of a small quantity of a fine black powder from the film. In some cases, the discoloration was found to be very uniform, but in other cases it was irregular. The extent of discoloration varied with the thickness of the layer.

Figure 1 – Photographs of two representative samples of Cu fuel gas distribution tubing.

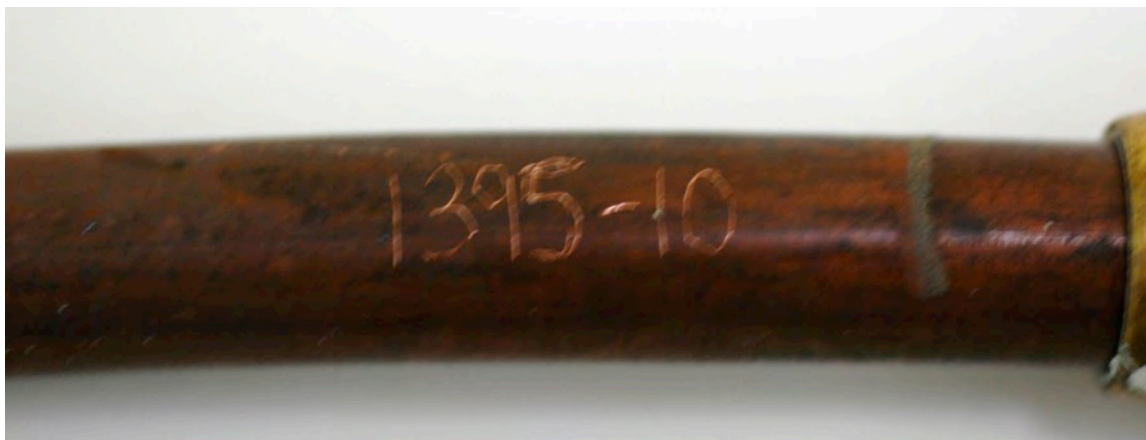
Figure 2 – Scribe marks illustrating the contrast between the color of bare copper and a sample of copper natural gas line tubing.

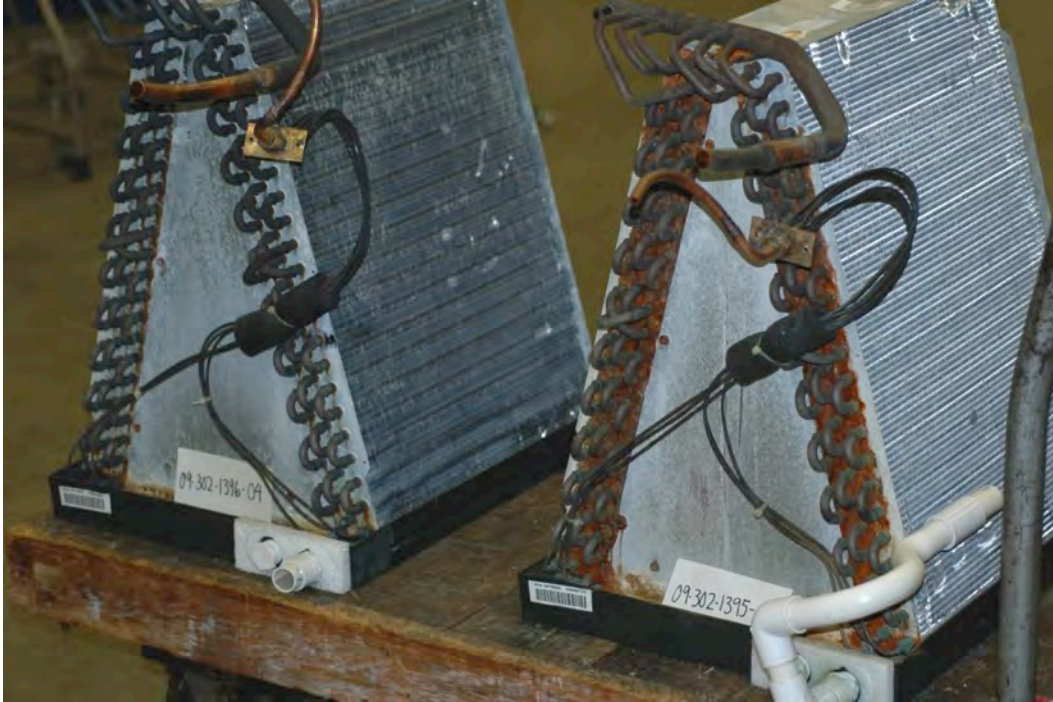
The air conditioner evaporator coils were also examined, Figure 3. From the two coils in this figure, all exposed copper surfaces appear to have turned dark. These coils are constructed out of parallel lines of copper tubing placed through thin sheets of aluminum (Al) that serve as the heat transfer fins. The copper tubing is linked by soldered U-bends to the ends of adjacent lengths of copper tubing. The end plates that hold this assembly in place are made out of galvanized steel. Copper manifolds and valves complete the assembly. Figure 4 is a close-up of the end plates and the U-bend region. In this figure, brown and orange corrosion products can be seen on the galvanized end plates, while black and green corrosion products can be seen on the copper tubing. The normal patina that forms on copper in the cyclically wet and dry environment of an air conditioner evaporator coil would be expected to contain copper (I) or copper (II) ions in oxides (black to brownish-red), carbonates (green to blue), sulfates (bright blue), and chlorides (greenish white to blue-green).^{1,2} Again, the black color was found to be due to the presence of a thin layer of black powder.

Figure 3 – Photograph of the two air conditioner evaporator coils showing the black discoloration of the copper U-bends and corrosion of the end plate.

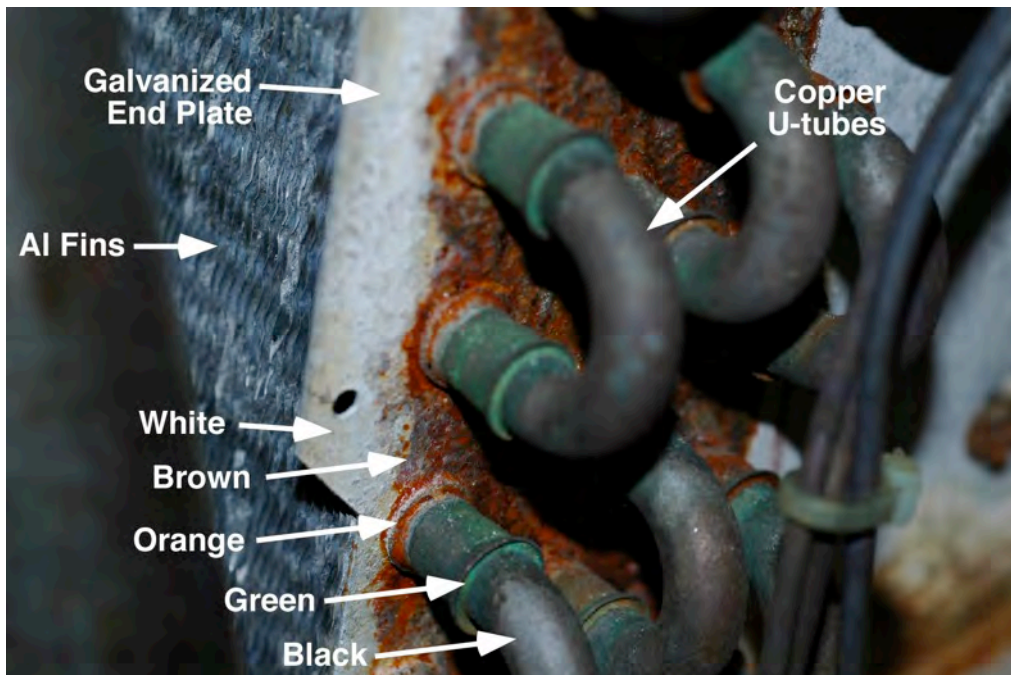
Figure 4 – Close-up photograph of the U-bends and end plate of an air conditioner evaporator coil showing that there appears to be five colors associated with the corrosion products: white, brown, orange, green, and black.

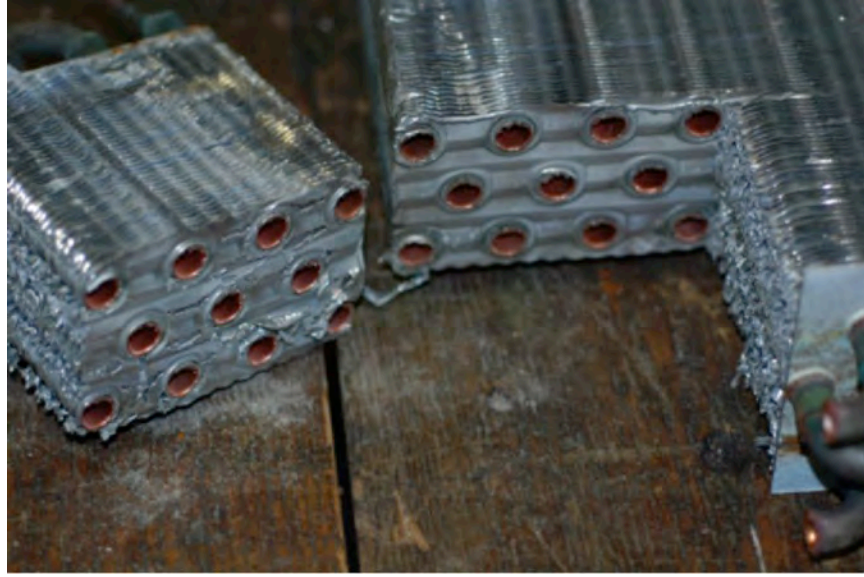
To evaluate the possibility of corrosion damage occurring between the aluminum heat transfer fins and the copper tubing inside them, the heat exchanger unit was sliced with a band saw, as shown in Figure 8, to expose these internal surfaces for examination of the copper. No evidence of localized attack was found, and visual inspection did not detect a black corrosion product layer between the aluminum fins and the copper tubes of the evaporator coil.

Figure 8 – Air conditioner evaporator coil after slicing to allow for examination for corrosion damage between the aluminum sheets and the copper tubing.

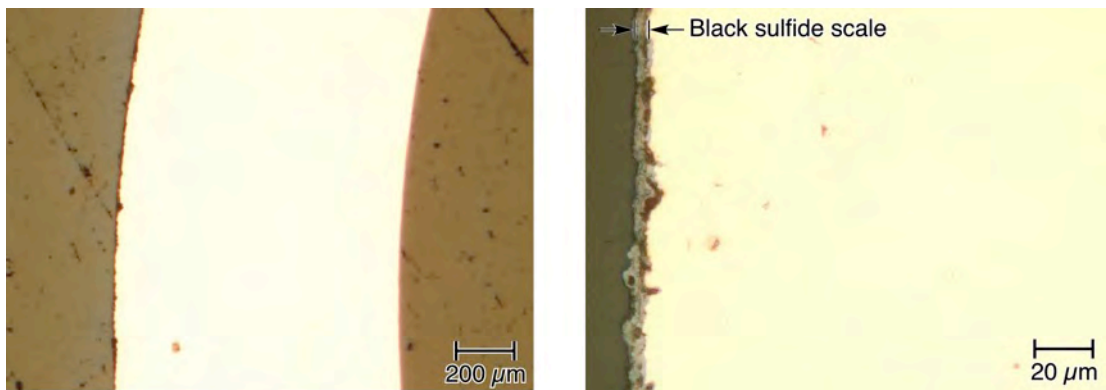
The thickness of the black corrosion product on a fuel gas supply tube was measured using optical microscopy of samples prepared in cross section. For this analysis, samples of natural gas supply lines were cut, mounted in epoxy, and polished, using standard metallurgical practice, exercising care to maintain the edge of the sample with the corrosion products in place. Figure 9 shows optical micrographs of this sample, where the corrosion product layer varied from $(5 \text{ to } 10 \pm 0.5) \mu\text{m}$ thick.

Figure 9 – Optical micrographs of the wall of a copper natural gas supply line and the corrosion product layer at two magnifications.

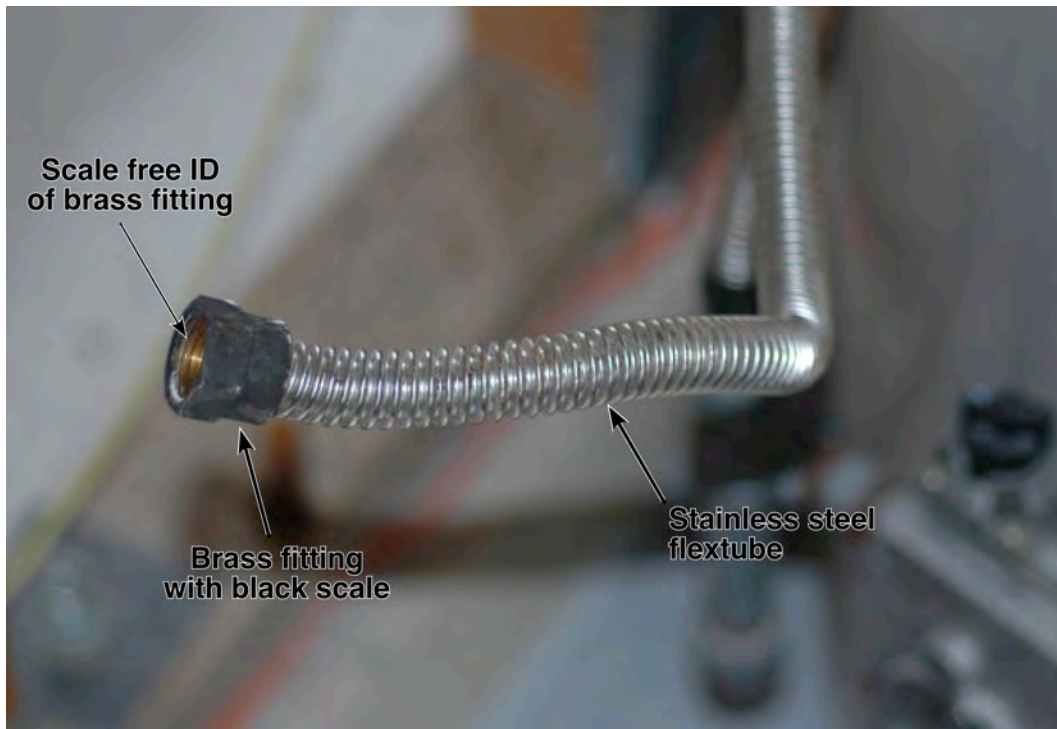
Figure 11 – Stainless steel fuel gas supply tube for the water heater. Note the contrast in the color between the inside and the outside of the brass fitting on the end.

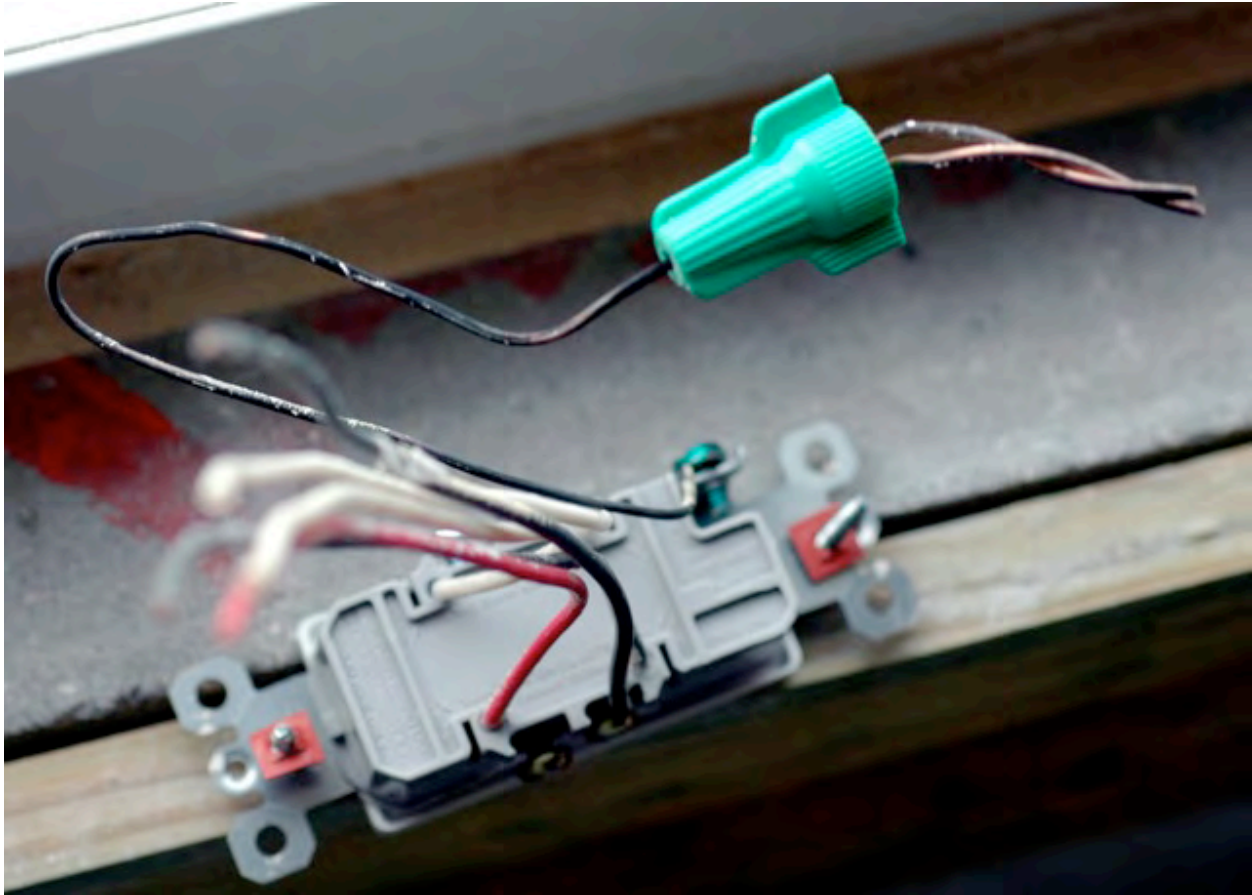
Figure 12 – Electrical wall receptacle in a home with problem drywall showing the characteristic black deposits on the bare copper ground wire.

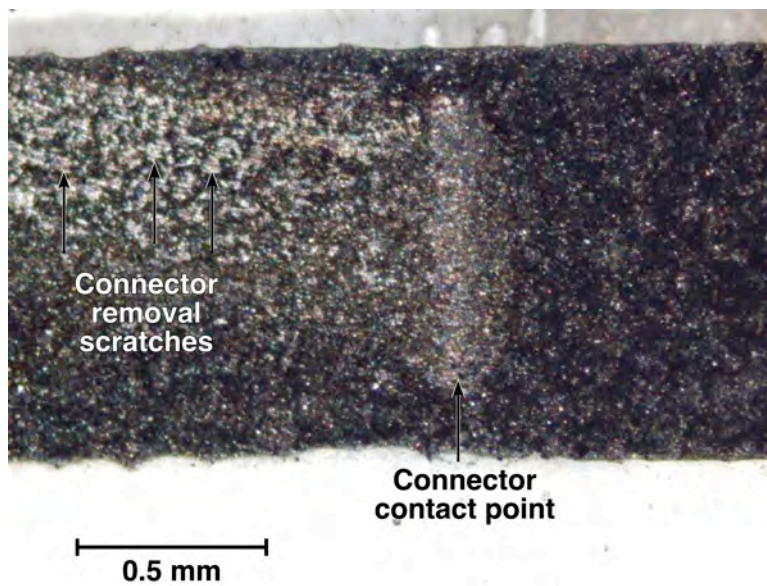
Figure 19 – Black deposits on silver connector for flat flexible cable, connector contact area, and scratches from unplugging the cable.

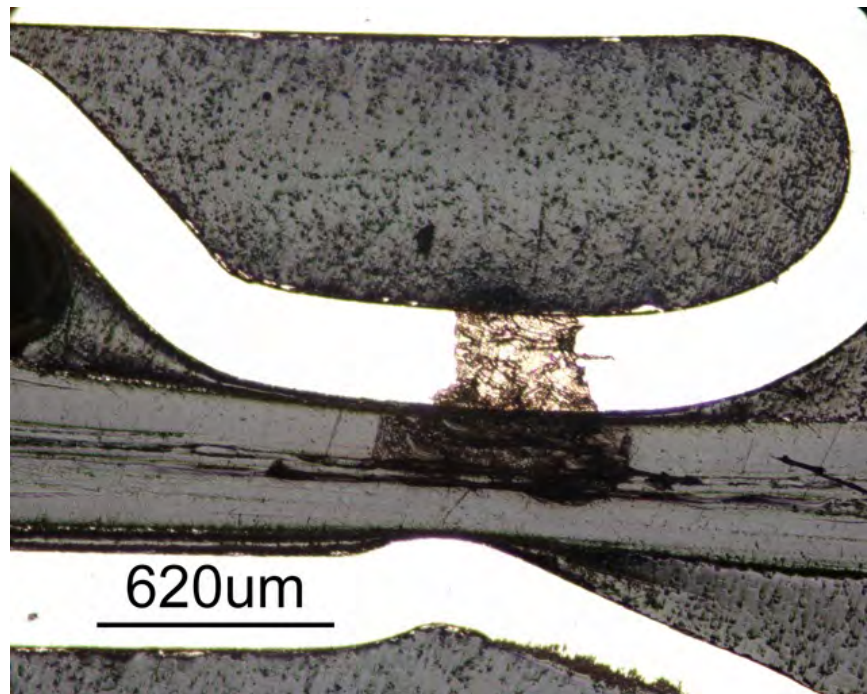
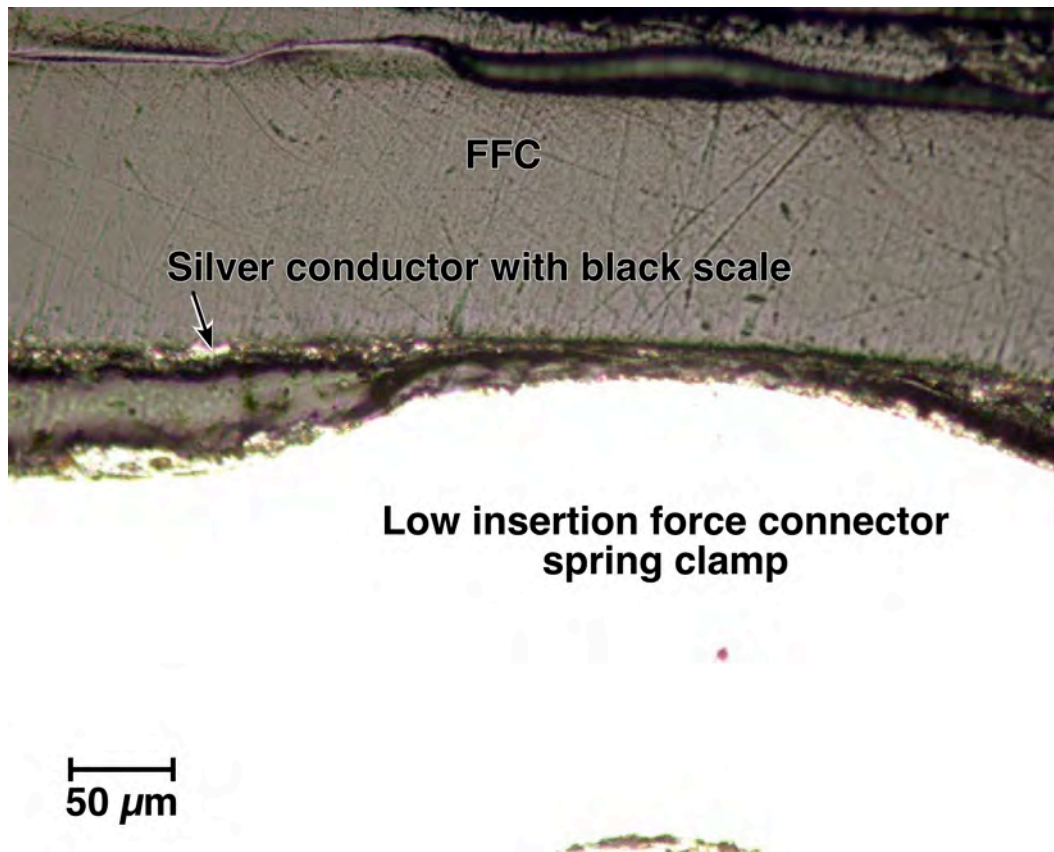
Figure 21(a) – Optical micrograph of the contact area of the flat, flexible cable plug in between the spring contacts of the female receptacle in cross section.

Figure 21(b) – Higher magnification view of flat, flexible cable contact area.

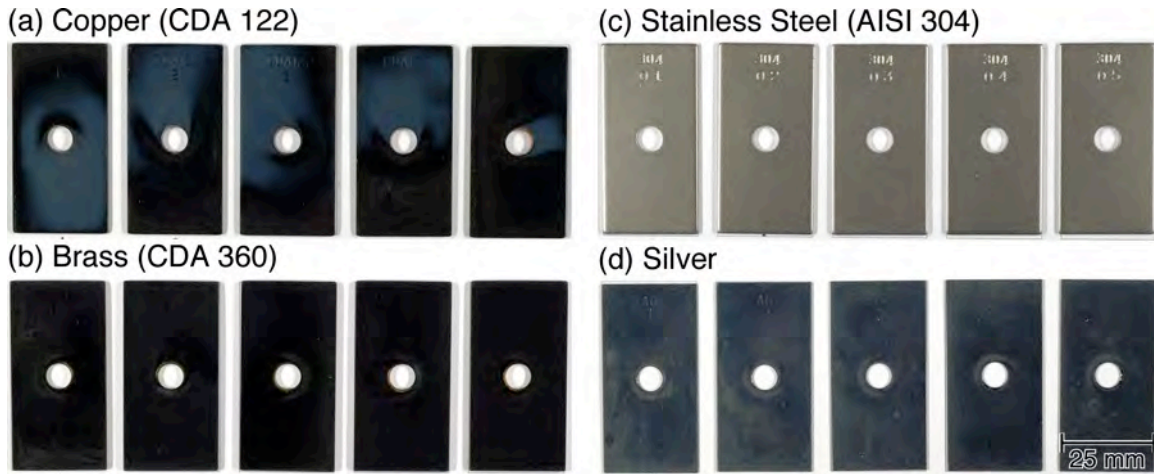
(2) Optical Examination Results. Figure 23 shows photographs of the five flat coupon samples of each alloy after exposure to the accelerated test environment at SNL. Figure 24 shows a photograph of a representative sample of each alloy, after exposure, next to a sample that was not exposed to the accelerated test environment. By comparing these photographs, it can be seen that the alloys that contain copper formed very dark deposits that appear to be thick due to the dark opaque color of these deposits. The silver samples are also significantly altered

by this exposure, although the change seems to be more of a case of loss of luster rather than the development of a corrosion product. No evidence of general or localized attack was observed on any of the stainless steel coupons. Similar deposits were found on the U-bend coupons, but no evidence of any form of localized corrosion, pitting, or stress corrosion cracking was found on any of the samples.

Figure 23 – Flat coupons after exposure to the simulated Class IV accelerated corrosion environment at SNL.

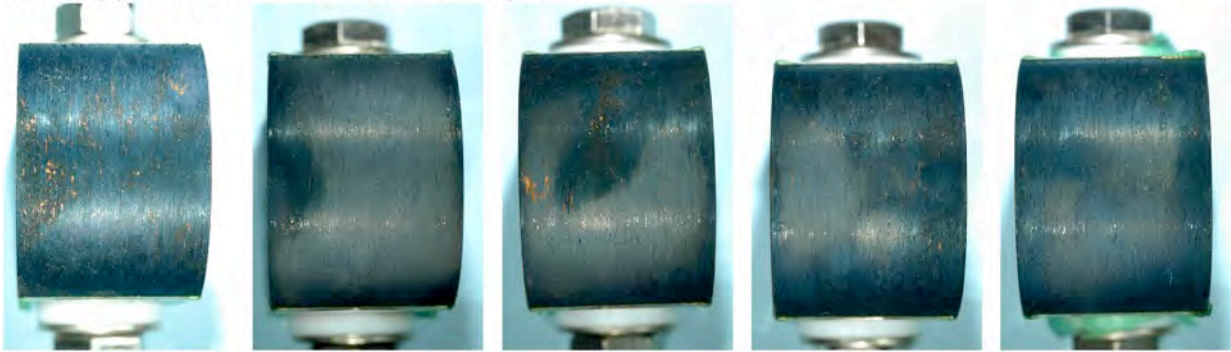
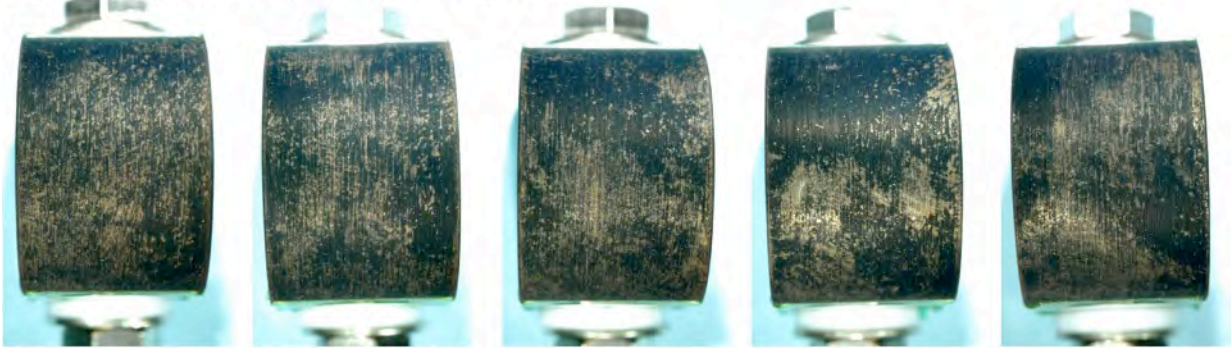
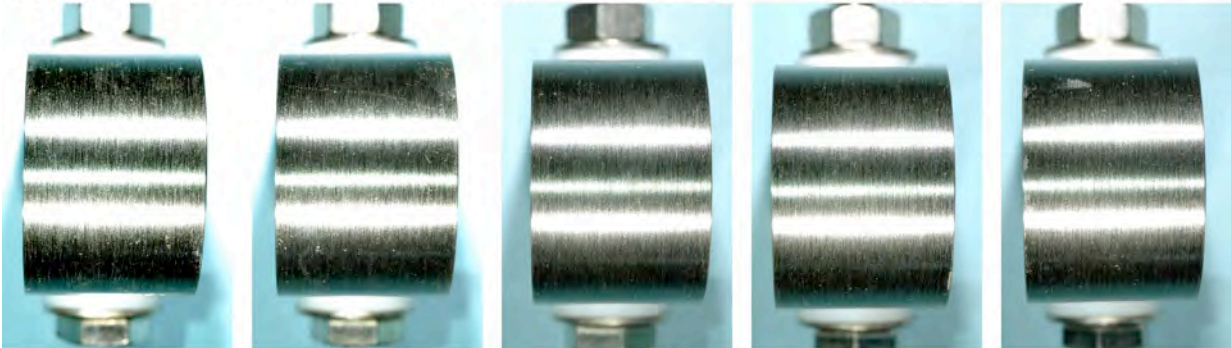
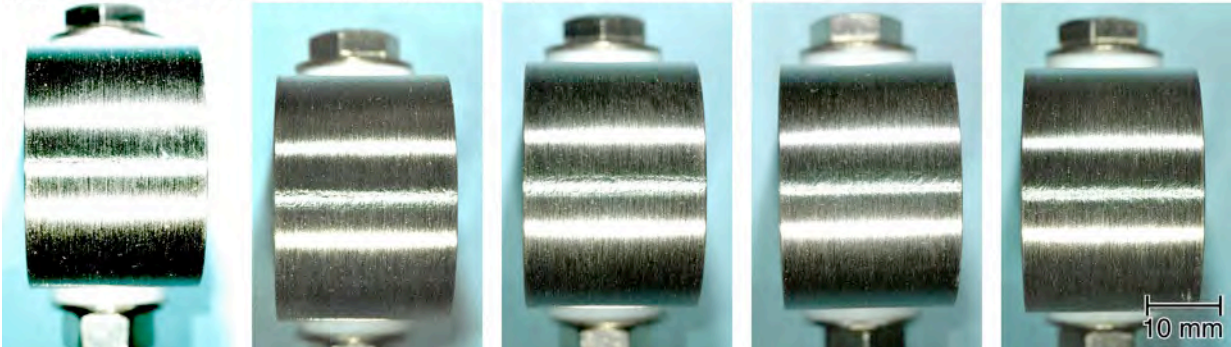
The U-bend samples were examined to determine if there was any evidence of stress corrosion cracking, pitting, or crevice corrosion. These samples were examined by eye, macroscopically, and microscopically with a metallurgical microscope. No evidence of any of these forms of attack was found on any of these samples. Figure 26 and 27 are macro photographs of the apex of the bend section of all 20 of the U-bend samples exposed to the accelerated testing environment at SNL. Figure 26 shows the stressed face across the entire width of the bend while Figure 27 shows the edge and corner of the bend in each sample. In these figures, the thin layer of uniform corrosion product can be seen on the copper and brass samples, while there is no visual evidence of any attack on the stainless steel or the welded stainless steel samples.

Figure 26 – Macro photographs of the bend apex in all 20 of the U-bend samples exposed to the accelerated testing environment at SNL.

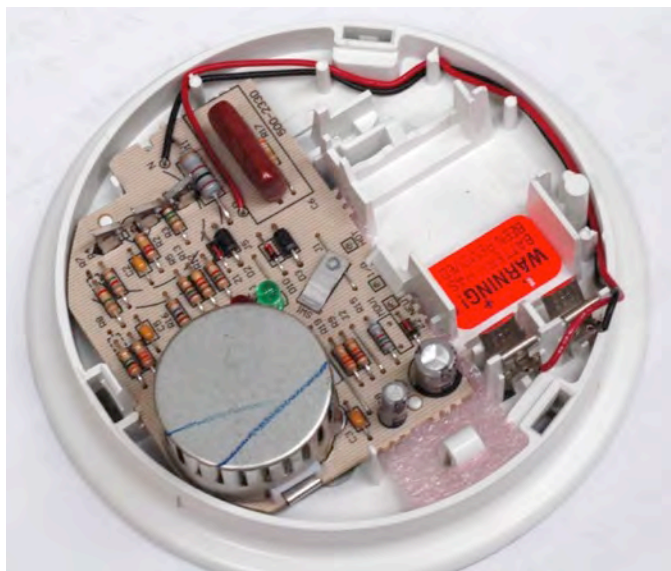
(2) Results of Metallurgical Examinations: The smoke alarm examined was one that failed to produce a strong and steady alarm. Figure 28 is a photograph of this unit with the cover removed. In this figure, the circuit board, with the cell containing the electrodes and the Americium source and connections for the 9-volt battery are immediately obvious. Less obvious are the connections to the piezoelectric bending disc used for the alarm-sounding device. These connections are of the lever spring-type, and they are located on the upper left side of the circuit board in the figure. The piezoelectric alarm-sounding device is attached to the cover and makes electrical contact with these connections by pressing against them when the cover is put into place. Figure 29 is a photograph of two piezoelectric bending discs used for the alarm-sounding device in smoke alarms. The one on the left is from the alarm that failed to present a normal signal when it triggered the alarm, and the one on the right is from an alarm of the same type that had been used for smoke testing, but had not been exposed to the accelerated corrosion environment at SNL. The difference in the appearance between these piezoelectric discs is remarkable, and the one of the left appears to be covered with a black corrosion product that has spalled off, at several locations, at the point of contact with the spring connections, probably due to repeated disassembly and reassembly of the unit. To determine the composition of this black film, this sample was placed into the X-ray diffractometer and examined in the same manner as the corrosion coupons above. This analysis, Figure 30, found peaks for silver metal and silver sulfide (Ag_2S). The silver sulfide phase was identified as the same phase found on the corrosion coupons listed in Table II (acanthite). Therefore, it is concluded that, as in the microwave connection, the growth and creep of Ag_2S into the interface between the lever-type spring connections and the silver-coated piezoelectric of the alarm sounding device is responsible for the failure of this unit to make a normal alarm sound.

Figure 28– Open smoke detector alarm after exposure to the accelerated corrosion-testing environment at SNL.

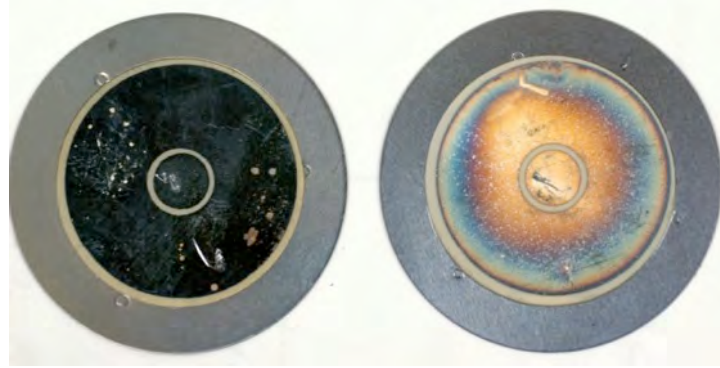
Figure 29 – Comparison of the piezoelectric alarm tone-producing disks from a smoke detector after exposure to the accelerated corrosion-testing environment at Sandia National Laboratory (on left) to one from a detector not exposed to this environment (on right). These photographs were taken after smoke response testing where the one on the left failed to produce a normal tone while the one on the right functioned normally.

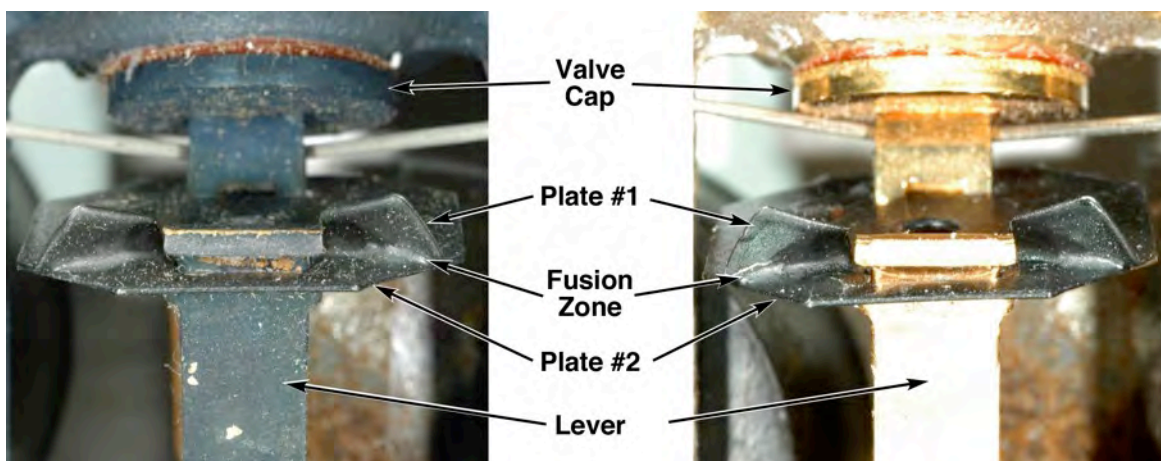
Figure 32 – Close-up of the fusible link of the units shown in Figure 31, demonstrating the gap between the two plates of the link where they are fused together. It should be noted that the black coating is on the fusible link of both the unexposed and exposed units.
