NATIONAL BUREAU OF STANDARDS REPORT

7489

PERFORMANCE OF ROOFING IN PUERTO RICO

20 April 1962

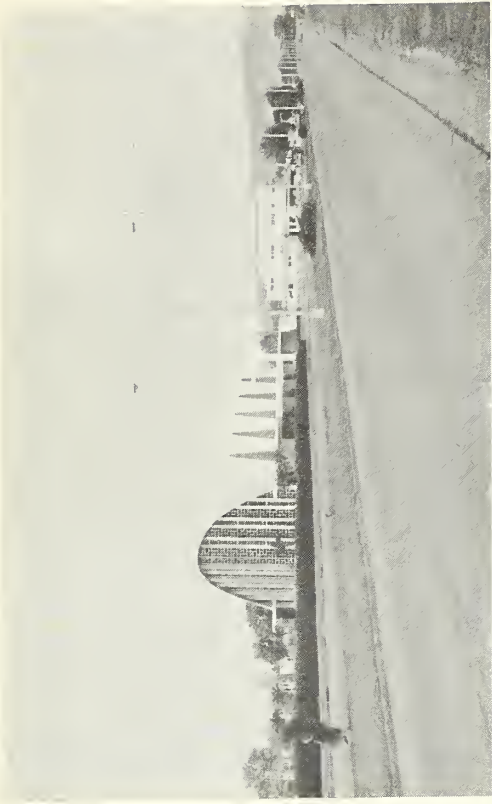
6

The performance of an elastomeric type of coating identified as "Hypalon" (a chlorosulfonated polyethylene roofing solution) was observed on the parabolic roof of the Santa Maria Reina Cathedral in Ponce, P.R., shown in Figure 6. The roof consisted of a 3-inch reinforced concrete shell supported by a series of 54-foot span catenary arches and had an area of about 240 squares. It was reported that two coats of "Hypalon" were applied by conventional pressure pot-spray equipment in January 1957. Our observations indicated the material had weathered quite well and no obvious defects were observed after 5 years exposure. A general view showed a somewhat mottled appearance indicating either unequal coverage or unequal weathering. It was felt that an additional application of the material should be applied in the near future.

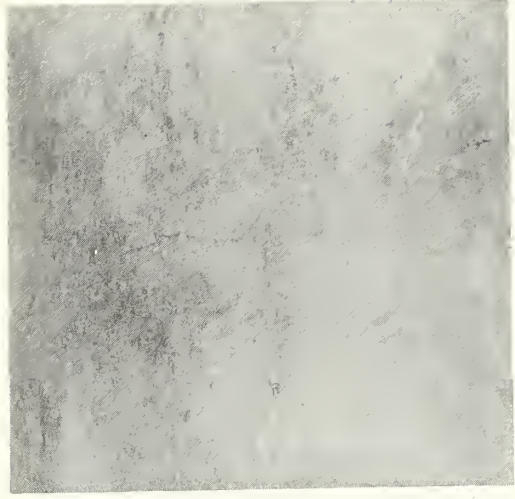
8

Protective coatings of various types were observed on many of the exposed slabs. These materials were, in many cases, employed for aesthetic reasons, but were primarily used to reduce temperatures by reflecting solar energy and, therefore, were pigmented white, aluminum, or other pastel shades. The use of these coatings apparently had little effect on the waterproofness of the slab. However, it was obvious that the light-colored coatings exerted a dominate influence on the temperatures attained by the slab. There is a tendency to think of unpainted concrete slabs as white in color, but this is not true in Puerto Rico where exposed slabs are quite dark due to biological growths, as illustrated in Figure 8.

- (5) In the warm, humid climate of Puerto Rico, concrete slabs become quite dark due to biological growths on the surface and, therefore, reflective coatings should be employed to reduce thermal movements in the slab.

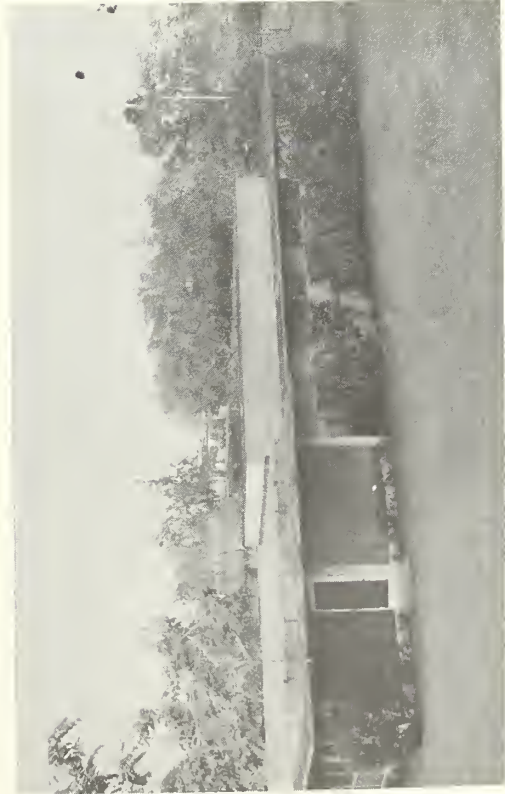
7

The built-up roof was also used to repair exposed concrete when it became uneconomical to isolate and repair cracks in the deck. A typical structure employing such a roof is shown in Figure 7.

Built-up roofs used to render cracked slabs waterproof were also observed on residential buildings at the N.C.S., Sabana Seca, P.R., illustrated in Figure 7. The membranes were applied in 1961 to the main roof sections, as shown in Figure 20. The roofs were in excellent condition and were watertight. However, some leakage was still apparent in the interior. It, no doubt, resulted from cracks observed at the angles formed by the intersection of the roof slab with vertical surfaces.

An examination of the asphalt revealed it to be very soft (135°F Softening Point or less) at roof temperatures. The use of this soft material between the deck and the first ply of felt resulted in an asphalt drippage through a crack in the slab. This, of course, was a matter of some concern to the building occupants.

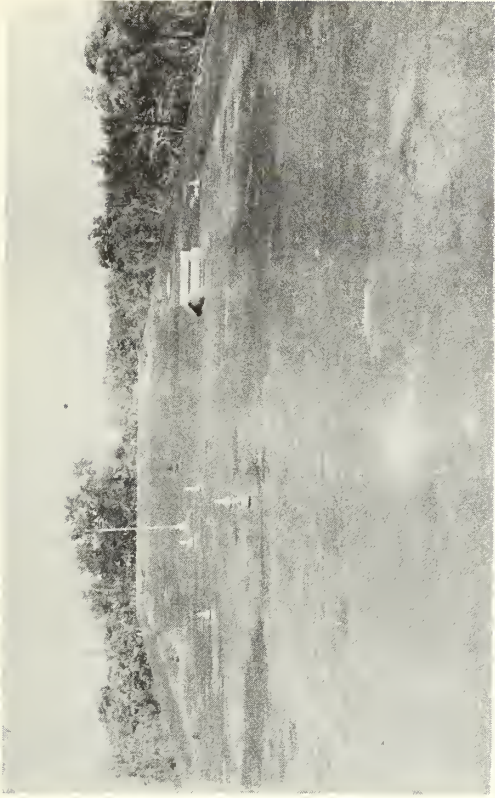
10

The exposed slab of one relatively large structure (EM Barracks, NCS, Sabana Seca, P.R.), illustrated in Figure 10, was relatively free of cracking and the occupants reported it to be watertight. This two-story structure was of reinforced concrete construction and was built in 1952. The roof slab had a broom finish. A biological growth, common to the exposed roofs in Puerto Rico, contributed to the dark roof surface, as shown in the photograph.

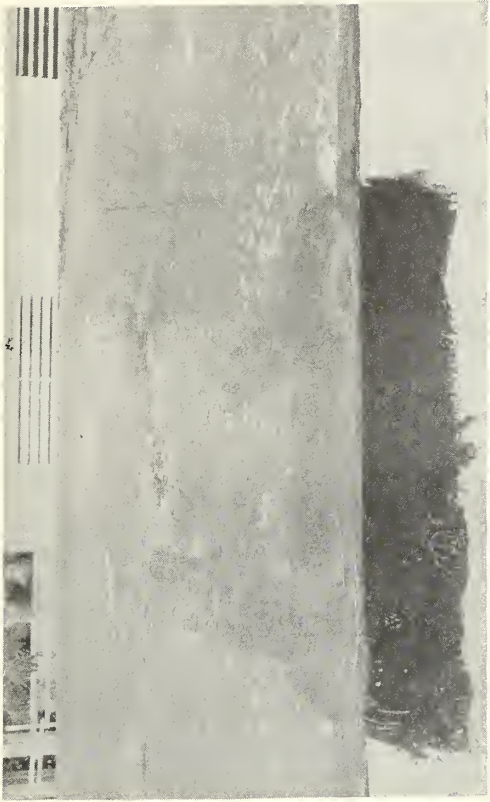
14

The repair method consisted of applying a mastic (bituminous emulsion, asphalt plastic cement, or proprietary materials of similar viscosity) over the crack and extending 4 to 6 inches on both sides of the crack. A reinforcing strip (generally woven glass fabric or glass mat) was embedded in the mastic and coated with a similar material. A typical roof employing such a system is illustrated in Figure 14.

This method of crack repair has proven the most successful of the many methods tried. However, it has many limitations. Our observations indicated that movements in the deck at the crack due to expansion and contraction sometimes resulted in a break in the system over the crack. In addition, poor adhesion between the fabric and the deck was observed, indicating poor preparation of the surface.

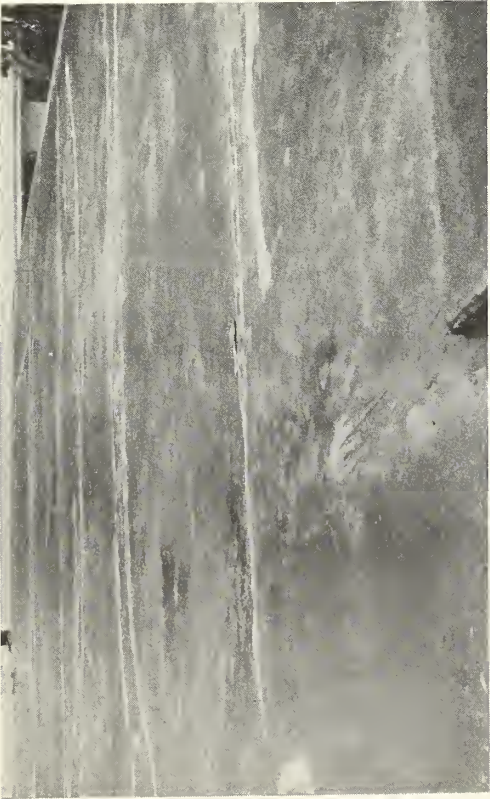
13

This method consisted of applying a cement grout directly over the crack, as illustrated in Figure 13. Our observations indicated that this method was not effective due to the poor adhesion to the dense concrete deck. On the other hand, if proper adhesion was obtained it is predicted that the crack in the substrate would soon be transferred to the patching compound due to its relatively poor elasticity.

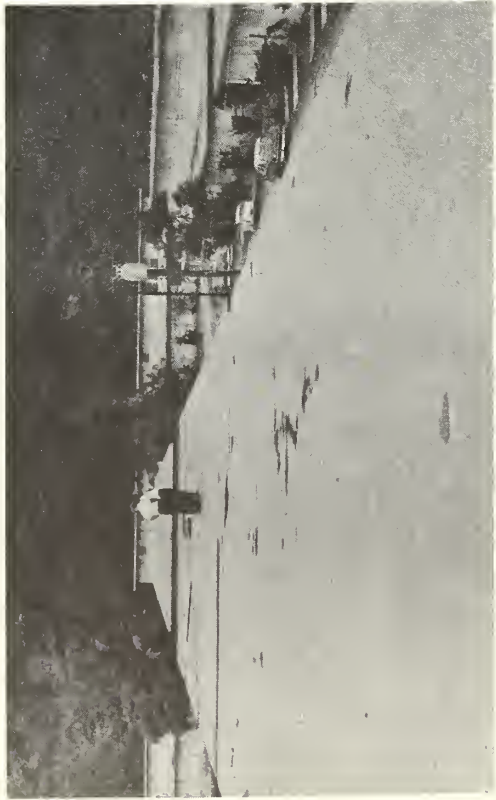
The application of a waterproof membrane over the entire deck was deemed necessary in cases where the cracks became so numerous that the isolation and the repair of each individual crack became uneconomical. A case in point was the Lanham Act Housing at Fort Buchanan. This development was constructed in 1940 and consisted of 200 units in 25 two-story buildings, one of which is shown in Figure 5. The exposed concrete slabs performed adequately until 1957, when due to the high maintenance cost of crack repair and the relative ineffectiveness of the repair, a complete roof system was applied. The roof system consisted of asphalt emulsion (5 gal. per square) - glass mat combination, followed by a reflective aluminum coating. It was reported that leakage has almost been eliminated with this repair system.

Our observations indicated the condition of the membrane was good after five years exposure, as shown in the general view in Figure 15. Two deficiencies were noted in the system. Ruptures of the membrane, as illustrated in Figure 16, were observed in two areas. However, these cracks were not typical of the irregular cracks generally found in the exposed decks. Therefore, they were attributed to other causes. In addition, many blisters were observed which ranged from a few inches in diameter up to 15 inches or more, as shown in Figure 17. The blisters apparently occurred between the deck and the membrane and were possibly caused by poor preparation of the surface prior to the application of the membrane. The blisters have caused no particular problems and, therefore, no action to eliminate them is indicated at this time.

The aluminum coating had weathered to a dull finish exposing the bituminous material in some areas and its condition after 5 years exposure indicated that additional coatings are warranted.

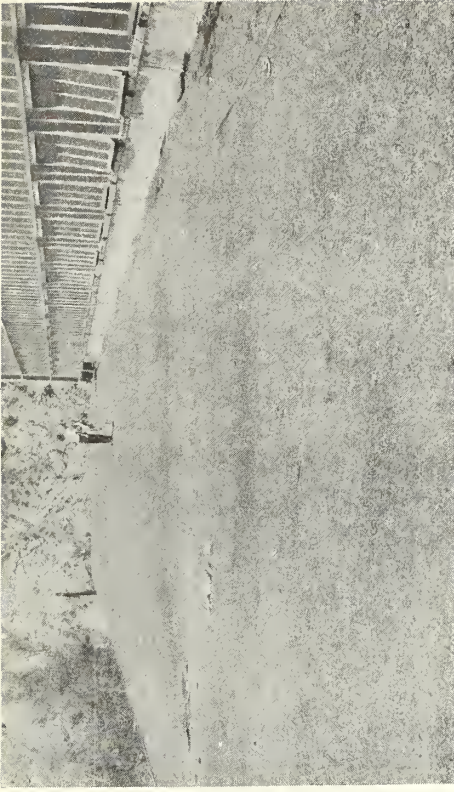
18

The appearance of this roof was good after about 20 years exposure, as shown in Figure 18. An examination of the asphalt showed it to be very hard and brittle even at the high temperature of the roof. However, there were no other signs of deterioration and it was apparently performing its basic function. The only defects observed were a number of bare areas where the felts were exposed. Some 41 leaks were reported in this roof. However, our observations indicated that most, if not all, of the leaks resulted from defective flashings, as shown in Figure 19. Obviously such deficiencies could be prevented by adequate and timely maintenance.

In our opinion, this roof could be expected to perform for another 10 years with adequate repair and maintenance procedures. The performance of this roof compares favorably to the performance of similar roofs in the continental United States.
