THE APOLLO 13 ACCIDENT

HEARINGS
BEFORE THE
COMMITTEE ON
SCIENCE AND ASTRONAUTICS
U.S. HOUSE OF REPRESENTATIVES
NINETY-FIRST CONGRESS
SECOND SESSION

JUNE 16, 1970

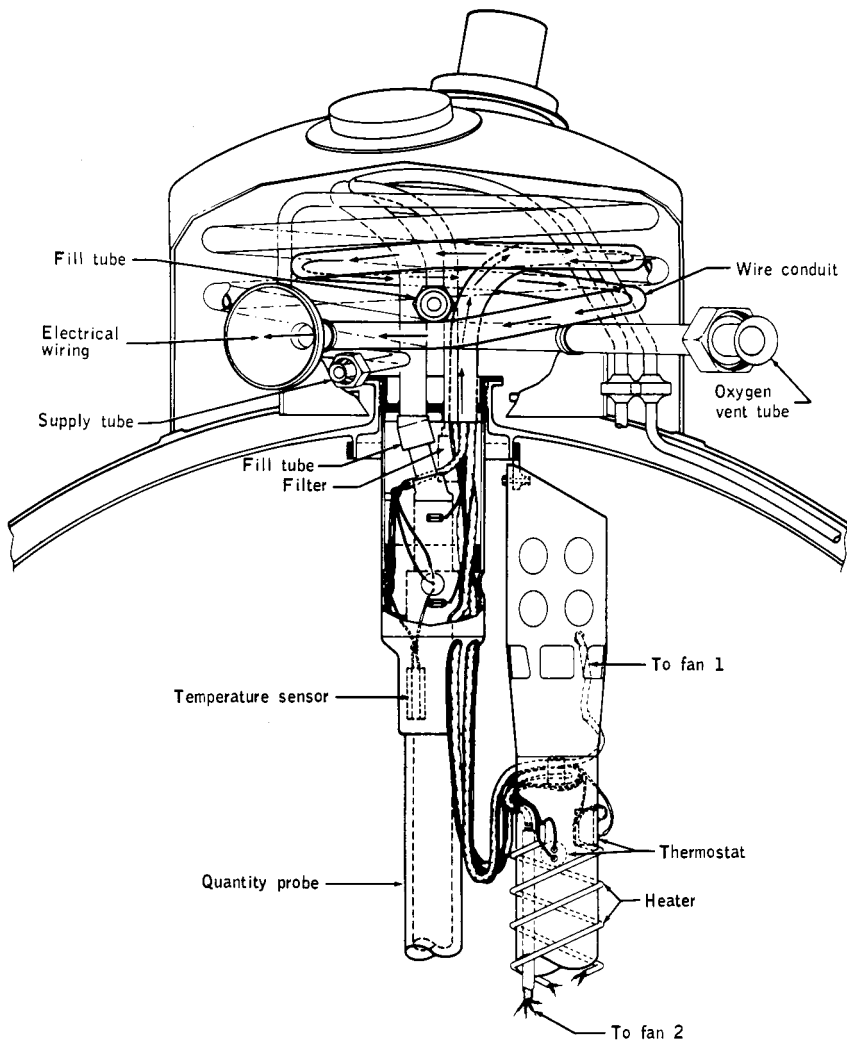
Figure 4-2.- Oxygen tank wiring and lines.

As shown in Slide 9, each heater coil is protected with a thermostatic switch, mounted on the heater tube, which is intended to open the heater circuit when it senses a temperature of 80° F. As I will point out later in tracing the Board's conclusions as to the cause of the accident, when the heaters were powered from a 65 volt DC supply at KSC during an improvised detanking procedure, these thermostatic switches, because they were rated at only 30 V DC, could not prevent an overheating condition of the heaters and the associated wiring. Tests conducted for the Board indicate that the heater tube assembly was probably heated to a temperature of as much as 1000° F during this detanking procedure.

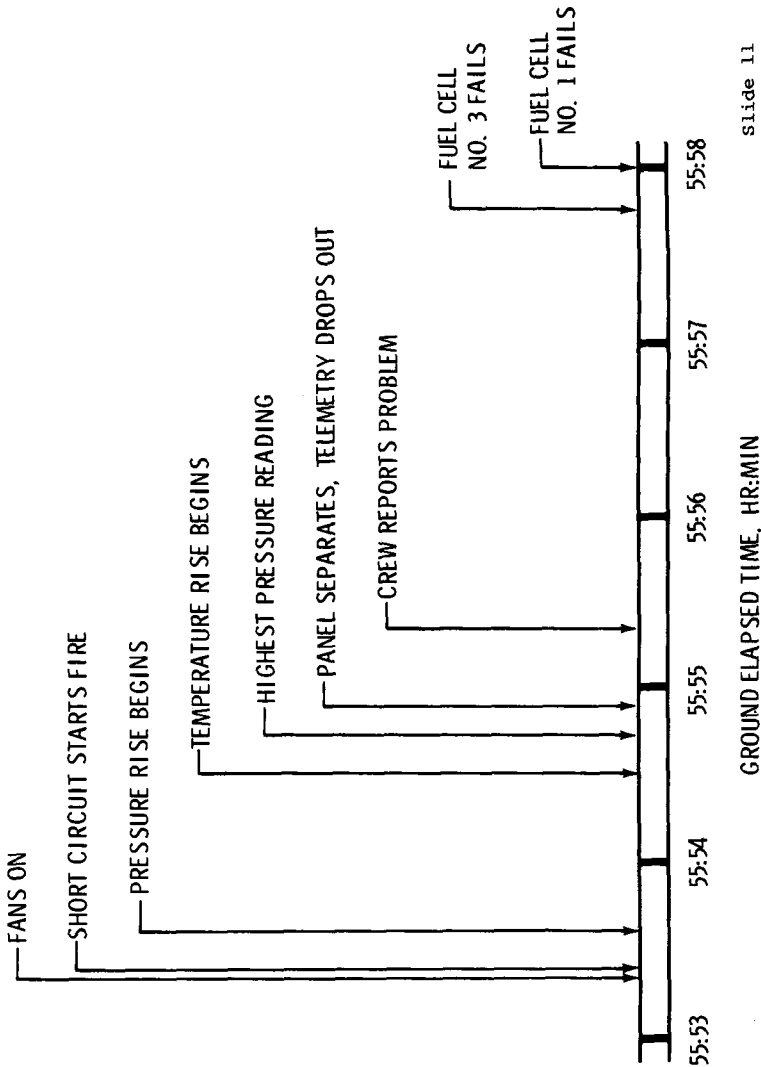
ACCIDENT EVENTS

The evidence points strongly to an electrical short circuit with arcing as the initiating event. Near the end of the 55th hour of flight, about 2.7 seconds after the fans were turned on in the SM oxygen tanks, an 11.1 ampere current spike and simultaneously a voltage drop spike were recorded in the spacecraft electrical system. Immediately thereafter current drawn from the fuel cells decreased by an amount consistent with the loss of power to one fan. No other changes in spacecraft power were being made at the time. No power was on the heaters in the tanks at the time and the quantity gage and temperature sensor are very low power devices. The next anomalous event recorded was the beginning of a pressure rise in oxygen tank #2, 13 seconds later. Such a time lag is possible with low level combustion at the time. These facts point to the likelihood that an electrical short circuit with arcing occurred in the fan motor on its leads to initiate the accident sequence. The energy available from the short circuit is estimated to have been at least 10 to 20 joules. Tests conducted during this investigation have shown that this energy is more than adequate to ignite Teflon wire insulation of the type contained within the tank.

This likelihood of electrical initiation is enhanced by the high probability that the electrical wires within the tank were damaged during the abnormal detanking operation at KSC prior to launch. The likelihood of damage and the possibility of electrical ignition have been verified by tests.

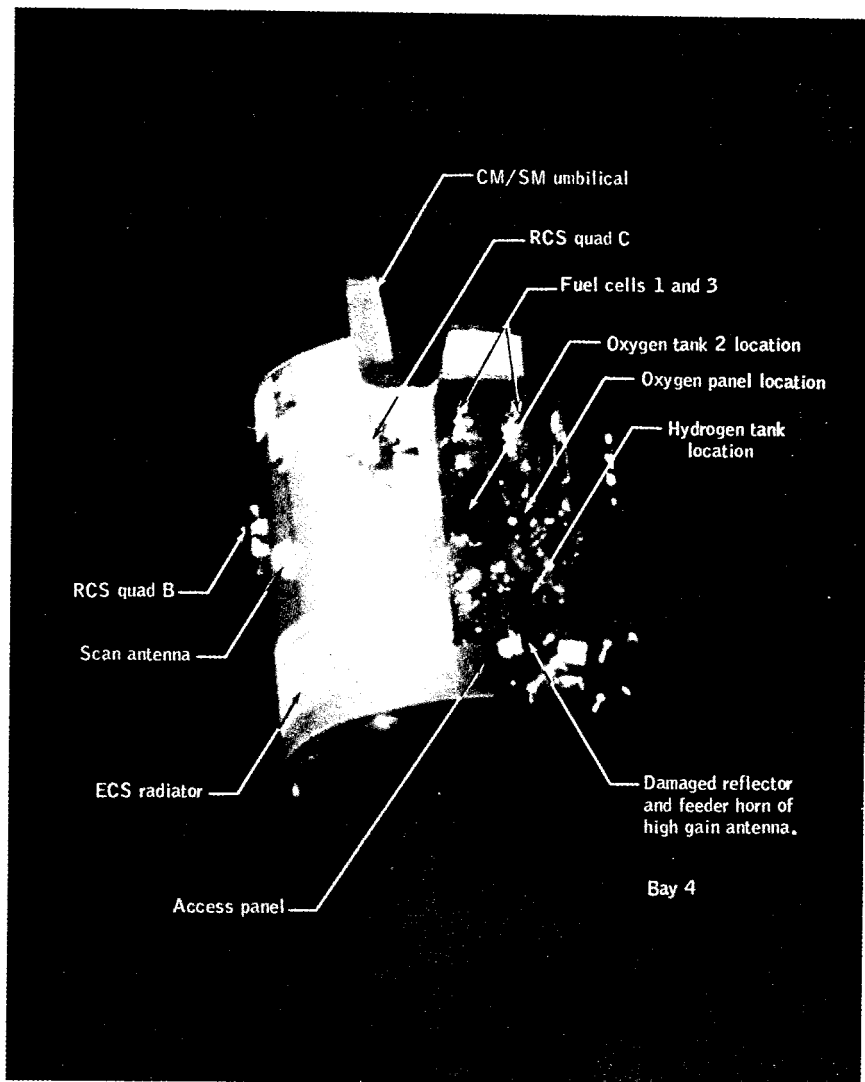
Inflight photograph of service module showing damage to bay 4.
