# APOLLO 13 MISSION REVIEW

HEARING  
BEFORE THE  
COMMITTEE ON  
AERONAUTICAL AND SPACE SCIENCES  
UNITED STATES SENATE  
NINETY-FIRST CONGRESS  
SECOND SESSION

JUNE 30, 1970

## CHAPTER 5—FINDINGS, DETERMINATIONS, AND RECOMMENDATIONS

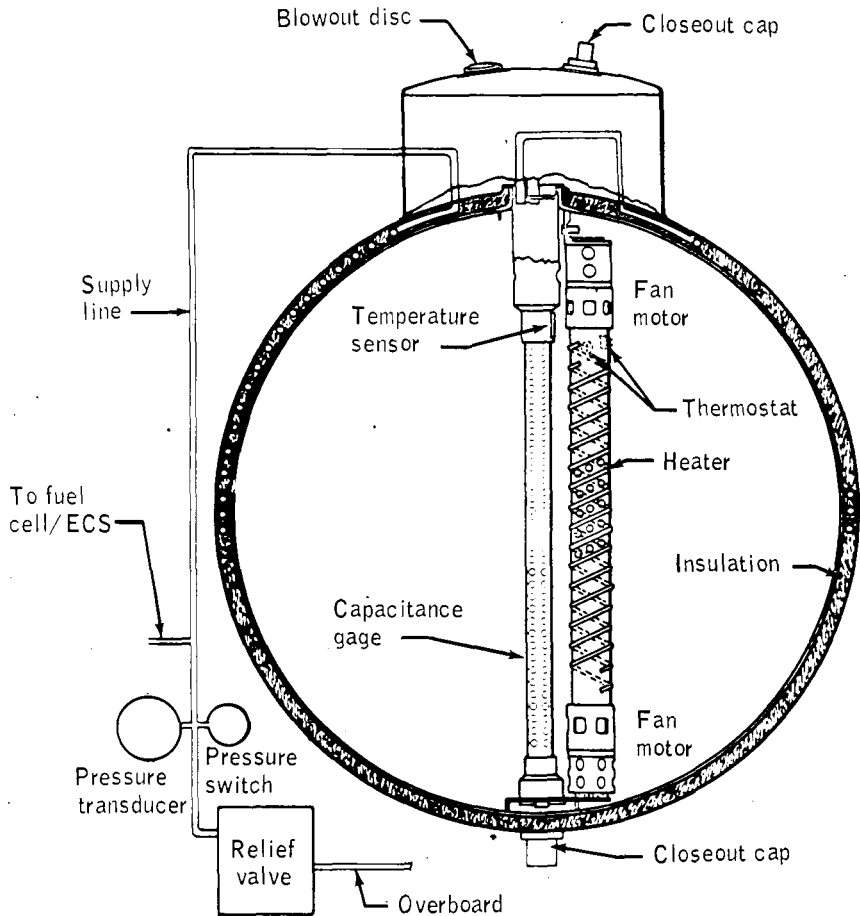
FIGURE 1. Oxygen tank No. 2 internal components.

Slide 1 (see fig. 1) shows the simplified drawing of the oxygen storage tank in which the accident occurred. I will just say a brief word about this slide to orient you to the nature of the problem that was encountered.

Now, in brief, this is what happened. After assembly and acceptance testing the oxygen tank No. 2 which flew on Apollo 13 was shipped from Beech Aircraft Corp. to North American Rockwell in apparently satisfactory condition. It is now known, however, that the tank contained two protective thermostatic switches on the heater assembly. These switches were inadequate and subsequently failed during ground test operation at Kennedy Space Center.

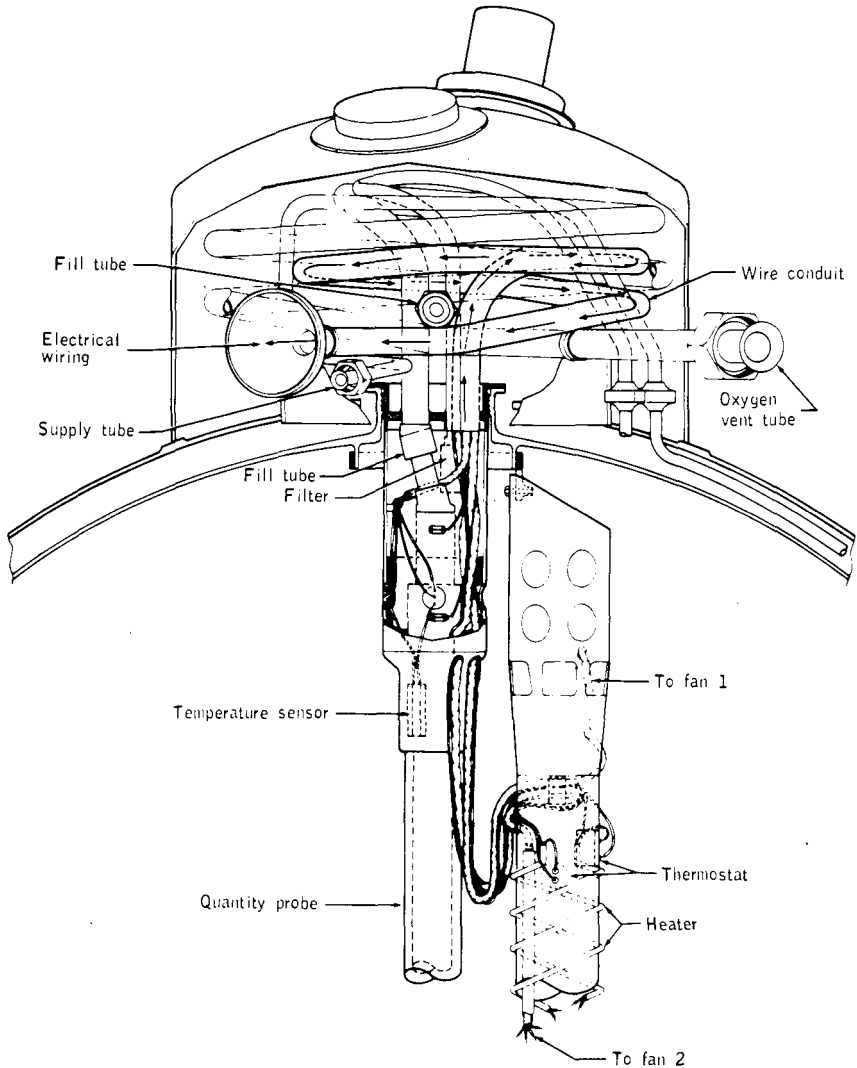
FIGURE 2. Oxygen tank wiring and lines.

Now, the second slide (see figure 2) shows this in a little more detail. As you can see at the top of the heater-fan assembly the word "thermostat" is shown with two arrows. These arrows point to the two thermostatic switches which failed. In addition, there is a fill tube assembly shown right here at the top of the quantity probe which was loose in a manner which I will describe in just a moment and this led to a special detanking procedure which failed those switches and ultimately damaged the wiring.

During this procedure as the switches started to open when they reached their upper temperature—they were welded permanently closed or otherwise failed permanently closed by the resulting arc and were rendered inoperative as protective thermostats.

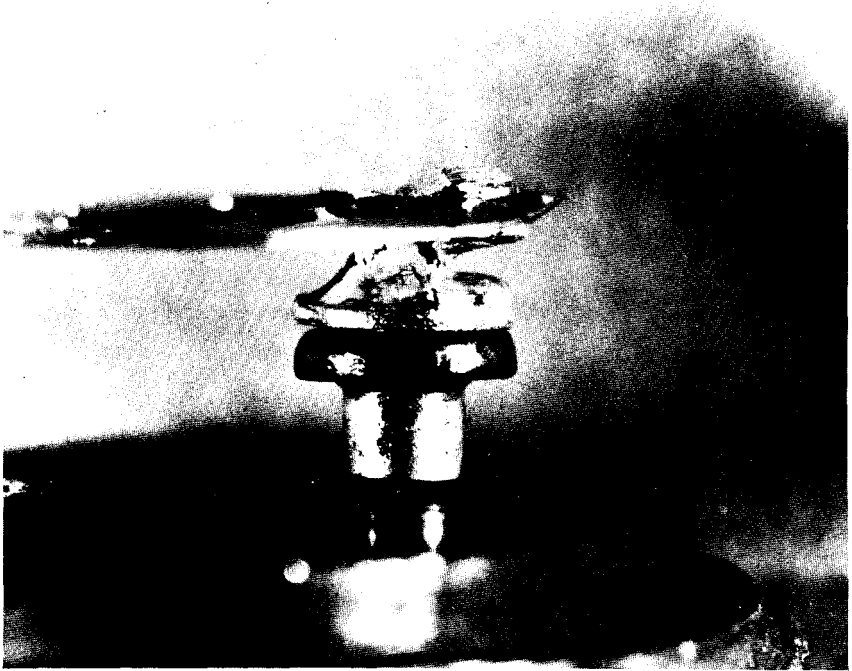
FIGURE 3

Now, the next slide (see fig. 3) shows a photograph of a switch

which was failed with this current during tests at the Manned Spacecraft Center. The drawing is in the report and in the statement that I submitted today—the photograph is in there.
