[Docket No. 95–CE–14–AD]

#### Airworthiness Directives; Cessna Aircraft Company 150 and A150 Series and Models 152 and A152 Airplanes

**ACTION:** Notice of proposed rulemaking (NPRM).

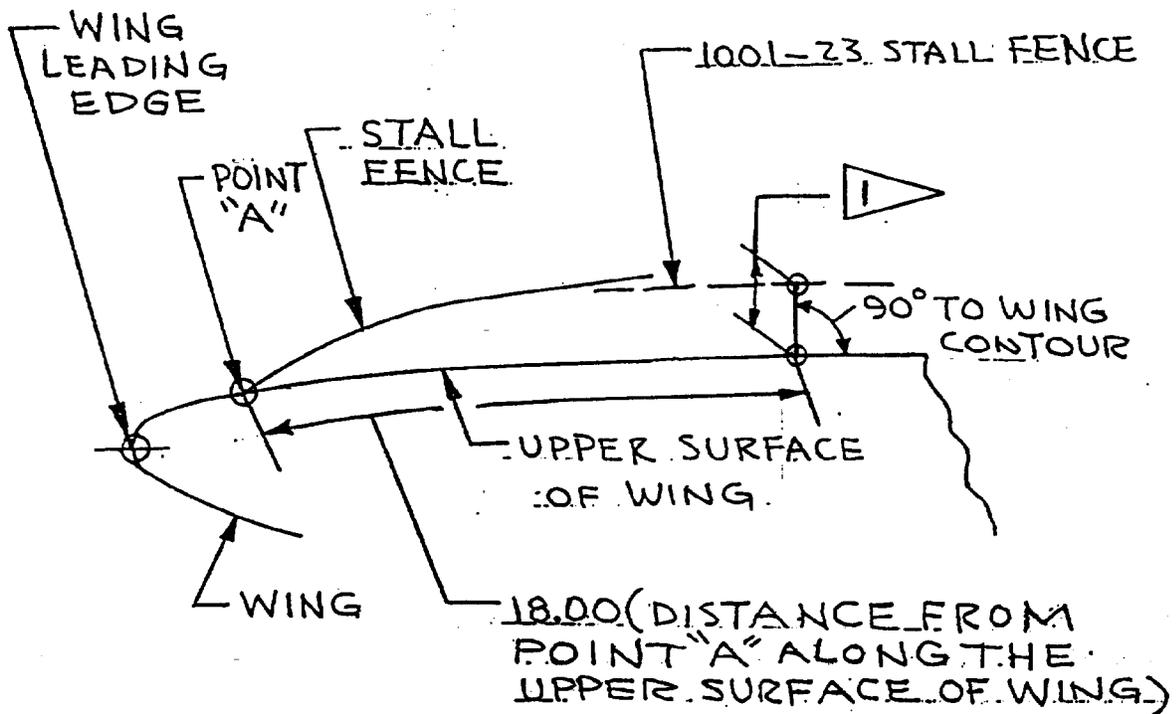
FIGURE 1  
MID-AMERICA DWG No. 1001  
(STC SA1371 SW)

installed in accordance with Supplemental Type Certificate (STC) SA1371SW. This kit includes a wing leading edge cuff and stall fence on each wing that is installed on the top of the wing chordwise in line with the aileron/flap juncture. The wing stall fence on this Cessna Model 152 airplane measured 1.625 inches in height at its trailing edge and maintained that height through approximately 70 percent of the fence's length, gradually tapering to the contour of the wing's leading edge.

The FAA approved the fence height of the Bush Conversions, Inc., STOL kit at a height of 1.16 inches (plus or minus .12 inches) for Cessna 150 and A150 series and Models 152 and A152 airplanes. Mid-America Drawing No. 1001 references this height and is included as part of STC SA1371SW. Mid-America Drawing No. 1001 is included as Figure 1 of the proposed AD.

(a) Measure the height of the wing stall fence at its trailing edge to ensure that the height does not exceed 1.28 inches. (See Figure 1 of this AD).

1 ▽ IF STALL FENCE IS  $1.16 \pm .12$  HIGH, THAT IS CORRECT HEIGHT FOR STALL FENCE. IF GREATER THAN 1.28 HIGH, REMOVE STALL FENCES AND INSTALL THE CORRECT ONE.

(b) If the wing stall fence height exceeds 1.28 inches, prior to further flight, install a smaller fence in accordance with instructions obtained from the Wichita Aircraft Certification Office (ACO), FAA, 1801 Airport Road, Mid-Continent Airport, Wichita, Kansas 67209.
