SANTA CRUZ RIVER, PASEO DE LAS IGLESIAS, PIMA
COUNTY, ARIZONA FINAL FEASIBILITY STUDY

A STUDY ON THE SANTA CRUZ RIVER, PASEO DE LAS IGLESIAS,
PIMA COUNTY, ARIZONA, PURSUANT TO PUB. L. 75-761

The Final Feasibility Report and Environmental Impact Statement (FR/FEIS) for the Santa Cruz River (Paseo de las Iglesias) Ecosystem Restoration project, Arizona, dated July 2005, addresses ecosystem restoration and flood damage reduction opportunities along the Paseo de las Iglesias reach of the Santa Cruz River in Pima County, Arizona. Based on my review and the views of interested agencies and the concerned public, I find the project authorized by Congress in Section 1001(3) of the Water Resources Development Act of 2007 (Public Law 110-114) to be technically feasible, economically justified, environmentally acceptable, and in the public interest.

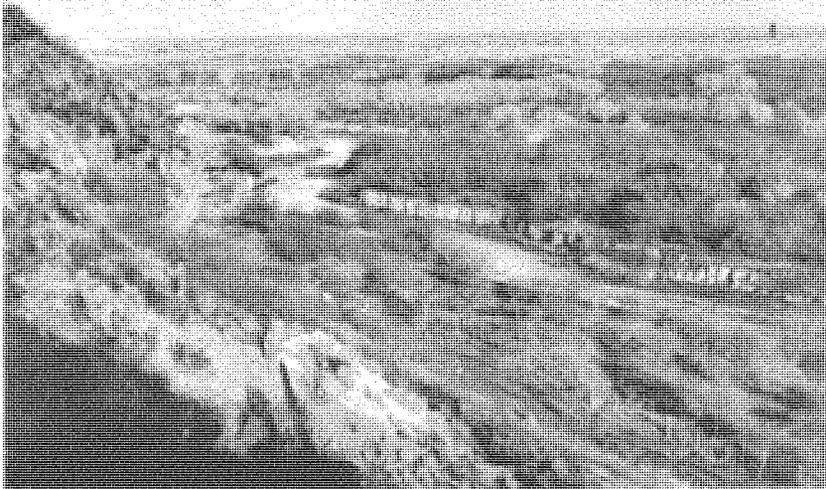
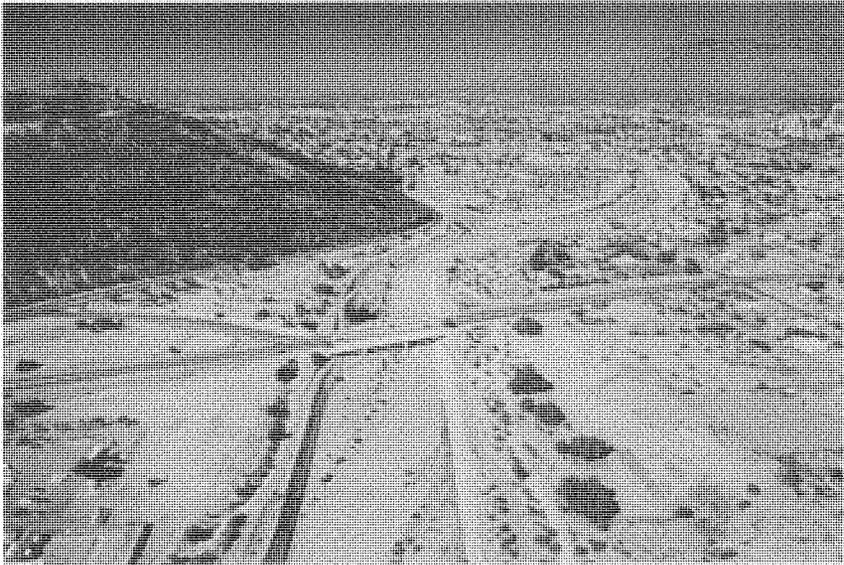
FIGURE 4.1 Comparison of Historic and Present Conditions

Confluence of the West Branch and the Santa Cruz River from Sentinel Peak, 1904
(Arizona Historical Society, Tucson)

The same area as it appears in a contemporary photograph

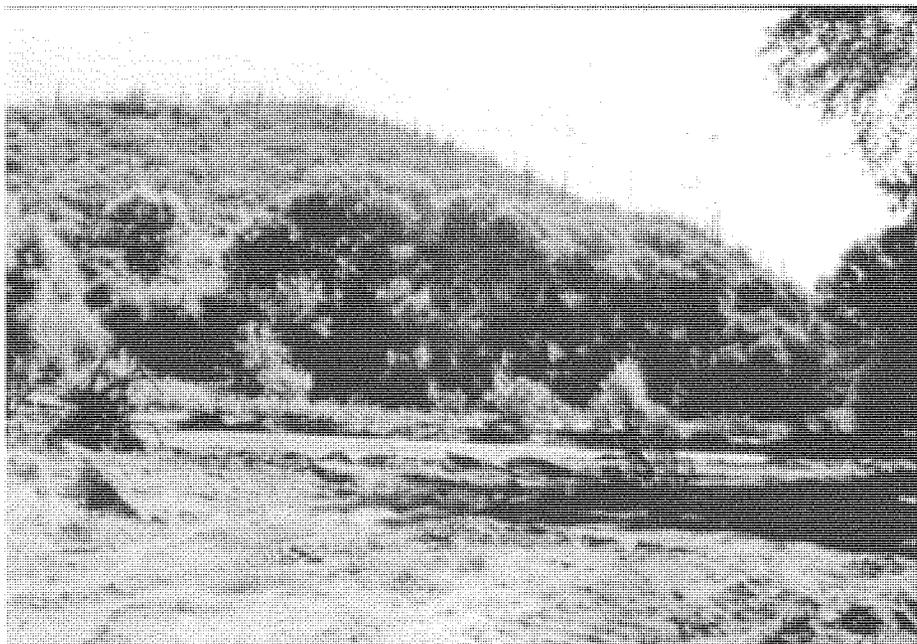
FIGURE 4.2 Historic Conditions

Cottonwoods persisted at the base of Martinez Hill near San Xavier in the 1940s
(Arizona Historical Society, Tucson)

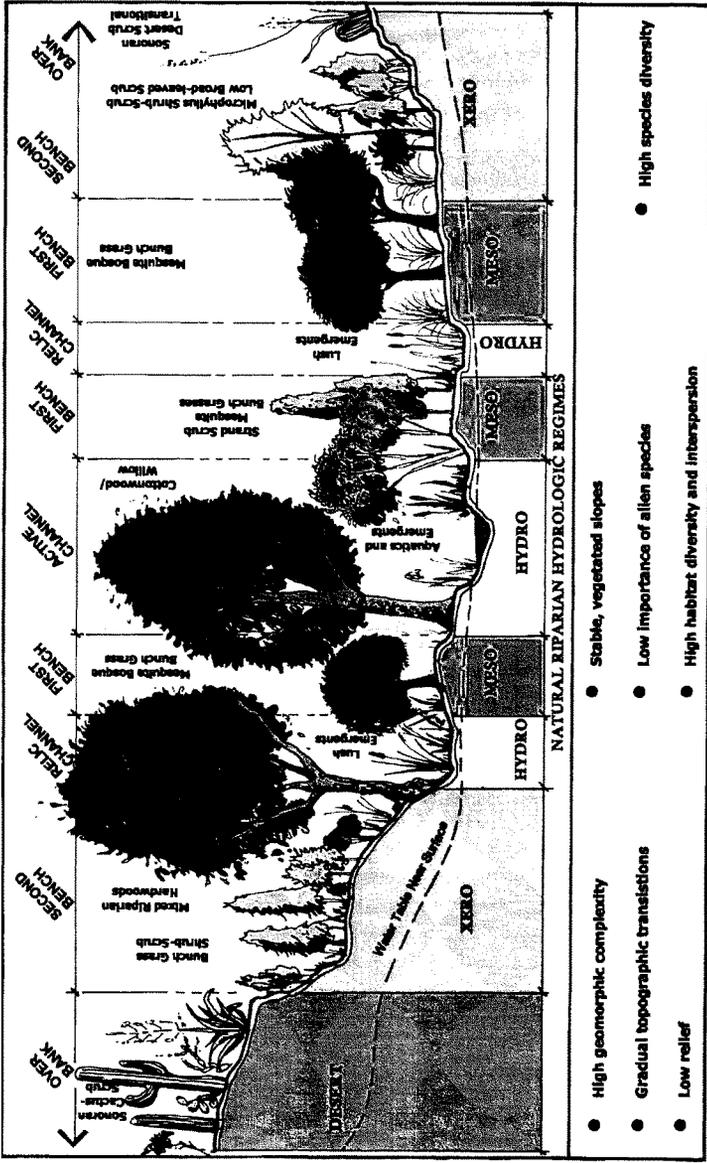
FIGURE 4.3 Natural Sonoran Riparian System

Xeroriparian regime. This zone is found on secondary terraces, generally above the elevation of the two-year recurrence interval storm, extending upward to the periphery of the ten-year storm floodway (and higher). Available moisture in this zone always exceeds surrounding desert and includes sources of direct precipitation, lateral overland flow from uplands and occasional flood inundation. Groundwater may be important to only the more deep-rooted trees and shrubs. Vegetation density may range from high to low depending on position relative to actual water concentration potential, but is lowest on average for all the riparian zones. Species diversity is moderate to high. Typical vegetation is the mesquite bosque habitat, although various brush or cactus-dominated communities may temporarily prevail due to flood or fire disruptions.

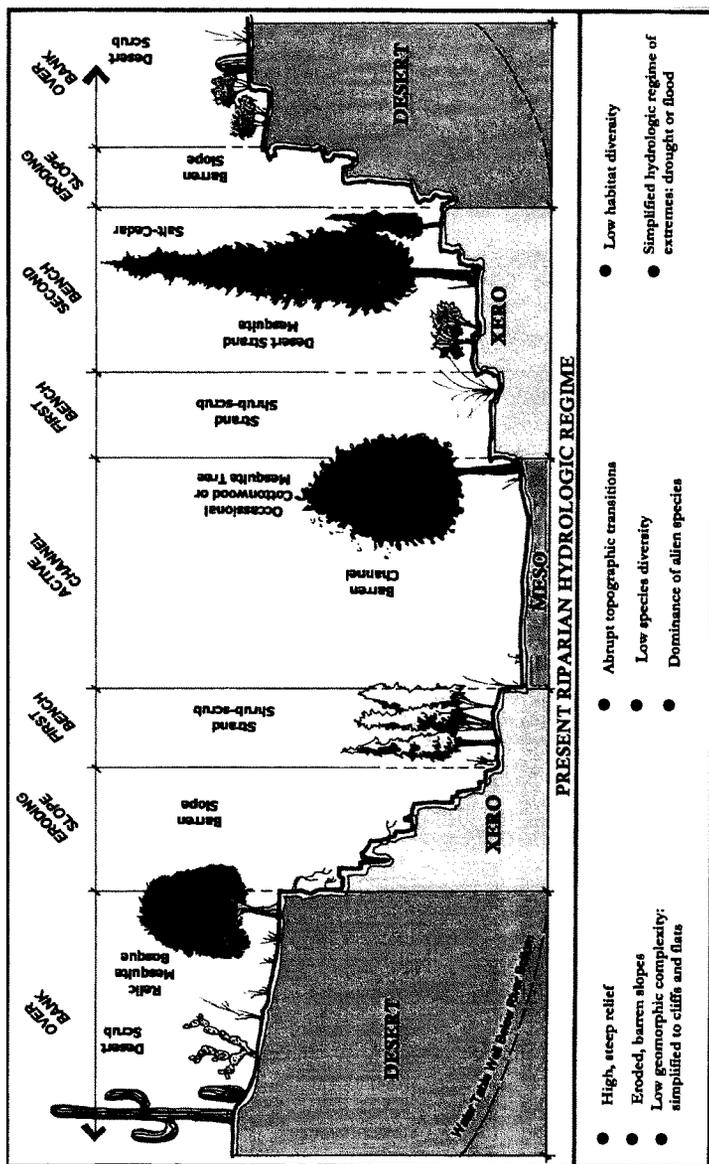
FIGURE 4.4 Degraded Santa Cruz Riparian System

Currently, the study area consists primarily of urban and disturbed land on both sides of a frequently disturbed, deeply entrenched ephemeral riverbed (Figure 4.5 & 4.6). It is almost entirely isolated from natural vegetative communities by urban development and barren lands. Continuing disruptions in the former floodplain include chronic channel and overbank erosion, ongoing development, relict agricultural operations and landfills, off-road vehicle use, construction of soil cement lined banks, illegal dumping, and transient camps. The aquatic and riparian communities have vanished, and the mesquite bosques are represented only in diminished, isolated pockets of stunted trees sprouting from cut or burned stumps. Exotic plant species, including salt cedar (*Tamarix ramosissima*) and Athel tamarisk (*Tamarix aphylla*), have replaced most of the native cottonwood and willow.

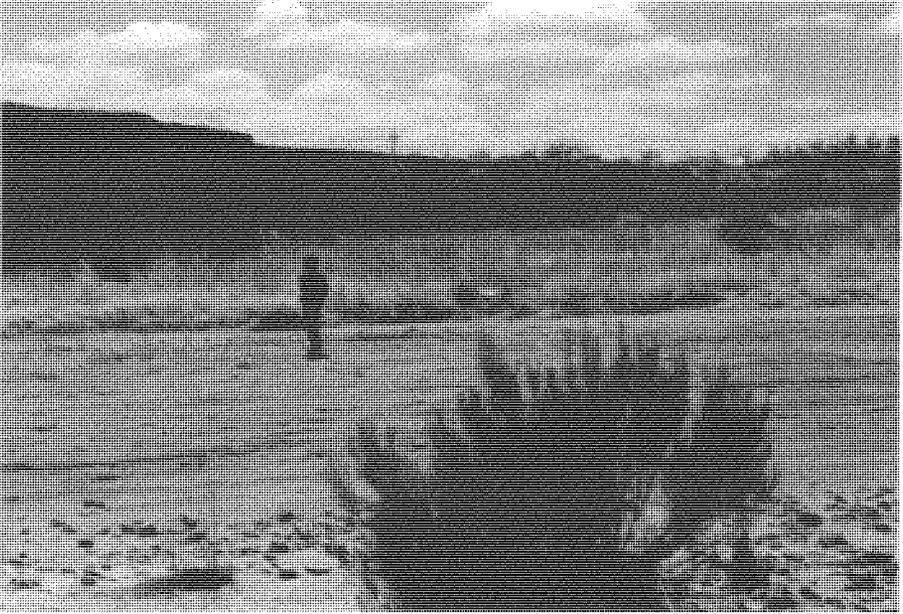
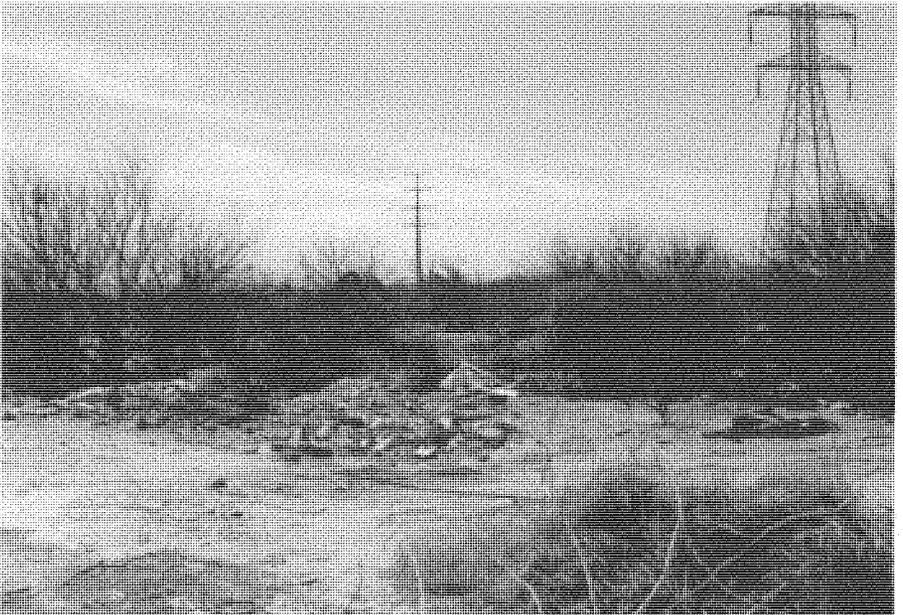
FIGURE 4.5 Existing Conditions

Note the nearly vertical banks in this unprotected reach south of Drexel

Debris left in channel north of Irvington

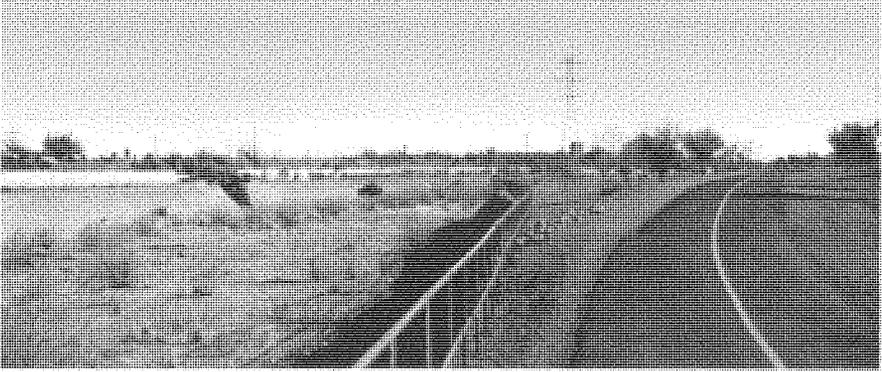
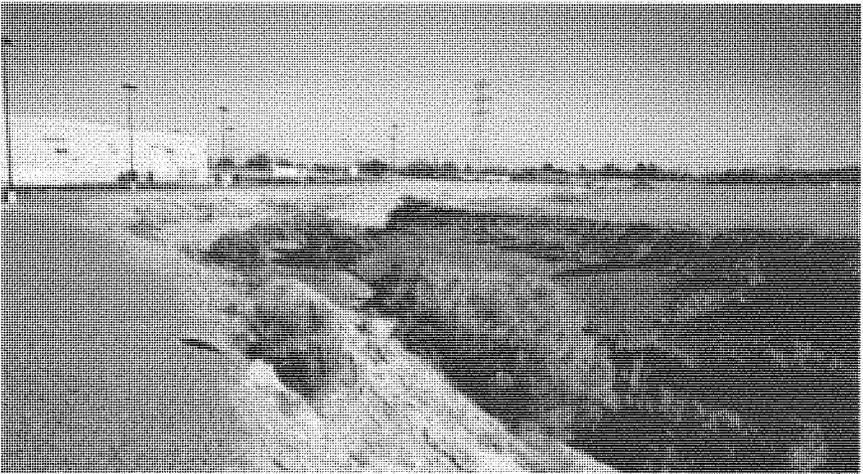
FIGURE 4.6 Existing Conditions

Bank and River Park trail south of Ajo Way

New housing and drainage structures on the Santa Cruz west bank south of Ajo Way

Condition of tributary wash upstream of its confluence with the Santa Cruz River

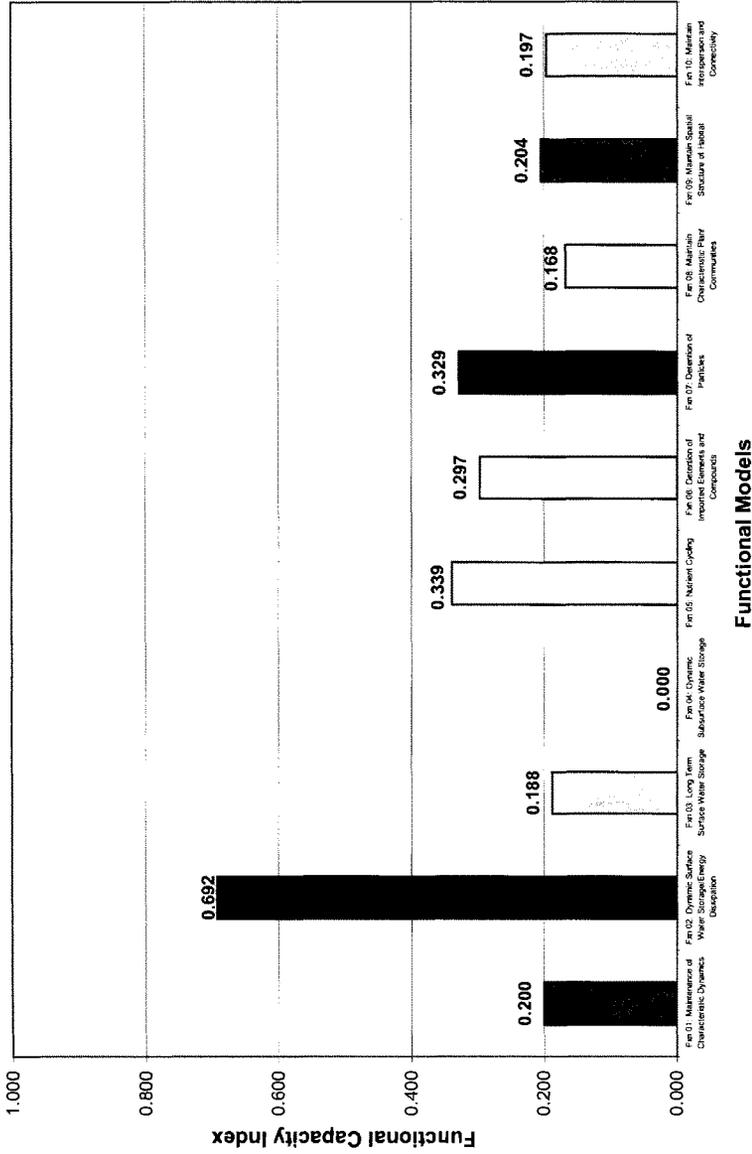
FIGURE 4.8 Baseline Functional Capacity Index Results

To compare Functional Capacity Units between the reference site(s) and the study area, the FCI for each reference site was multiplied times the same acreage per PWAA that exists in the Paseo de las Iglesias study area. When the Paseo de las Iglesias site is compared to the Arizona reference sites, the area has a much lower functional capacity index for desirable cover types. This illustrates the inability of the habitat within this reach to sustain itself. The average across the ten functions for the existing conditions in the study area is 154 AAFCUs, compared to the results for the Salt River reference site (the least productive of the five reference sites), which was 333 AAFCUs.

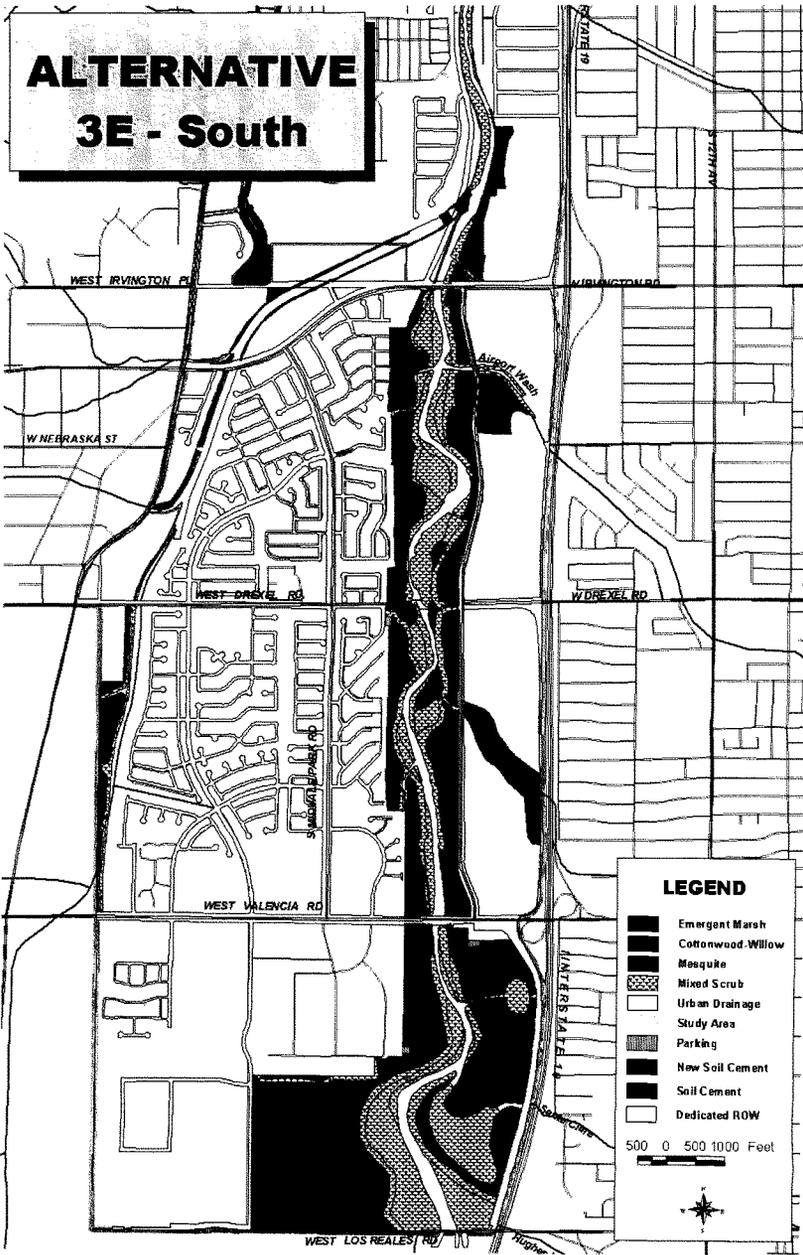
FIGURE 5.7b Alternative 3E

Alternative 3E: This alternative builds on 2A by providing irrigation to the subsurface water harvesting basins in addition to water harvesting, soil amendment, surface grading, irrigation of the lower reaches of the Old West Branch. Implementation of these measures will allow creation of new PWAAS, as well as supplemental Cottonwood-Willow, Mesquite, Scrubshrub, and Riverbottom plantings in existing PWAAs. These planted areas will be irrigated (Figure 5.7).

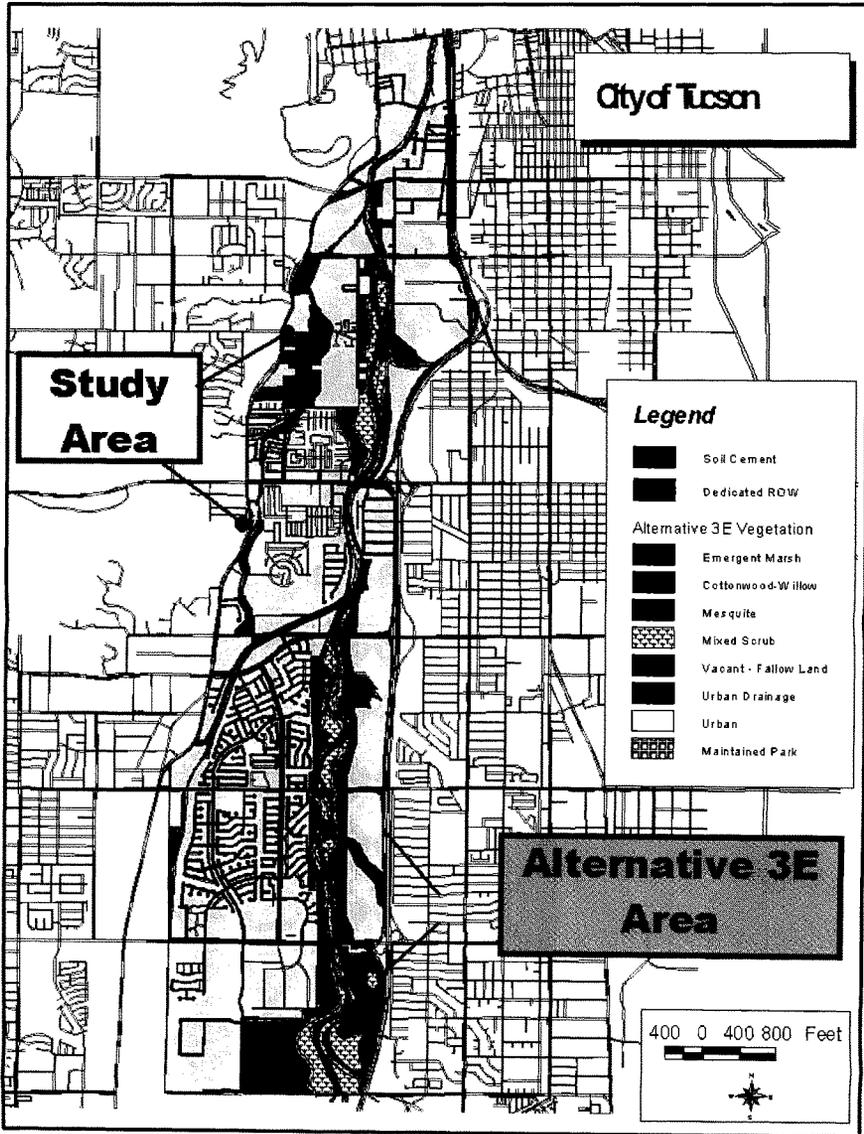
FIGURE 6.1 Recommended Plan

There are five short reaches of eroded bank where insufficient space exists to accommodate 5:1 slopes. These areas, totaling approximately 3,700 linear feet of bank, cannot be regraded; however, in their current state, they pose a threat of increased erosion and consequent destruction of plantings in adjacent areas. In order to preclude these risks, the areas would be stabilized using soil cement.

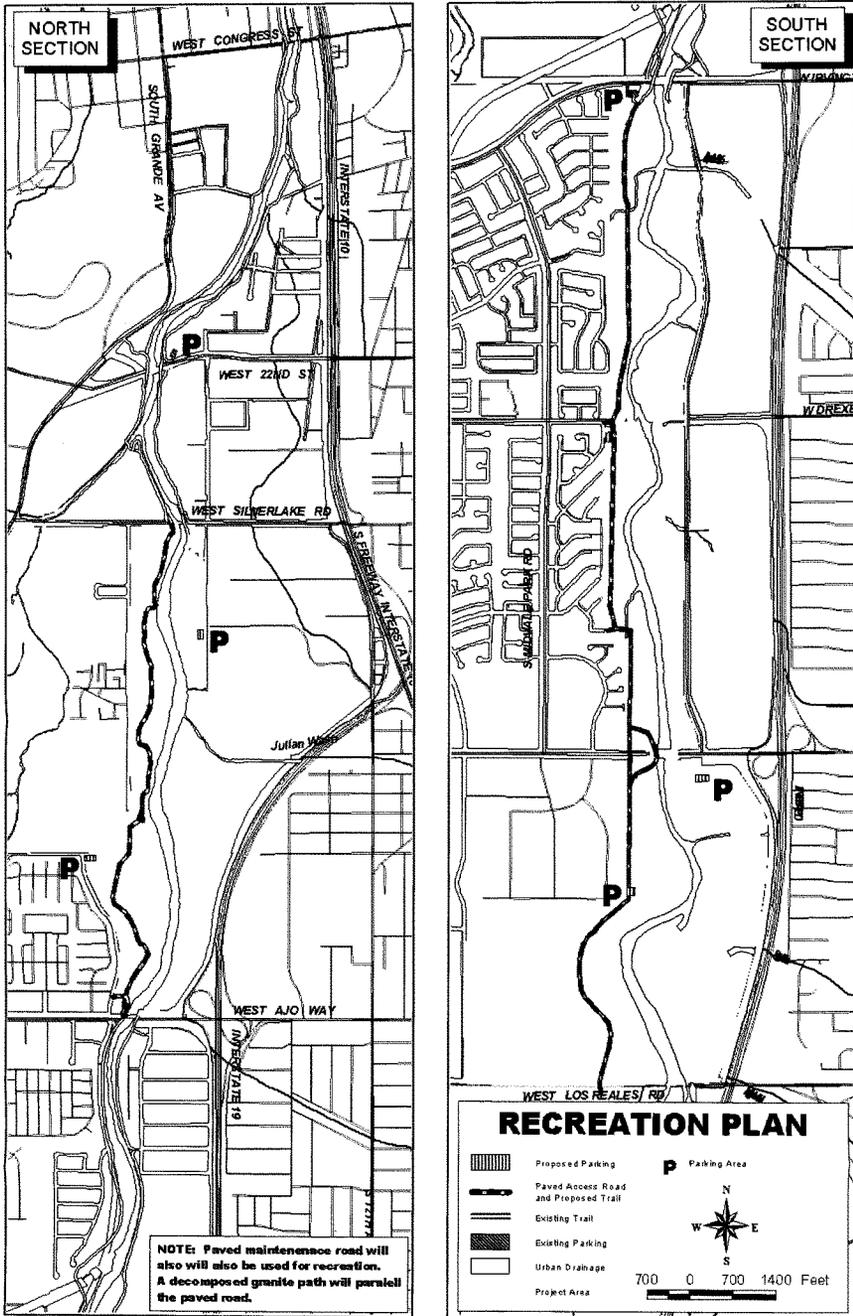
FIGURE 6.2 Recreation Plan

The Recreation Plan proposed in conjunction with the recommended restoration plan consists of decomposed granite (DG) multipurpose trails, parking, and trail links that serve a recreation purpose by connecting existing unlinked trail segments and providing opportunities to a variety of recreational users. Comfort stations will serve the basic safety needs of the recreational user. All road segments designated as maintenance provide access to areas in case of emergencies such as flooding and fire. Access will also provide a means to maintain vegetation in the newly restored area and park facilities. Warning signs are also added to direct pedestrians off the newly restored area and guide pedestrians away from any potential danger. These changes will provide a unique opportunity for resource-based recreation and environmental education. Trail alignments and parking locations are shown on Figure 6.2. Placement of comfort stations will be determined during detailed design.

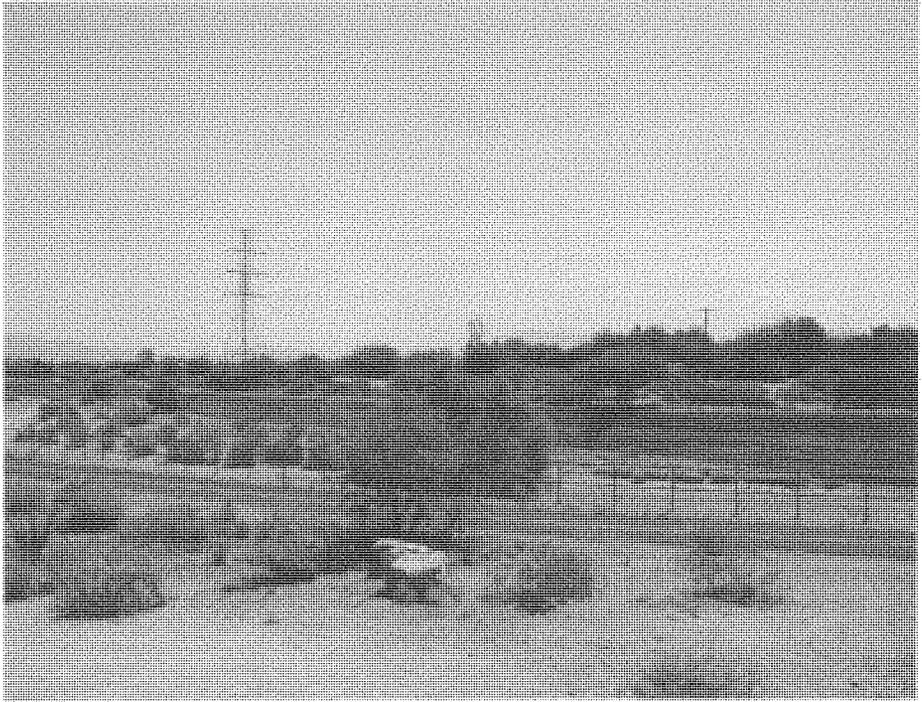
Figure 4.3 View from west bank, within Santa Cruz River Park, looking east. Note cement banks, railings, and landscaping.

The river itself is a highly disturbed, deeply entrenched ephemeral riverbed. Approximately half of the river's reach in the Study Area (see Figure 4.3) is artificially reinforced banks consisting primarily of soil cement armored sides; these soil cemented reaches create the impression of a relatively narrow ditch. Where there is soil cement, overbank areas have been developed into dual-purpose pedestrian/bicycle paths and landscaped areas consisting of a mixture of native and non-native trees and shrubs and dense patches of invasive non-native grasses and weeds (Figure 4.3). This is the Santa Cruz River Park, portions of which are managed by the City of Tucson, and portions by Pima County. The park provides dramatic views of the urban landscape and surrounding mountains and views of the Project Area. Access to the riverbed is available from ramps and parking lots along the banks within the river park boundaries.

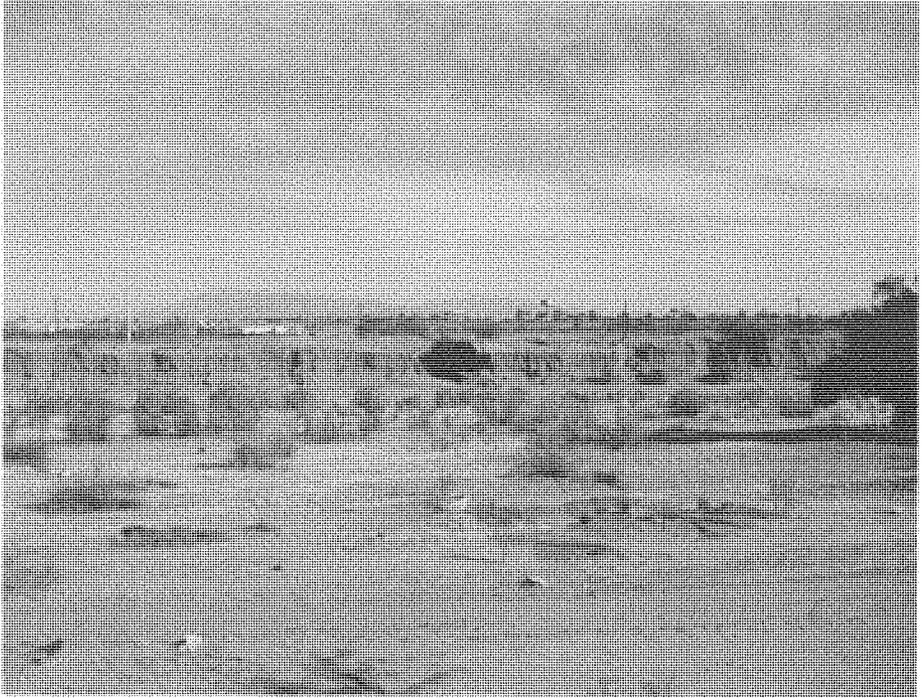
Figure 4.4 View Across River Bottom, Looking East. Note Cut Bank, Erosion, Buildings, Debris, and Tracks.

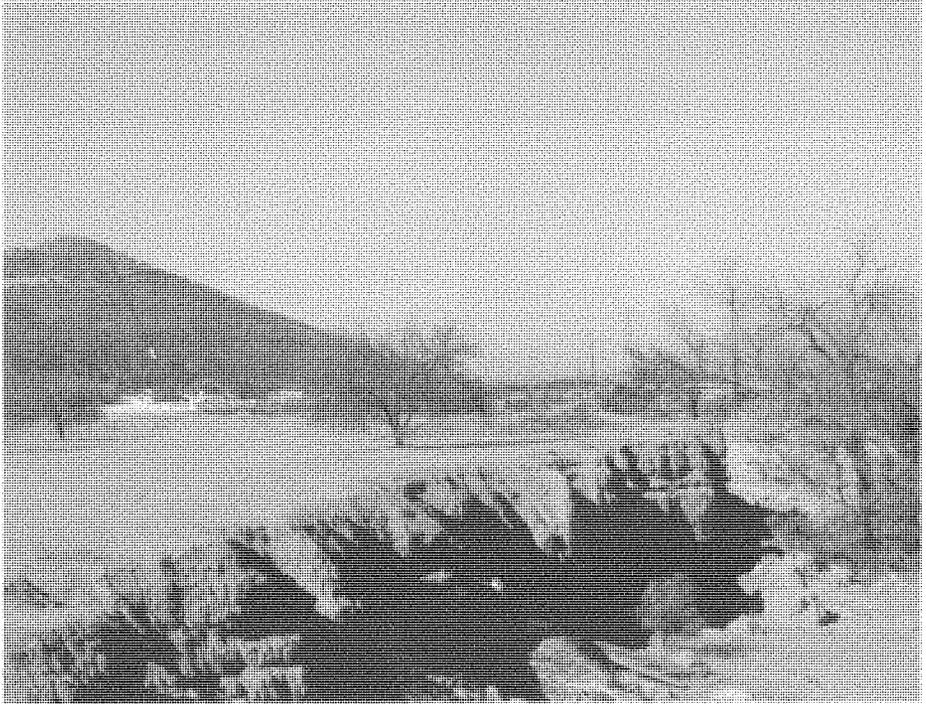
Figure 4.5 View Toward North, Showing West Bank of Santa Cruz River, Sentinel Peak in Left Background. Note Condition of Overbank Vegetation, Cut Bank, And Debris.

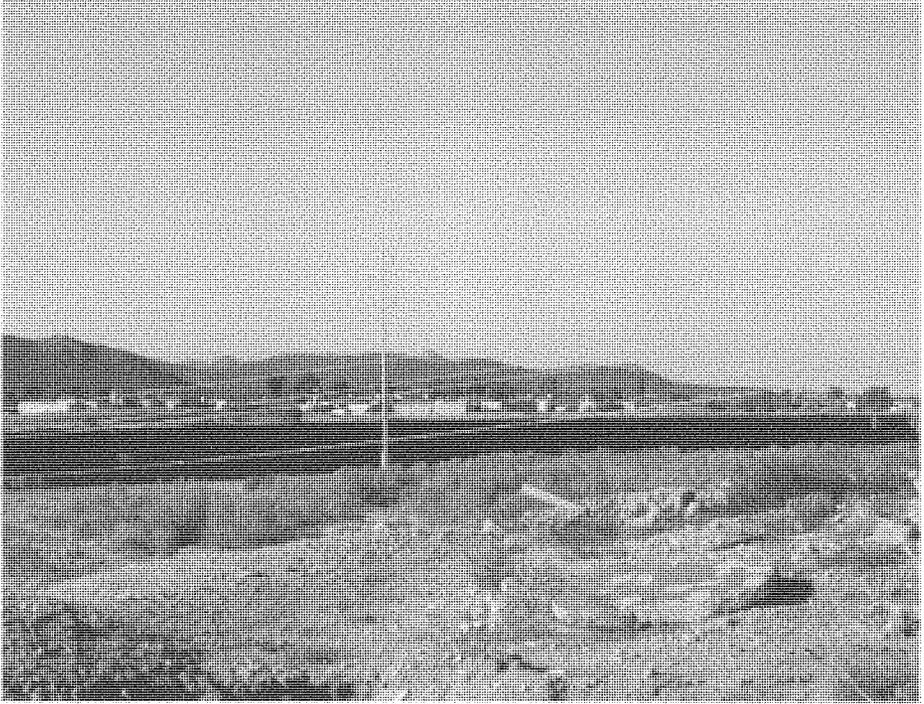
Figure 4.6 View From East Bank, Looking West.

Outside the developed river park, the overbank area consists primarily of abandoned agricultural land or the remains of houses carried away by floods or intentionally demolished. (Figures 4.4, 4.5, and 4.6). Banks are steep and eroding. Numerous dirt roads are present. Piles of refuse dumped illegally are scattered throughout the vacant lots and dumped into the riverbed. Through the entire Study Area, all-terrain vehicle enthusiasts and equestrians frequently use the Main Branch channel (Figure 4.7). Under many of the large Athol tamarisk trees are small homeless camps. Many camps continue to be actively used and the accumulated debris of such camps punctuates the otherwise

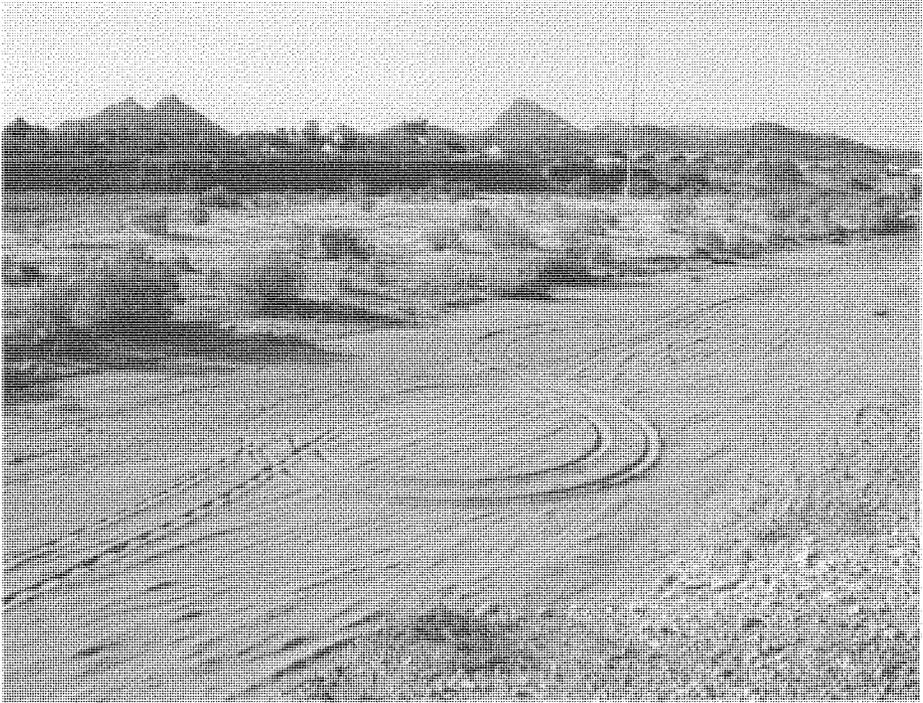
Figure 4.7 View From East Bank, Looking West. Note Vehicle Tracks and Eroding Banks.

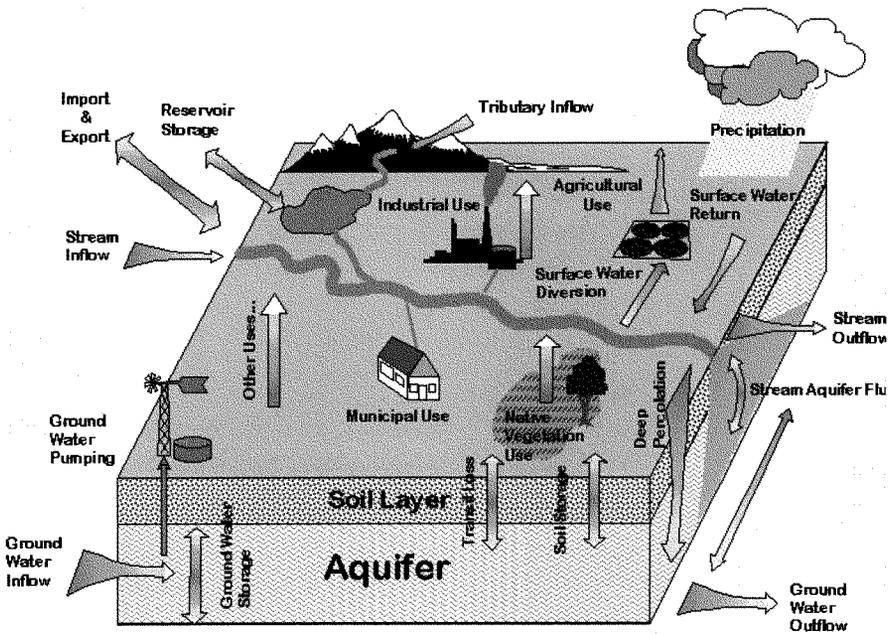
Groundwater and Water Budget Analysis (Future With Project Conditions)

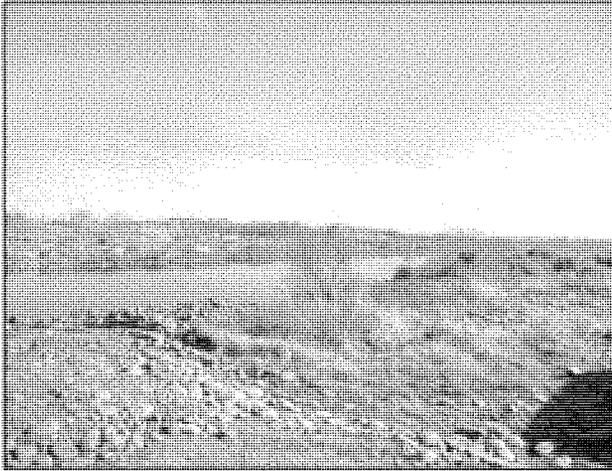
Scrub-shrub lands are dominated by saltbush and often cobble and sand substrate.

The existing scrub/shrub community occupies more acreage (256 ac.) than any other cover type within the study area. The majority of that acreage is on the low terraces elevated only slightly above the dry low flow channel of the Santa Cruz River. Compared to the reference sites and the model biodiversity for shrub-scrub, this cover type is severely lacking in diversity in the study area. Many of these areas have been highly disturbed in the past from the construction of bank protection, off road vehicle traffic, illegal dumping, and gravel mining activities.

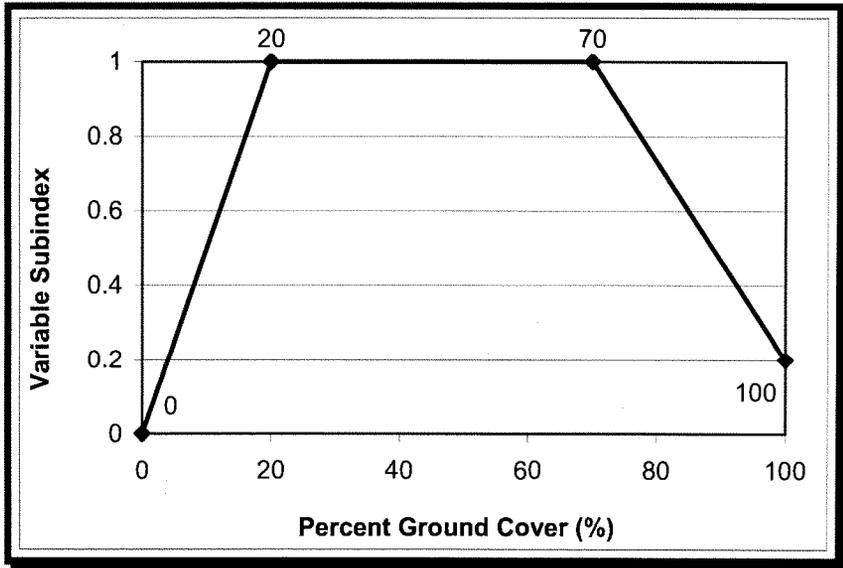
Figure 3: Example Variable Subindex (VSI) curve

Once the baseline inventory was conducted, and both the variable means/modes and the cover type acreages were determined, the baseline conditions in terms of Functional Capacity Units (FCUs) were generated. Strictly speaking, the means/mode values for each variable were applied to the Variable Subindex graphs as dictated by the model documentation. For example, if the percent of ground cover in the CTWWFOR PWAs at Site X was 50 percent on average, the value "20" was entered into the "X-axis" on the Variable Subindex curve below, and the resultant VSI score (Y-axis) was recorded (VSI = 1.0).

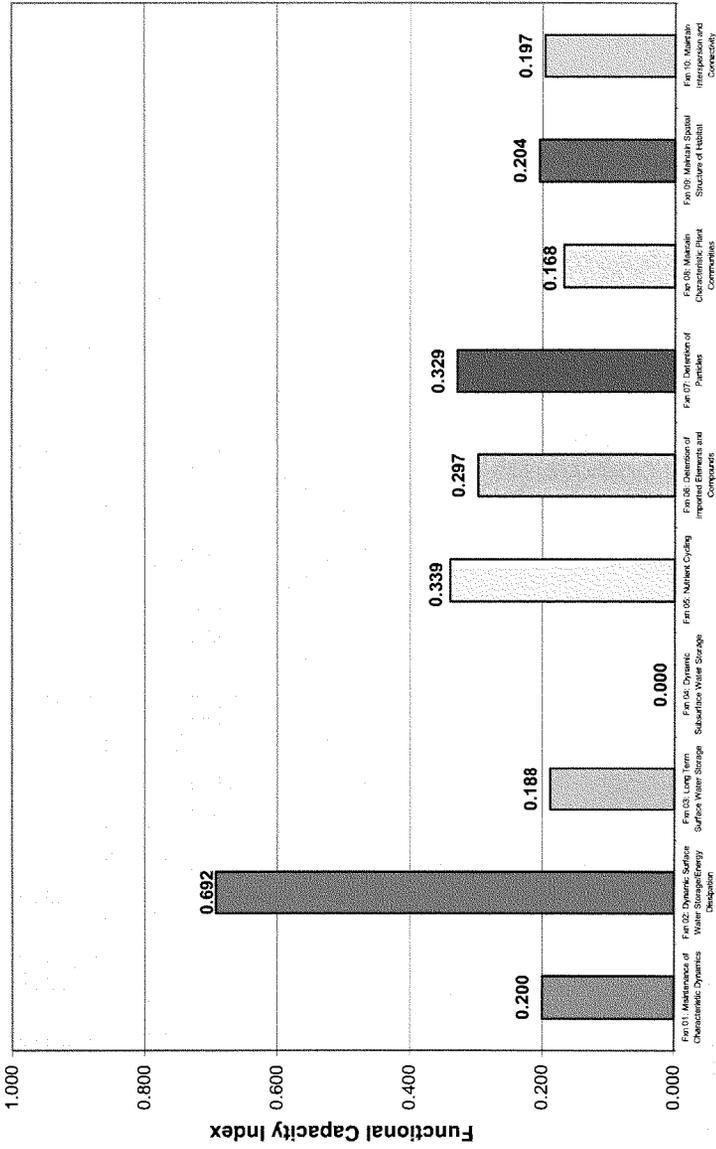
FIGURE 4: Baseline Functional Capacity Index Results
Functional Models

To compare Functional Capacity Units (FCUs) between the reference site(s) and the study area, the FCI for each reference site was multiplied times the same acreage per PWAA that exists in the Paseo de las Iglesias study area. When the Paseo de las Iglesias site is compared to the Arizona reference sites (see Figure 7), the area has a much lower functional capacity index for desirable cover types. This illustrates the inability of the habitat within this reach to sustain itself. The average across the eleven functions for the existing conditions in the study area is 154 AAFCUs, compared to the results for the Salt River Reference Site (the least productive of the five reference sites), which was 333 AAFCUs.

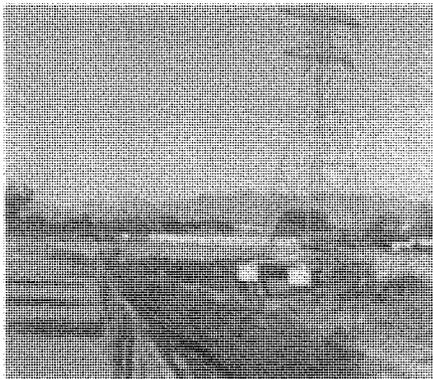
#22: Power pole base in Santa Cruz channel

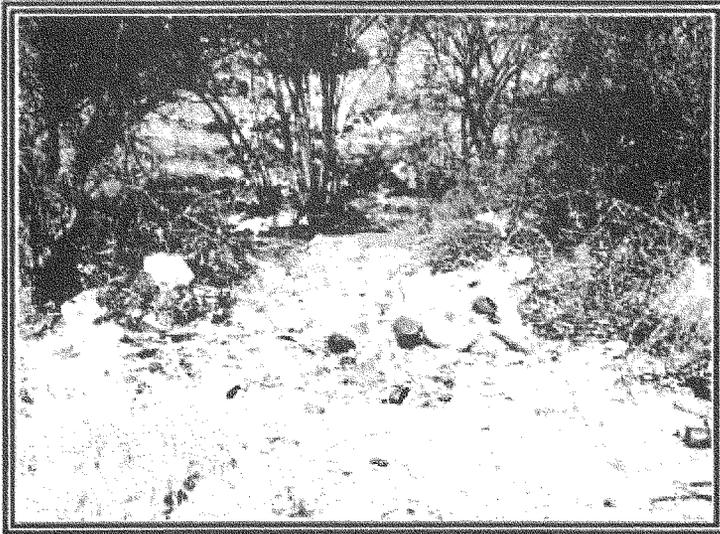
Photograph 2. Wildcat dump on surface of "A" Mountain Landfill at Site 11, view toward the southeast.

Field Description: "A" Mountain Landfill was located at this site and there was a major wildcat dump on the surface. PAG staff observed several wellheads (open and closed) on the site as well as two thin pipes protruding approximately 6 feet from the land surface. The surface material included partially buried rubber tires, old chairs and appliances (mostly on the northern edge of the site), and surface piles of concrete debris, rubber tires, glass, asphalt, plastic, cloth, paper, carpet, rubber, rebar, wood, tin cans, metal screening, cloth, concrete debris, and rubber throughout the site. Photograph #2 shows a 10-foot-by-10-foot area of wildcat dumping, which was representative of the concentration of surface material throughout the site. Access was available from Mission Road and Mission Lane by car; there was also a low post-and-cable fence that was part of the Santa Cruz River Park along the eastern edge of the site. The surrounding land uses included residential areas and the Rio Nuevo South Landfill to the north, "A" Mountain Park to the west, the Santa Cruz River Park to the east and south, and the Mission Landfill to the southwest. The surface was extremely hummocky and, according to a sign, there was an El Paso Gas

line at 39 feet below land surface. It was difficult to discern the amount of exposed buried material because there was so much surface material on the site.

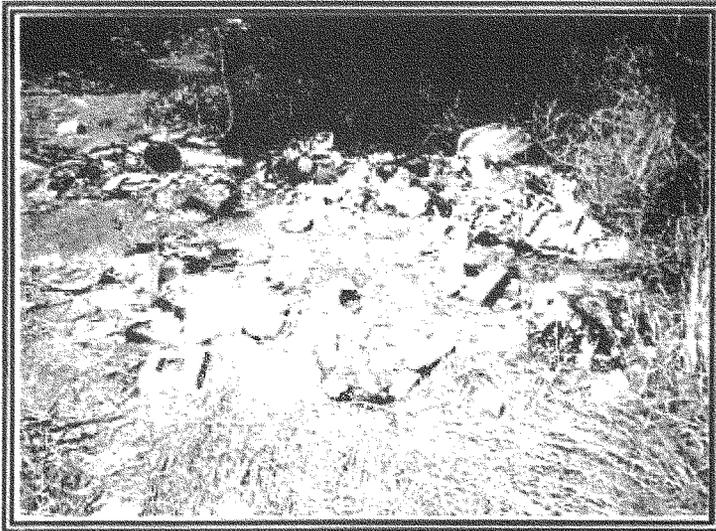
Photograph 3. Wildcat dump in center of vacant lot at Site 13, view toward the northeast.

Field Description: This site consisted of a minor wildcat dump on a vacant lot with shallow drainages running approximately southeast-northwest and desert broom along with other vegetation. Waste seen on the surface included dirt piles, asphalt, rubber tires, office dividers, a few empty 55-gallon drums, one-gallon cans, carpet, concrete debris, paper, metal screening, aluminum foil, a plastic oil bottle, rusted cans, glass, plastic, cloth, brick, mattress springs, and a refrigerator. Photograph #3 shows an area of concentrated dumping in the center of the site. The waste on the rest of the site was more scattered. Access was available from Kroeger Lane. The surrounding land uses included vacant land to the west (Site 12), and residential areas to the east, south, and north.

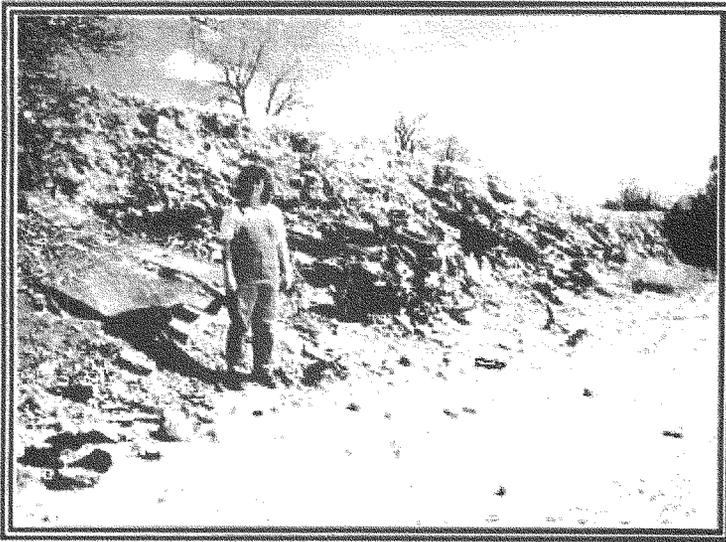
Photograph 5. Bank edge of Ryland Landfill at Site 22, view toward the southeast.

Field Description: Ryland Landfill was located at this site. The landfill material exposed along the river bank included glass, cans, paper, wood, plastic, concrete and asphalt debris, bricks, rubber tires, newspaper, and household waste. Photograph #5 shows most of the bank edge of the landfill. Rubber tires were also seen on the surface of the landfill. Access was available from Ajo Way along a dirt road. The surrounding land uses included the river with no bank protection to the west, I-19 to the east, and vacant lots to the north and south. The surface of the landfill was extremely hummocky, which was probably due to differential settling. PAG staff did not see any change in the appearance of the site since the area had been visited in the Spring of 1993.

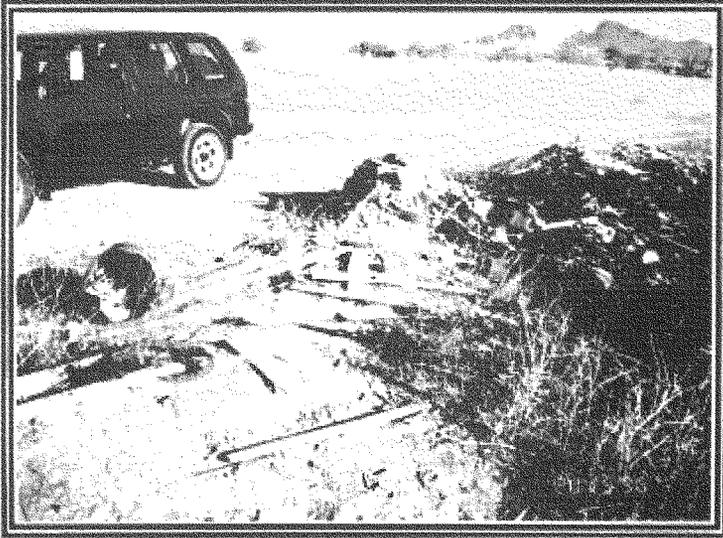
Photograph 11. Wildcat dump at Site 48, view toward the southwest.

Field Description: This site contained a major wildcat dump within a drainage and a 300-foot section (approximate) of the river bank. Most of the drainage was essentially clean. The site was located directly west of the Santa Cruz River approximately one mile north of

San Xavier Loop Road, and had mesquite and palo verde trees and grasses. The material seen on the site included piles of asphalt, bricks, scrap metal strips, roofing materials, a paint can, rubber tires, an old car, old corrugated pipes, glass, an old water heater, old stoves, carpet, concrete debris, metal cans, wire, a 5-gallon can of roof cement, an empty 55-gallon metal drum, and wood. Photograph #11 shows an area on the eastern edge of the site containing more concentrated waste than the rest of the wildcat dump. Access was available from Oidak Wo:g. The surrounding land uses included abandoned farmland to the north, west, and south, and the Santa Cruz River with minor bank protection to the east.

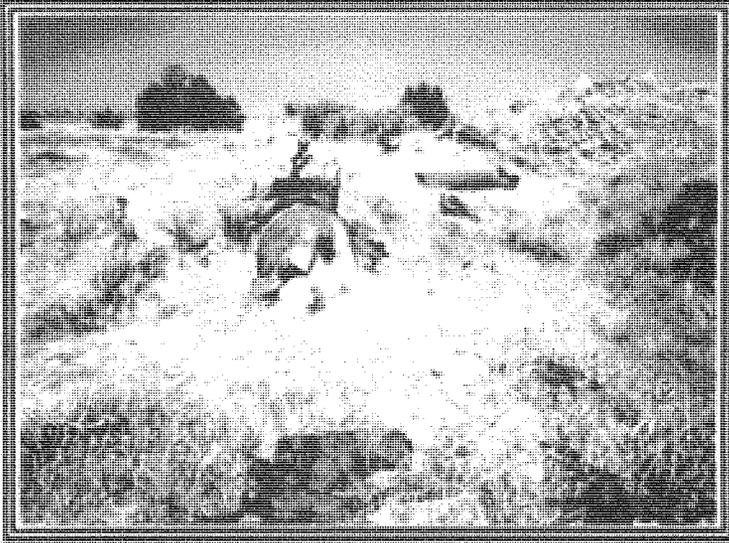
Photograph 13. Piles of concrete debris, dirt, and metal at Site 56, view toward the northwest.

Field Description: The site consisted of a major wildcat dump with excavated pits and piles of dirt in the floodway of the Santa Cruz River northwest of Martinez Hill. The waste seen on the site included concrete debris and metal pylons, and piles of dirt with old rubber car tires, steering wheels, and bumpers that appeared to have been dated from the 1940's. Photograph #13 shows piles of concrete debris, metal, and dirt that were representative of the rest of the site. Some of the waste had been buried, probably by natural deposition within the river channel. Access was available from two dirt roads directly west of I-19 and directly north of San Xavier Loop Road. The surrounding land uses included the Santa Cruz River to the west, north and south with riprap bank protection, and I-19 and vacant land to the east.

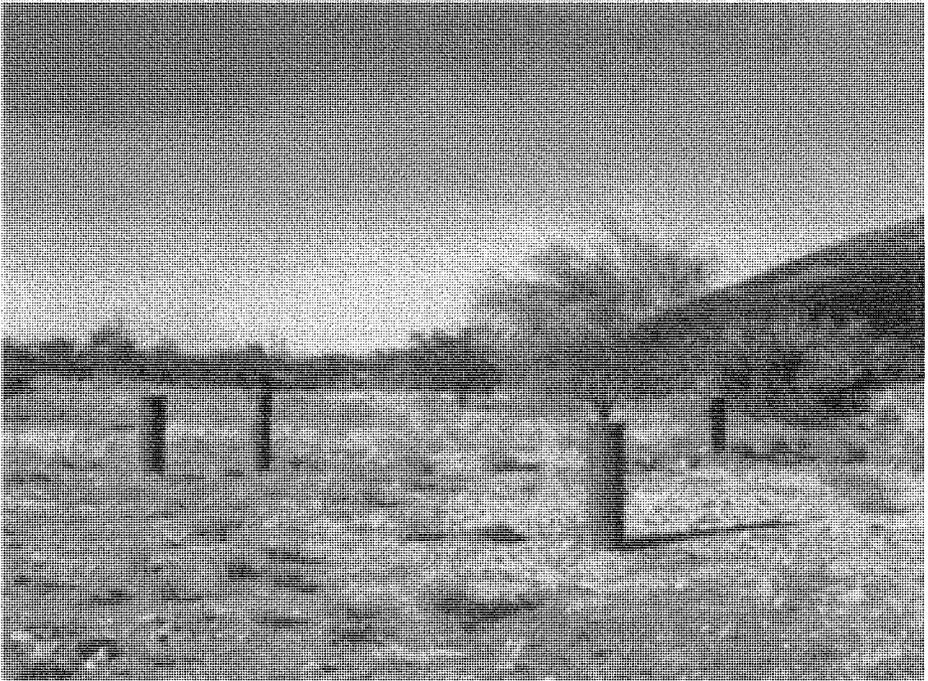
Photo 7: Water Monitoring wells near the Nearmont Landfill, south of Congress St., west of the Santa Cruz River

A concrete irrigation ditch is located along the top of the west bank of the Santa Cruz in this reach. There are signs along this ditch warning of the non-potable nature of the water. The water that normally flows through that ditch is effluent used for landscaping and golf course irrigation (Appendix D, Photo # 9). There are at least four groundwater monitor wells located at the north end of the Nearmont landfill in this reach (Appendix D, Photo #7).

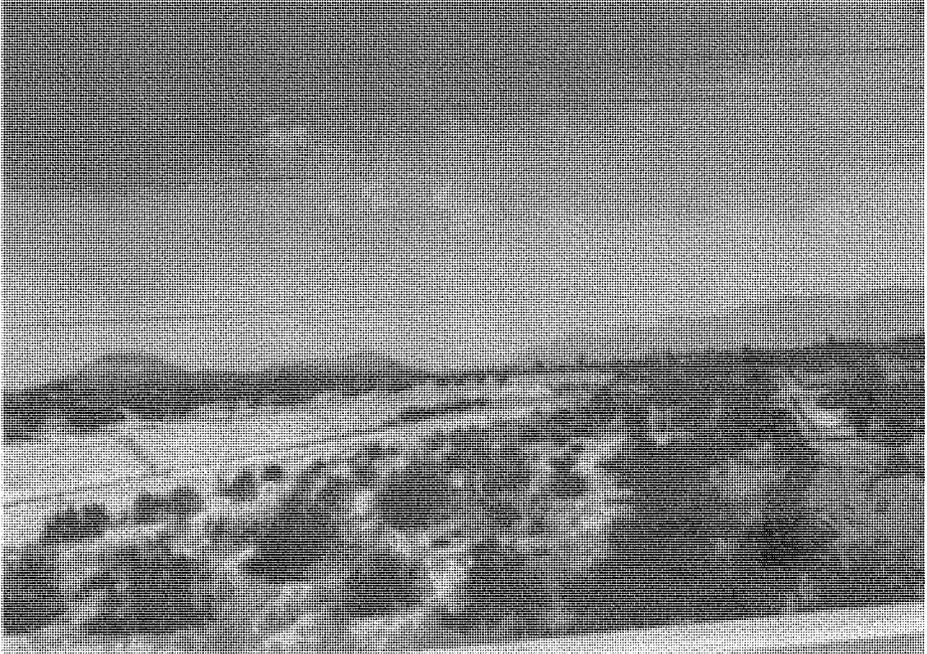
Photo 4: Santa Cruz River bottom looking north in project area from the Valencia Road Bridge

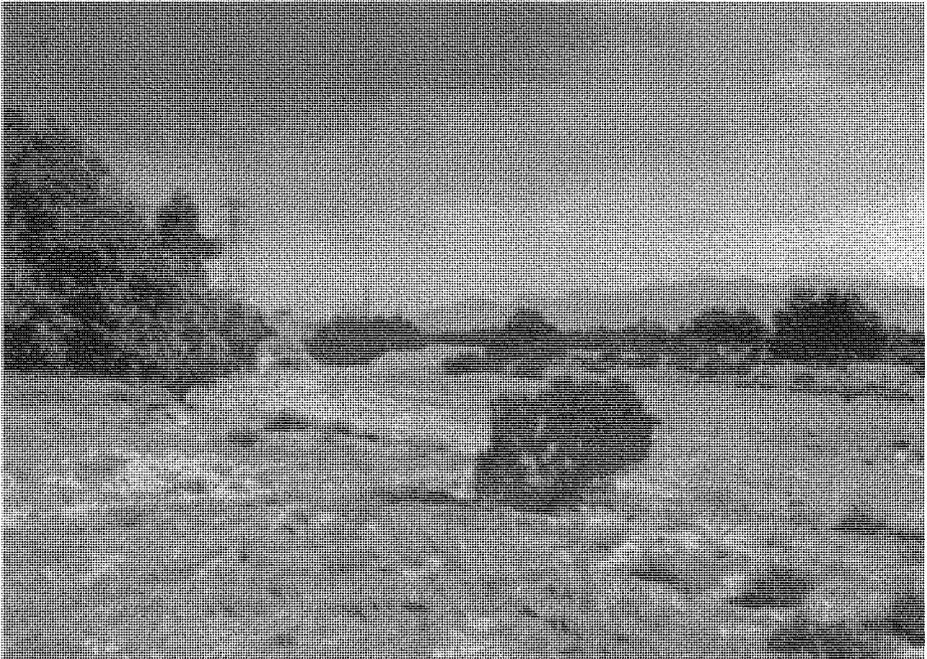
Photo 5: River bottom looking north, north of Ajo Way Bridge
