SANTA CRUZ RIVER, PASEO DE LAS IGLESIAS, PIMA
COUNTY, ARIZONA FINAL FEASIBILITY STUDY

A STUDY ON THE SANTA CRUZ RIVER, PASEO DE LAS IGLESIAS,
PIMA COUNTY, ARIZONA, PURSUANT TO PUB. L. 75-761

The Final Feasibility Report and Environmental Impact Statement (FR/FEIS) for the Santa Cruz River (Paseo de las Iglesias) Ecosystem Restoration project, Arizona, dated July 2005, addresses ecosystem restoration and flood damage reduction opportunities along the Paseo de las Iglesias reach of the Santa Cruz River in Pima County, Arizona. Based on my review and the views of interested agencies and the concerned public, I find the project authorized by Congress in Section 1001(3) of the Water Resources Development Act of 2007 (Public Law 110-114) to be technically feasible, economically justified, environmentally acceptable, and in the public interest.

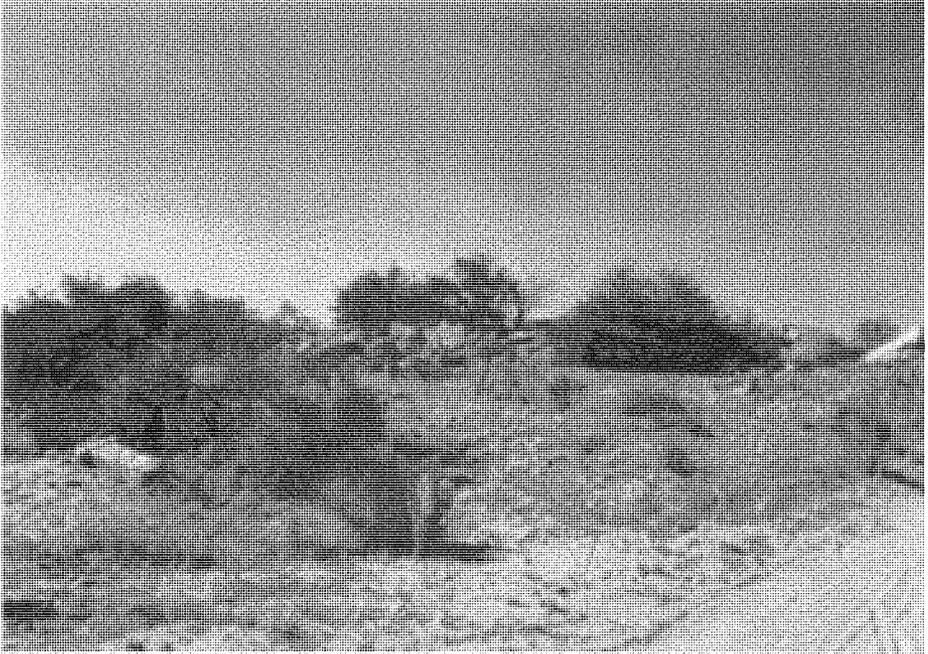
Photo 2: Rubble on west bank of Santa Cruz, looking southwest, north of Ajo Way Bridge

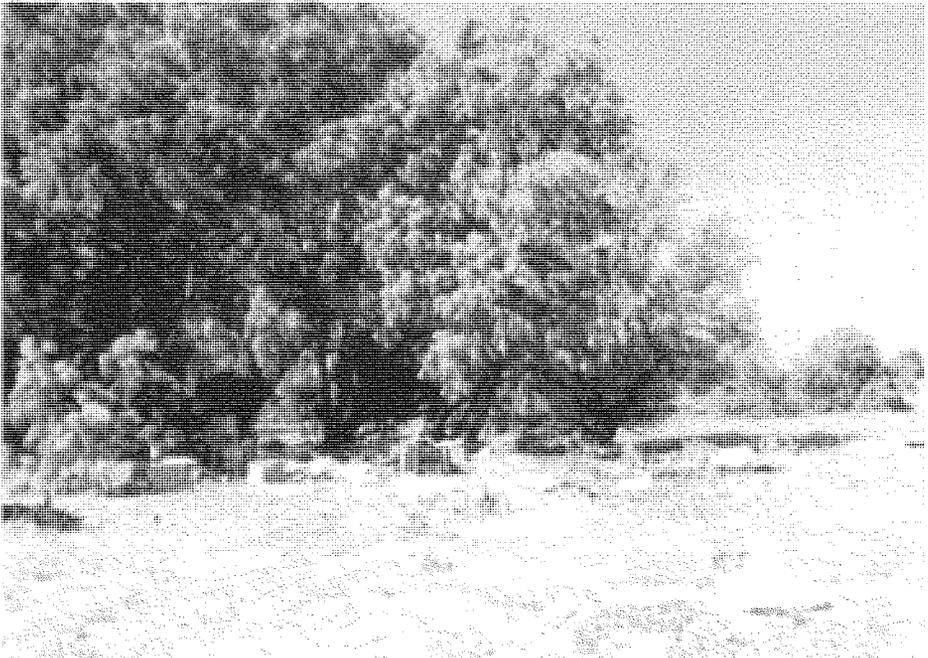
Photo 3: Debris in riverbottom, north of Ajo Way Bridge

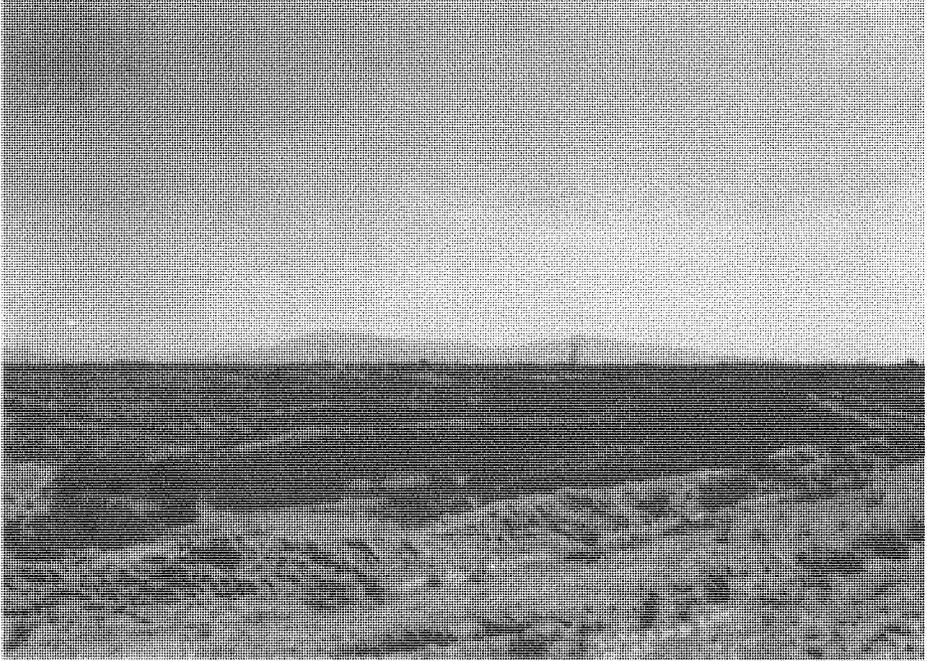
Photo 1: Gravel pit operation, north of Los Reales
