DRAFT  
ROCKAWAY/NEDONNA BEACH  
FOREDUNE MANAGEMENT STUDY

FEBRUARY 1986

A Revised Technical Report -- The Technical Report has been vastly reorganized and expanded from the original drafts you reviewed last year. Information is now divided on an area by area basis.

The Nedonna Beach Grading Plan -- Wilbur Ternyik and FGA have drawn up a detailed site specific grading plan for the Nedonna Beach area (from Manhattan Beach Wayside to the South Jetty). The plan identifies where grading can occur and where graded material may be placed. The plan also recommends standards for placement of sand fencing, fertilization and planting of beachgrass. The plan is intended to be used to obtain County and state approvals for grading of the foredune and implementation of other actions necessary to strengthen the foredune. A rough drawing of the proposed grading plan map is also enclosed. An existing conditions map will be provided with the final document, but it is not ready at this time.

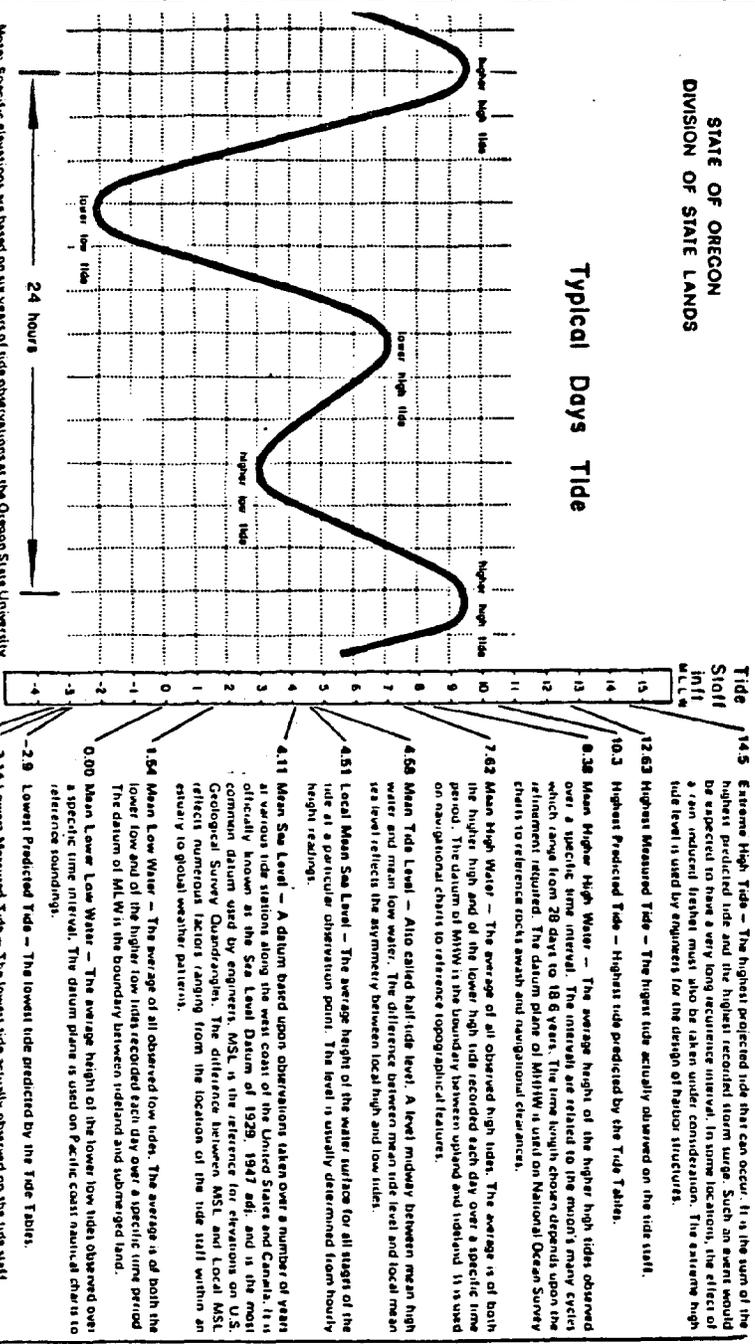
Figure 2. Tidal elevations as measured in Yaquina Bay (from Hamilton, 1973).

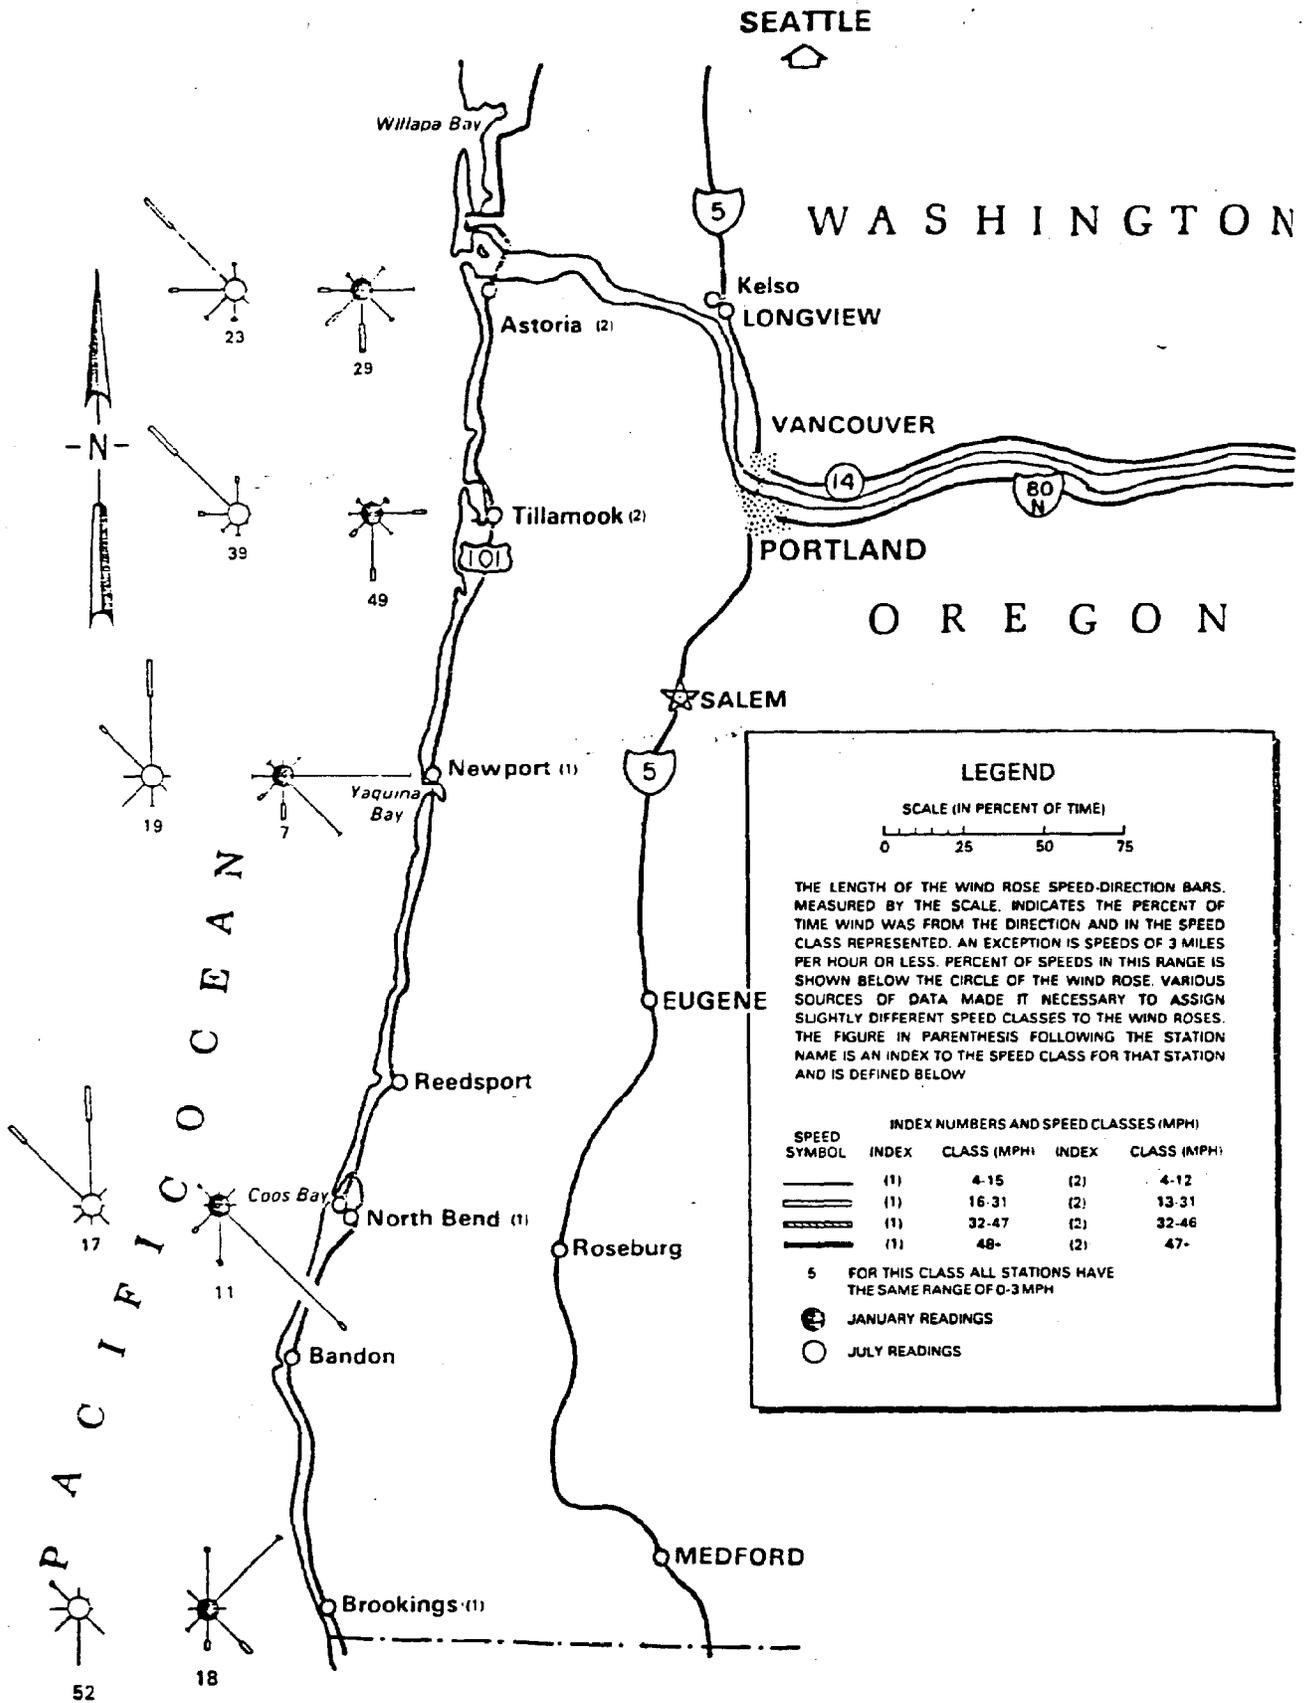
Figure 8. <sup>3</sup> January and July wind roses for selected sites. This plate was provided by the Portland District, U.S. Army Corps of engineers.

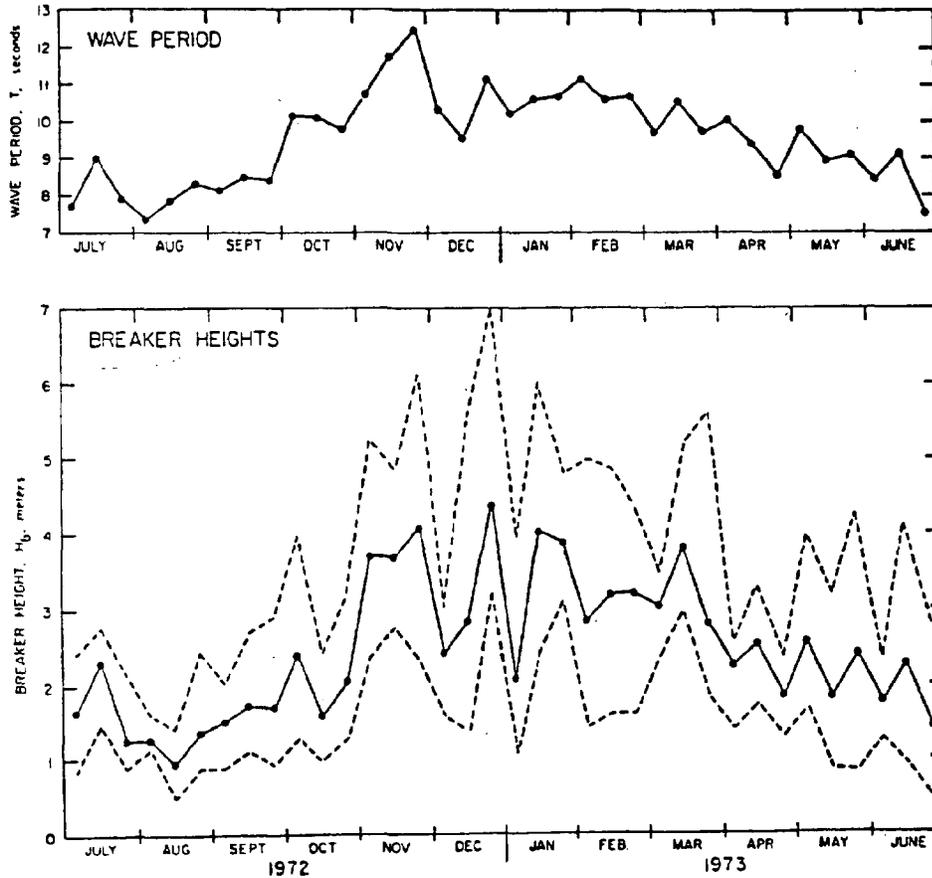
4  
 Figure 10. Significant wave breaker heights and periods measured at Newport during July 1972 through June 1973. Each datum point gives the average for one-third month. The dashed lines give the maximum and minimum breaker heights during those one-third month intervals. Note the arrival of large storm waves during the last part of December 1972. (From Komar, 1979).

limitations and provide an analysis of recorded measurements from November 1971 through June 1975. Figure 4 illustrates significant wave breaker heights from July 1972 through June 1973. This figure includes large storm waves produced in December 1972 that resulted in significant erosion on the shoreline. The maximum wave breaker height measured was 7

meters (23 feet). Average height of the larger breaking waves was estimated by Komar (1979) as about 15 feet. He also noted that heights of 23 feet are truly exceptional and that similarly high breakers were recorded in December 1972, October 1977 and February 1978 which were periods of severe shoreline erosion. Similar extreme wave heights were recorded more frequently for storms during the 1981 to 1984 El Nino episode. The evidence gives support to the somewhat obvious observation that large waves, especially on high tides, are largely responsible for shoreline erosion. Another reasonable conclusion is that moderate-sized breakers, days or weeks before a series of large breakers, can set up conditions for severe erosion. (Note the November breaker heights on Figure 4.) The first storm removes sand from the beach and enlarges rip-current embayments, allowing subsequent high tides and large breakers to come closer to the backshore and foredune before breaking and losing energy.

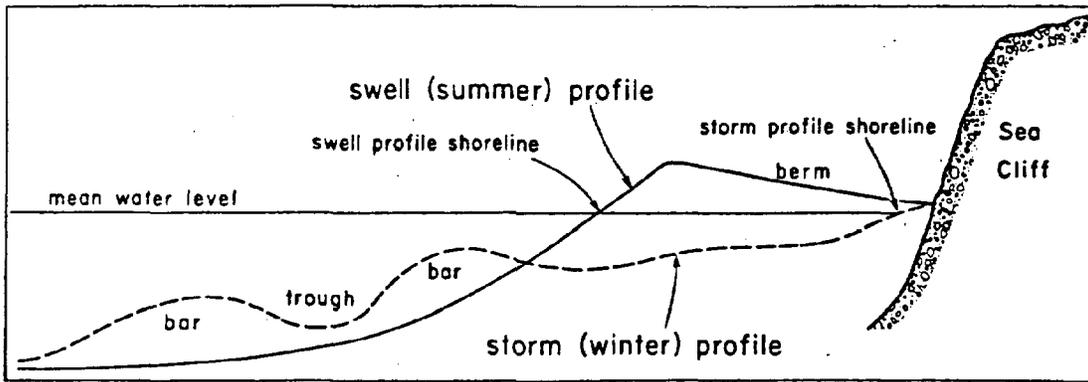
5  
 Figure 7. Schematic illustration of the beach profiles produced by storms versus gentle swell waves. On the Oregon coast these profile changes are approximately seasonal due to our storms occurring principally during the winter months. (From Komar, 1979).

The seasonal variation in wave conditions produces changes in the nearshore zone and beach (Figure 5). High and frequent waves in winter months erode sand from the beach and deposit the sand in offshore bars. In the summer months, the sand in the offshore bars is moved back on to the beach. Because this sand movement is controlled by wave conditions, this cycle is not strictly seasonal. Low waves during the winter will move sand onshore.

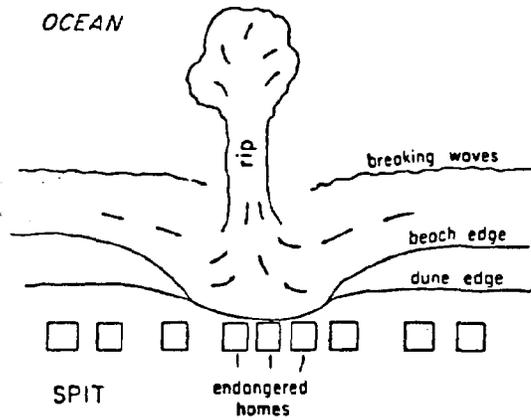
6  
Figure A. A rip current flowing outward across the beach hollowing out an embayment into the beach and eventually into the foredunes causing property losses. (From Komar, 1979).

Rip currents do develop along the shoreline of the study area and the embayments (cusps) that form are often related to local shoreline erosion (Figure 6). Rip current channels and embayments were observed on aerial photos and in field investigations. The locations were transferred to the

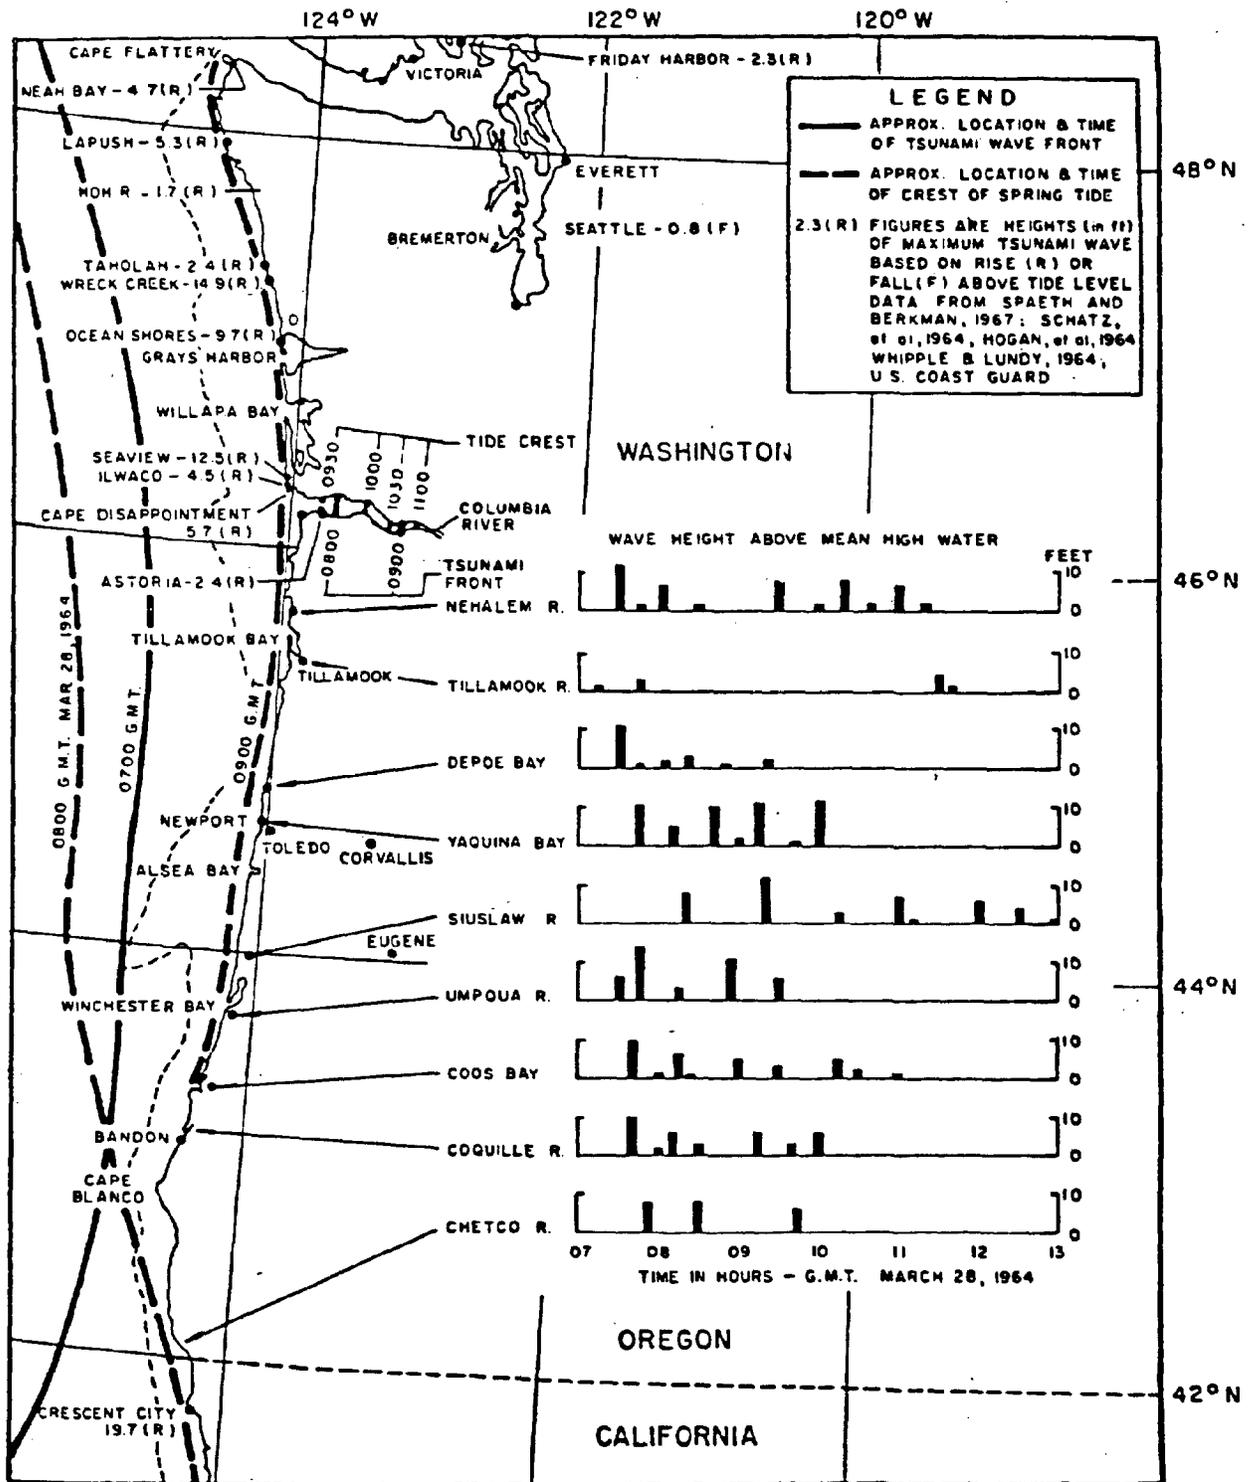
Figure 3. Maximum heights of tsunami waves recorded at tide stations or by observations along the Washington-Oregon coast (from Wilson and Torum, 1968).

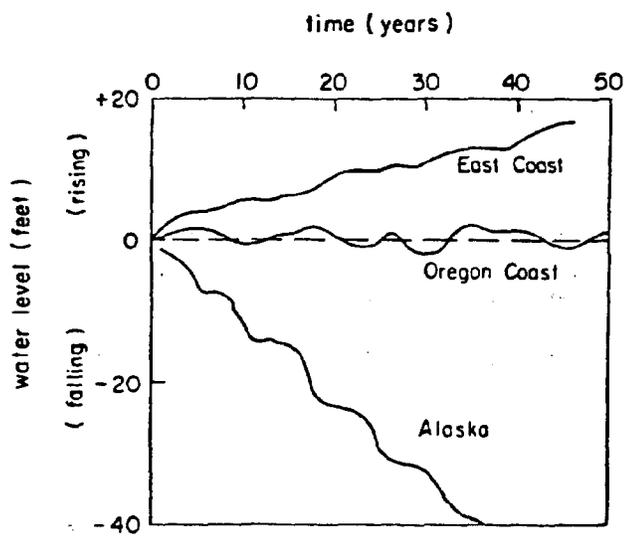
8  
 Figure 8. Schematic of water level changes on the Oregon coast as compared to the East coast and the coast of Alaska, based on the data of Hicks (1972). (From Komar, 1977).

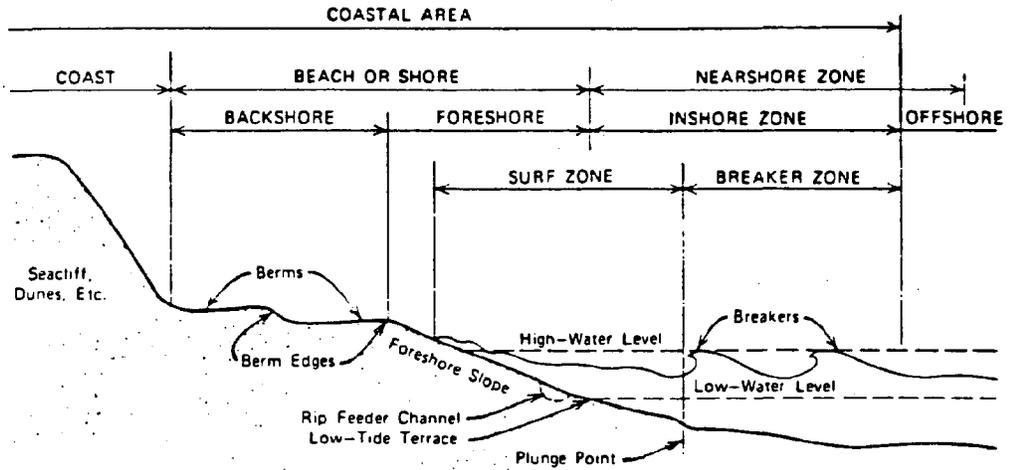
Figure 7. Features of a typical sand beach. (From U. S. Army Corps of Engineers, 1971).

Figure 10 illustrates the typical features of a sand beach and the names of the features. The offshore bar is not illustrated.

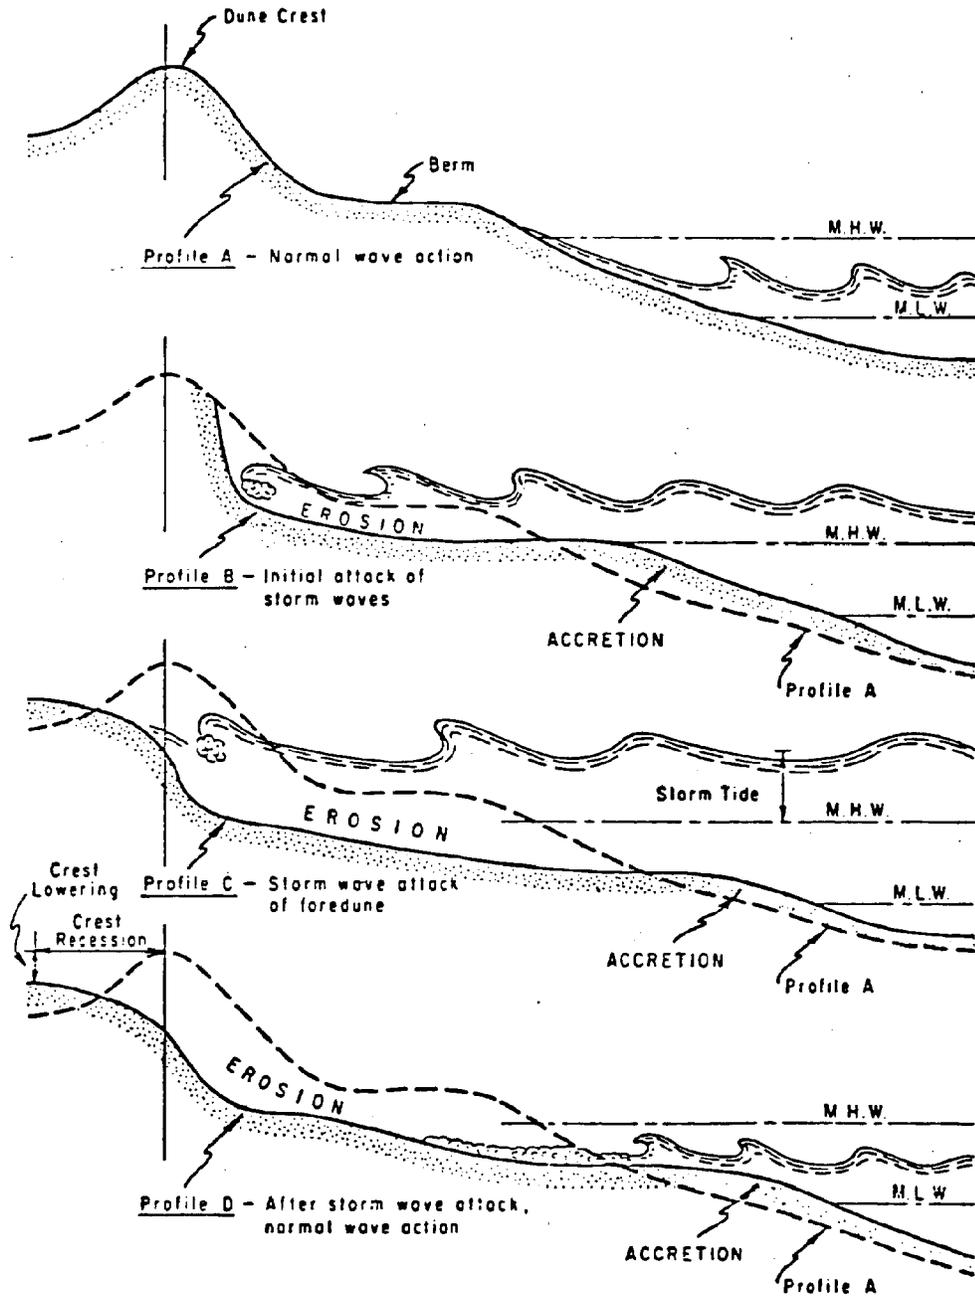
//  
 Figure 8. Schematic diagram showing shoreline changes and sand movement under storm wave attack. (From U.S. Army Corps of Engineers, 1973).

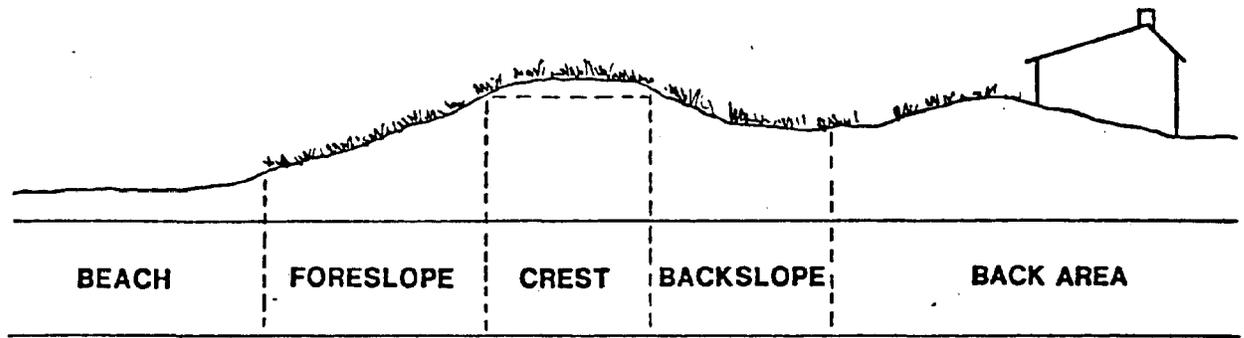
Figure 12. Typical foredune cross section and classification of features.

Variations in ocean erosion, wind deposition, and grading has resulted in a complex and somewhat irregular active foredune. The foredune is illustrated on the Technical Report Map. Figure 12 is a generalized cross section of a foredune. The unstable creek outlet areas are

The foreslope is the seaward side of the foredune. Most foreslopes in the study area show evidence of past erosion. Erosion in the past one or two years has left a nearly vertical foreslope in some locations. After erosion of the foreslope, wind transported sand, driftwood and European beachgrass combine to repair the damage to the foredune. At first the repaired foreslope has an uneven surface and an uneven distribution of beachgrass. With more sand deposition the foreslope eventually develops a relatively even slope and coverage of beachgrass. Depending on the amount of foreslope erosion, it can take two to over five years for the foreslope repair to occur. Of course, further erosion can take place before repair can be completed.

The foredune crest is the top of the foredune. The shape, width and height of the crest, like the foreslope, is dependent mostly on the past erosion history or the amount of grading. Wave erosion can extend in to the crest or, in extreme cases, all the way through the crest. Wind transported sand and European beachgrass repair the erosion damage over several years, similar to the natural repair of foreslope damage. As a result, the crest varies in the study area from very thin, low and irregular to broad, high and relatively smooth.

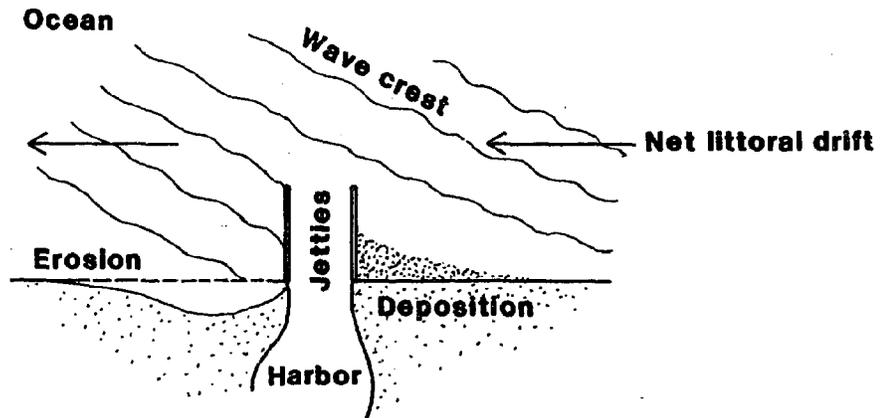
## NET LITTORAL TRANSPORT

# NET VERSUS ZERO LITTORAL TRANSPORT NEAR JETTIES

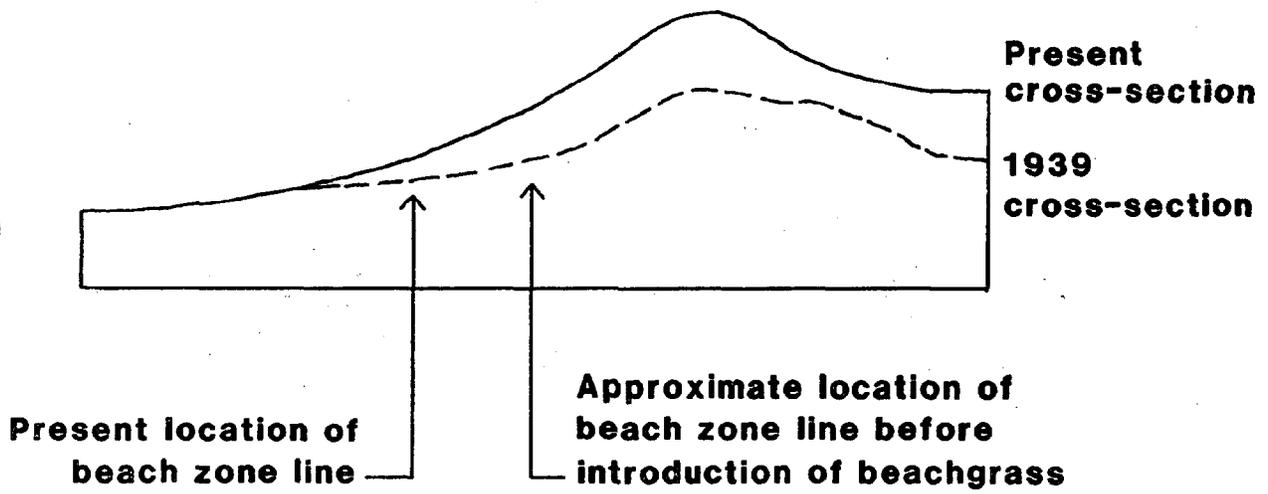
**FOREDUNE CROSS-SECTION:  
BEFORE & AFTER EUROPEAN BEACHGRASS**

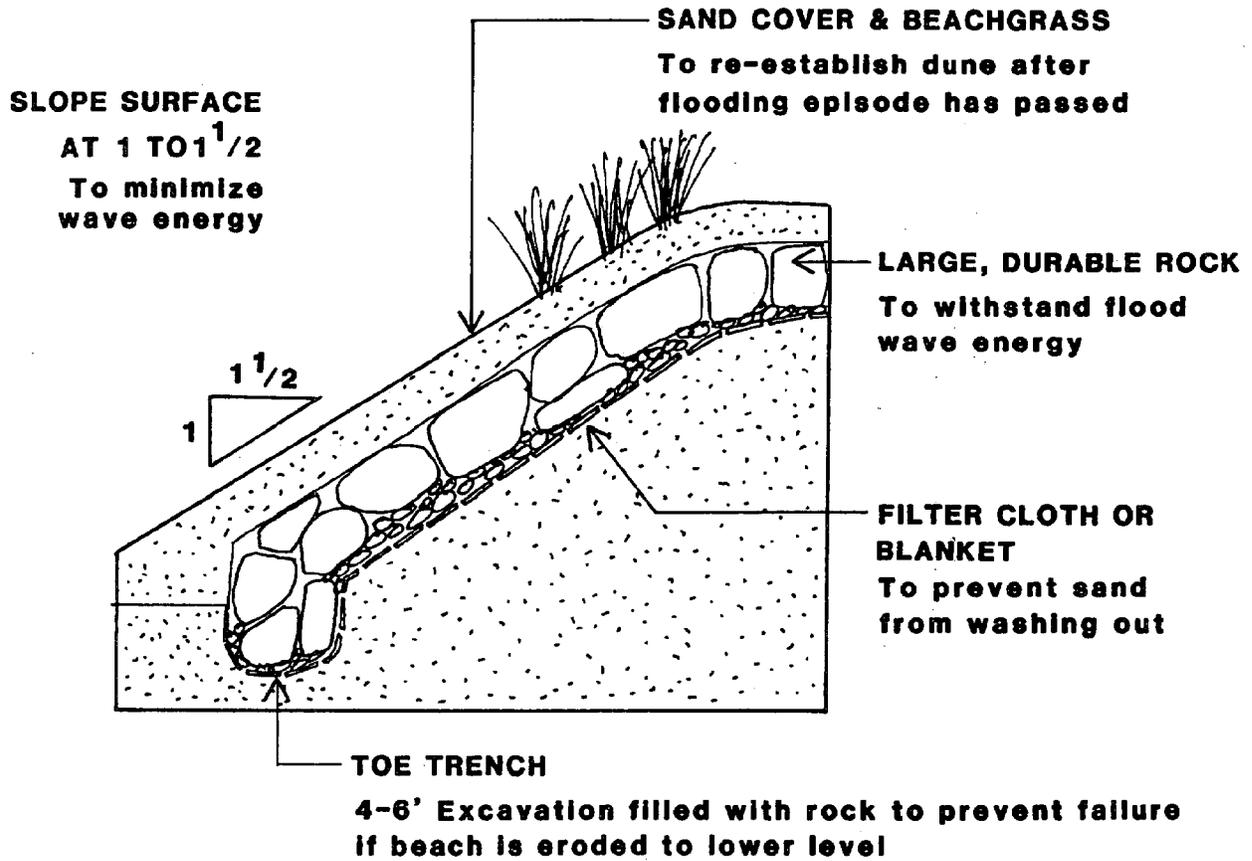
## RIP-RAP DESIGN & PLACEMENT

**CROSS-SECTION VIEW**

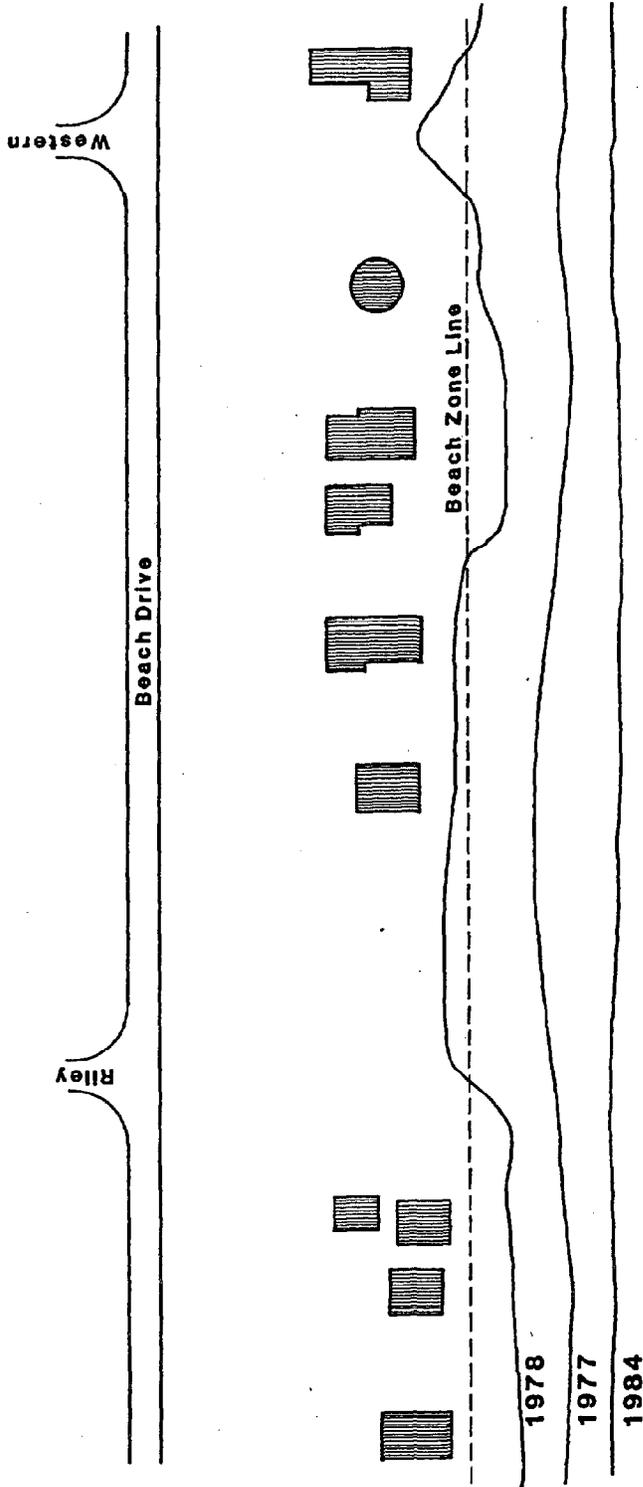
### SHORELINE CHANGE AT NEDONNA BEACH

The 1978 line shows approximate upper extent of rip-rap placed in 1978.

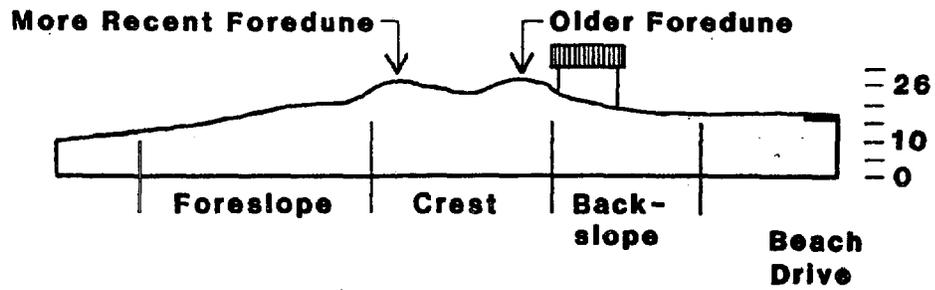
### CROSS-SECTION OF DUAL FOREDUNE

From cross-section #23

**Note that older foredune is approximately the same height as 'newer' foredune.**

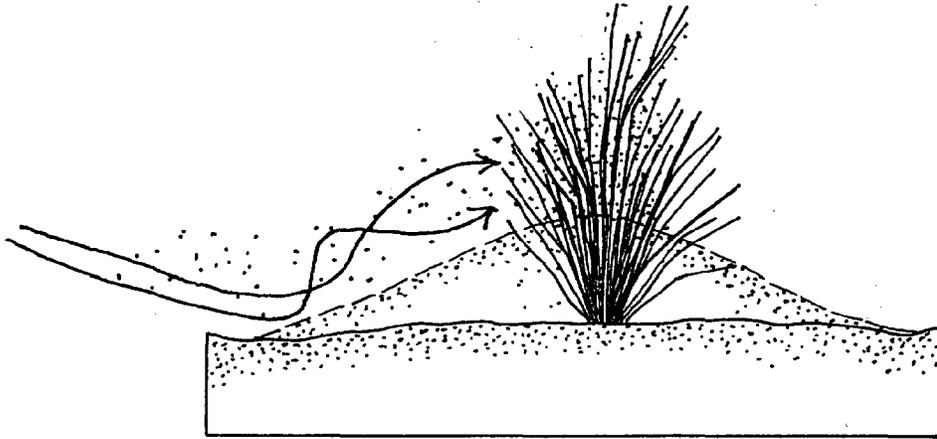
## HOW BEACHGRASS COLLECTS SAND

**Sand deposition around a beachgrass windbreak.**

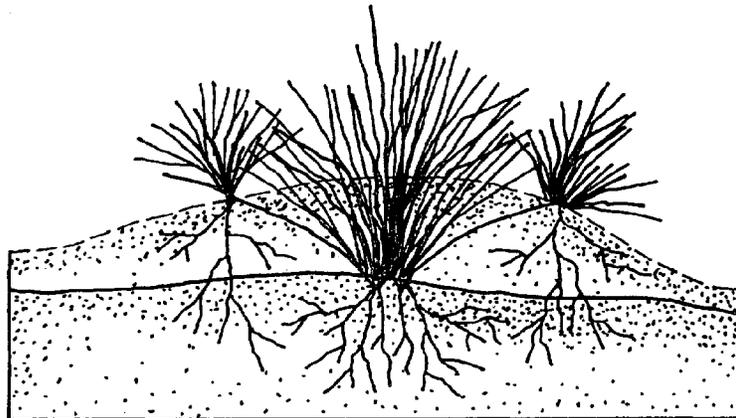
**As beachgrass is buried, new shoots and roots develop at the dune surface.**

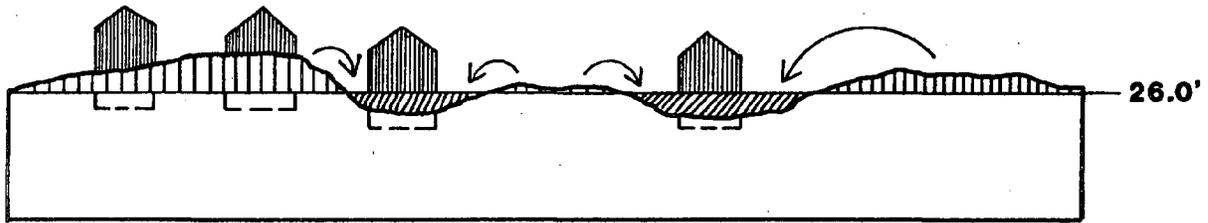
## PLACEMENT OF GRADED SAND

**PRIORITY ONE: Fill in low spots in crest to a minimum elevation of 26.0'**

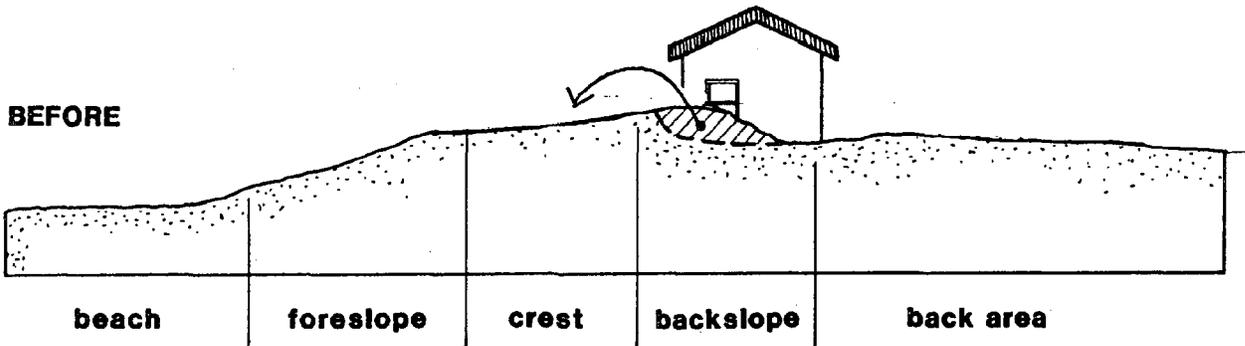
## CLEARING OF SAND ACCUMULATIONS

**NOTE: Only sand which is blocking doors or windows or access may be removed.**

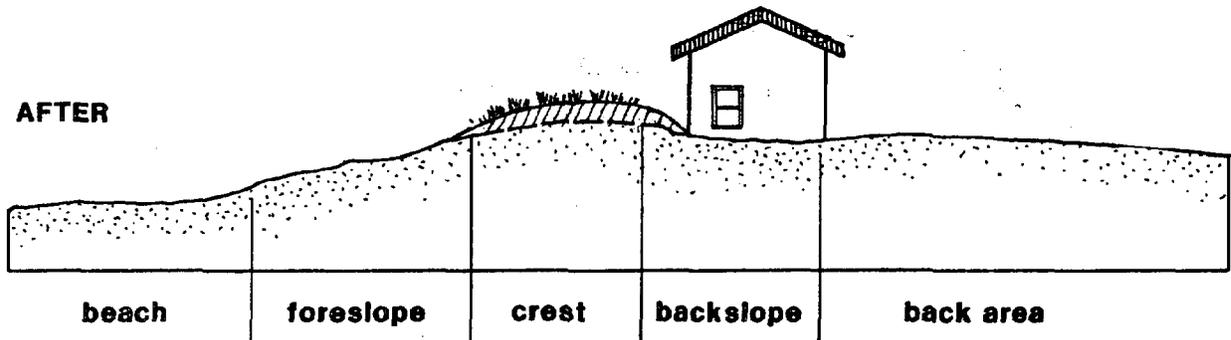
**Graded material should be placed on foredune crest and stabilized.  
Clearing sand from around structures does not include  
crest grading to create ocean views.**

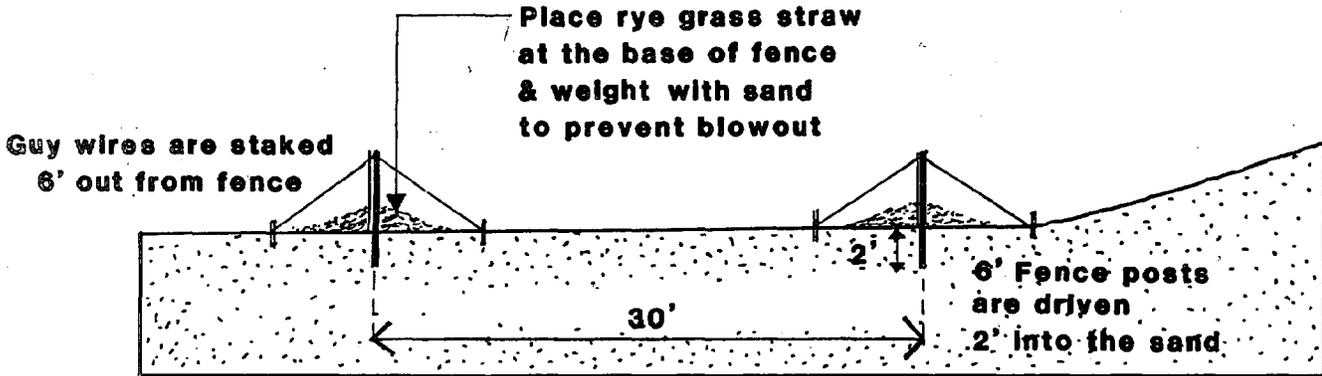
### PLACEMENT & SPACING OF SAND FENCING

Two rows of sand fence are placed 30' apart
