DARIEN (TOWN OF)

COASTAL AREA MANAGEMENT PROGRAM

ADOPTED FEBRUARY 7, 1984

MUNICIPAL COASTAL PROGRAM

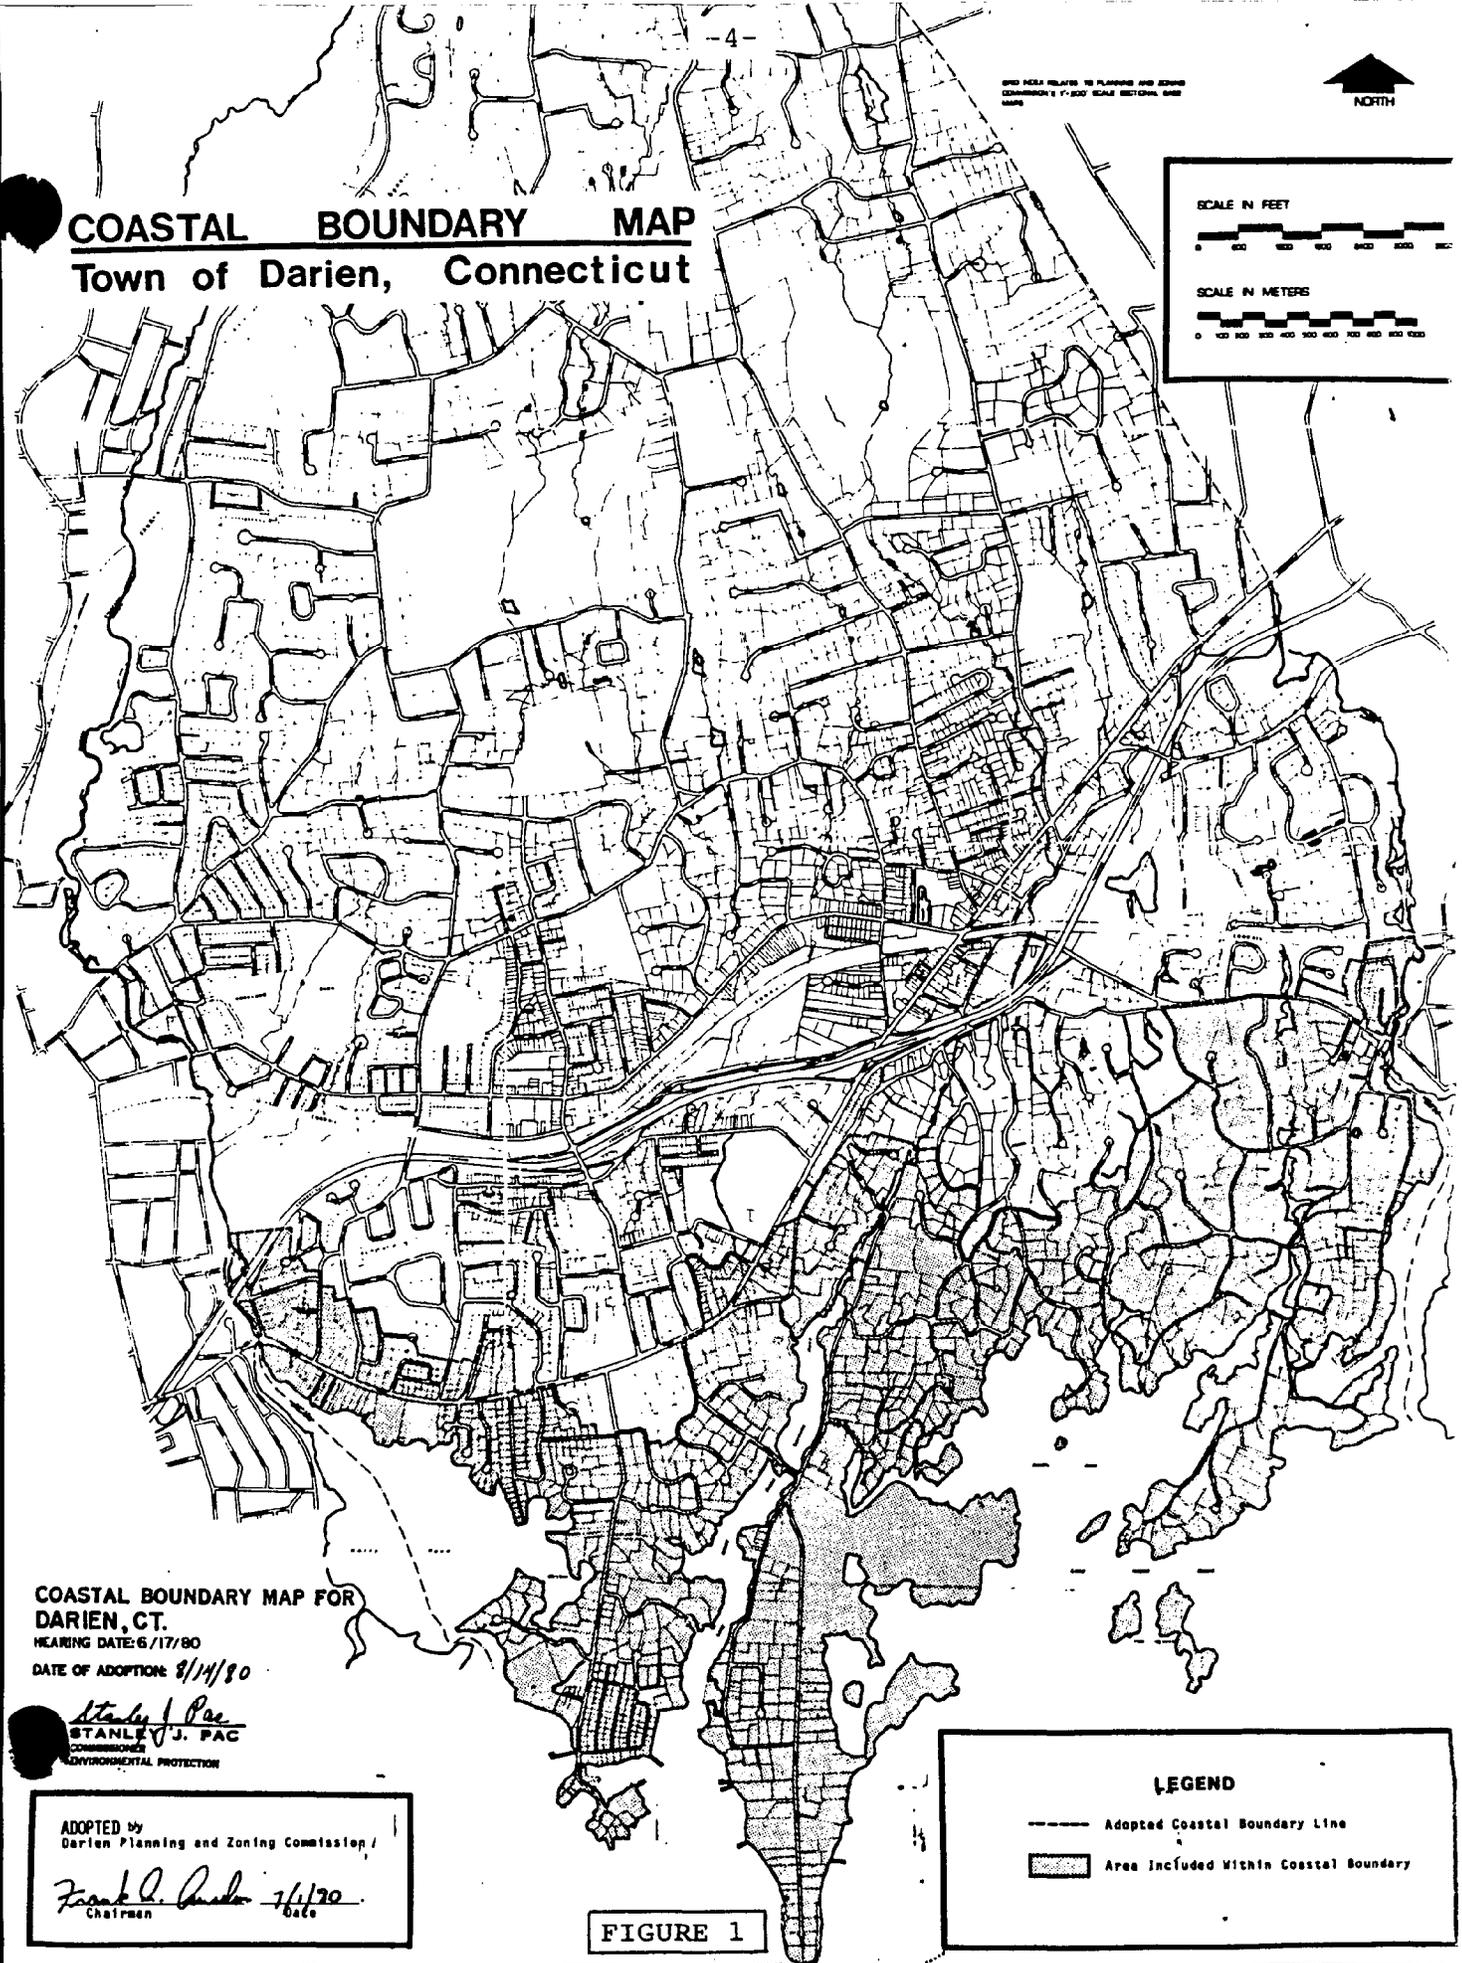
FIGURE 1

COASTAL BOUNDARY MAP FOR
DARIEN, CT.
HEARING DATE: 6/17/80
DATE OF ADOPTION: 8/14/80

was available. The new Boundary was subsequently approved by the Commissioner of the DEP and was put into effect officially on August 14, 1980.

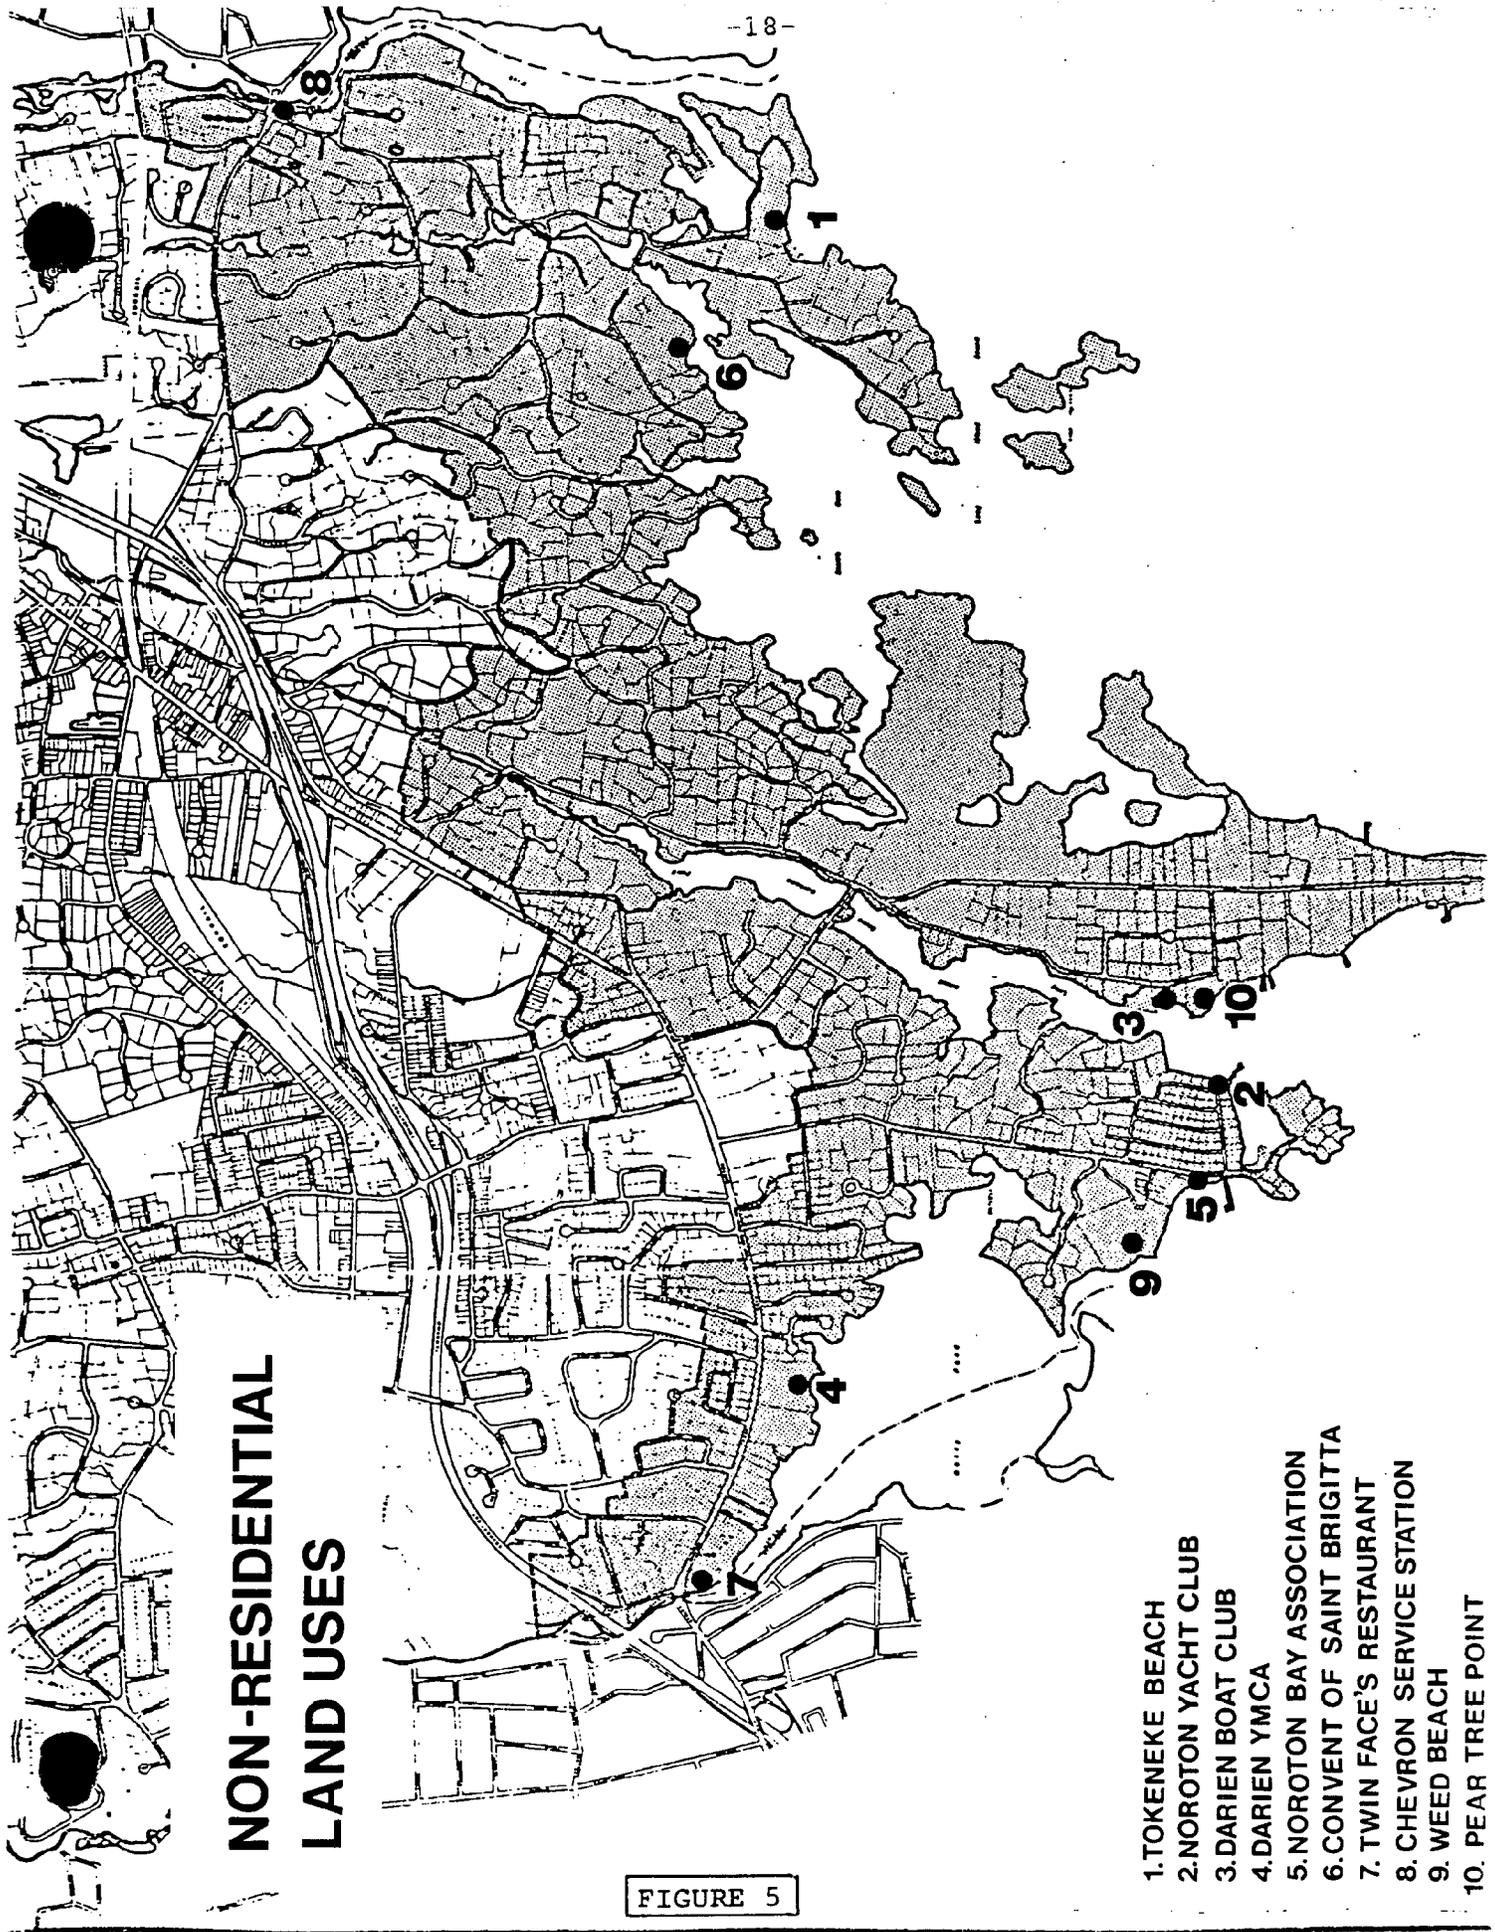
**NON-RESIDENTIAL
LAND USES**

- 1. TOKENEKE BEACH
- 2. NOROTON YACHT CLUB
- 3. DARIEN BOAT CLUB
- 4. DARIEN YMCA
- 5. NOROTON BAY ASSOCIATION
- 6. CONVENT OF SAINT BRIGITTA
- 7. TWIN FACE'S RESTAURANT
- 8. CHEVRON SERVICE STATION
- 9. WEED BEACH
- 10. PEAR TREE POINT

As noted in Section 2.2, only eight privately held and two public non-residential uses are currently located directly on the shoreline. Of these, five private and two public provide access to Long Island Sound for recreational purposes. These uses are described below and their location is shown on Figure 5:

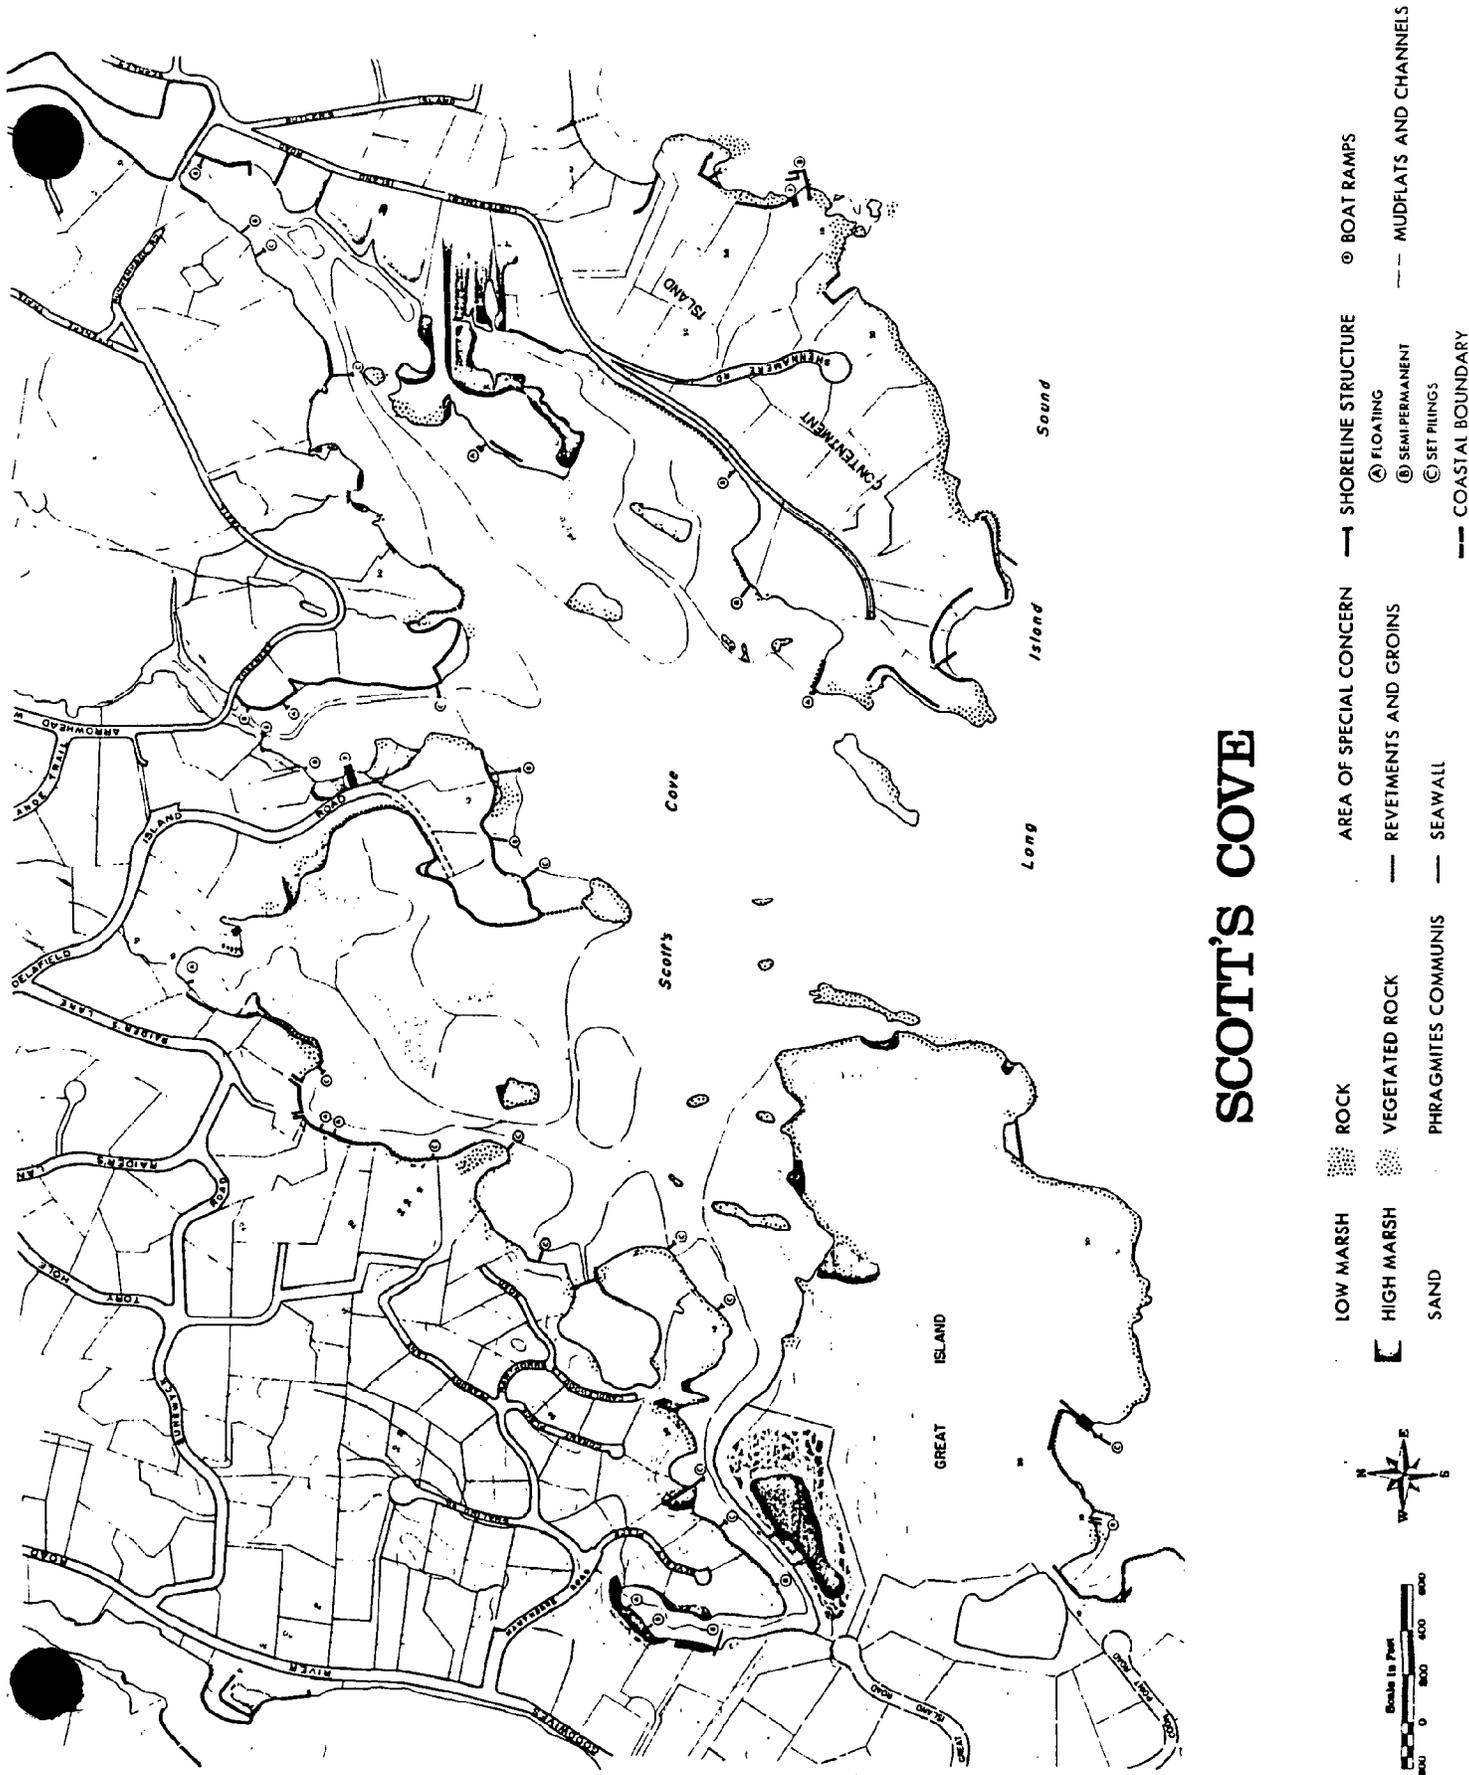
FIGURE 11

SCOTT'S COVE

Starting at the tip of Contentment Island, the coast is oriented on a north-northeast axis. The first 200 yards are characterized by low sloping bedrock and a cordgrass fringe, protected on the landward side by seawall. The adjacent upland areas are just above mean high tide. To the north, a point of exposed rock is connected by a sandbar to a long finger island which juts into the Cove. The island is comprised mainly of rock and cordgrass, with some phragmites, alder, and upland vegetation at its center. From this point north, the coast is under the protection of the Cove, and the cordgrass fringe becomes wider with less exposed bedrock being visible. The shore redirects to the northeast and extends some 700 yards to terminate at the high marsh system. The coastal resources involved along this section are largely mudflats and "hummocks" of alterniflora. Along the shore, cordgrass forms an unbroken border, and in most cases, seawalls lie landward. Contentment Island Road runs alongside a stretch of this shoreline, providing good visual access to Scott's Cove.

As this inlet narrows, the cordgrass stands become more dominant and, at the apex of this inlet, an extensive high marsh system exists. Covering approximately 3.50 acres, this high marsh bears the parallel scars of mosquito ditching. Likely once part of a larger system that extended approximately 200 yards to the north, this patens marsh appears to be highly productive, and forms the most extensive patens marsh to be found anywhere in Scott's Cove. A fringe of phragmites lines the upland borders of the marsh, and an access road forms its northern border.

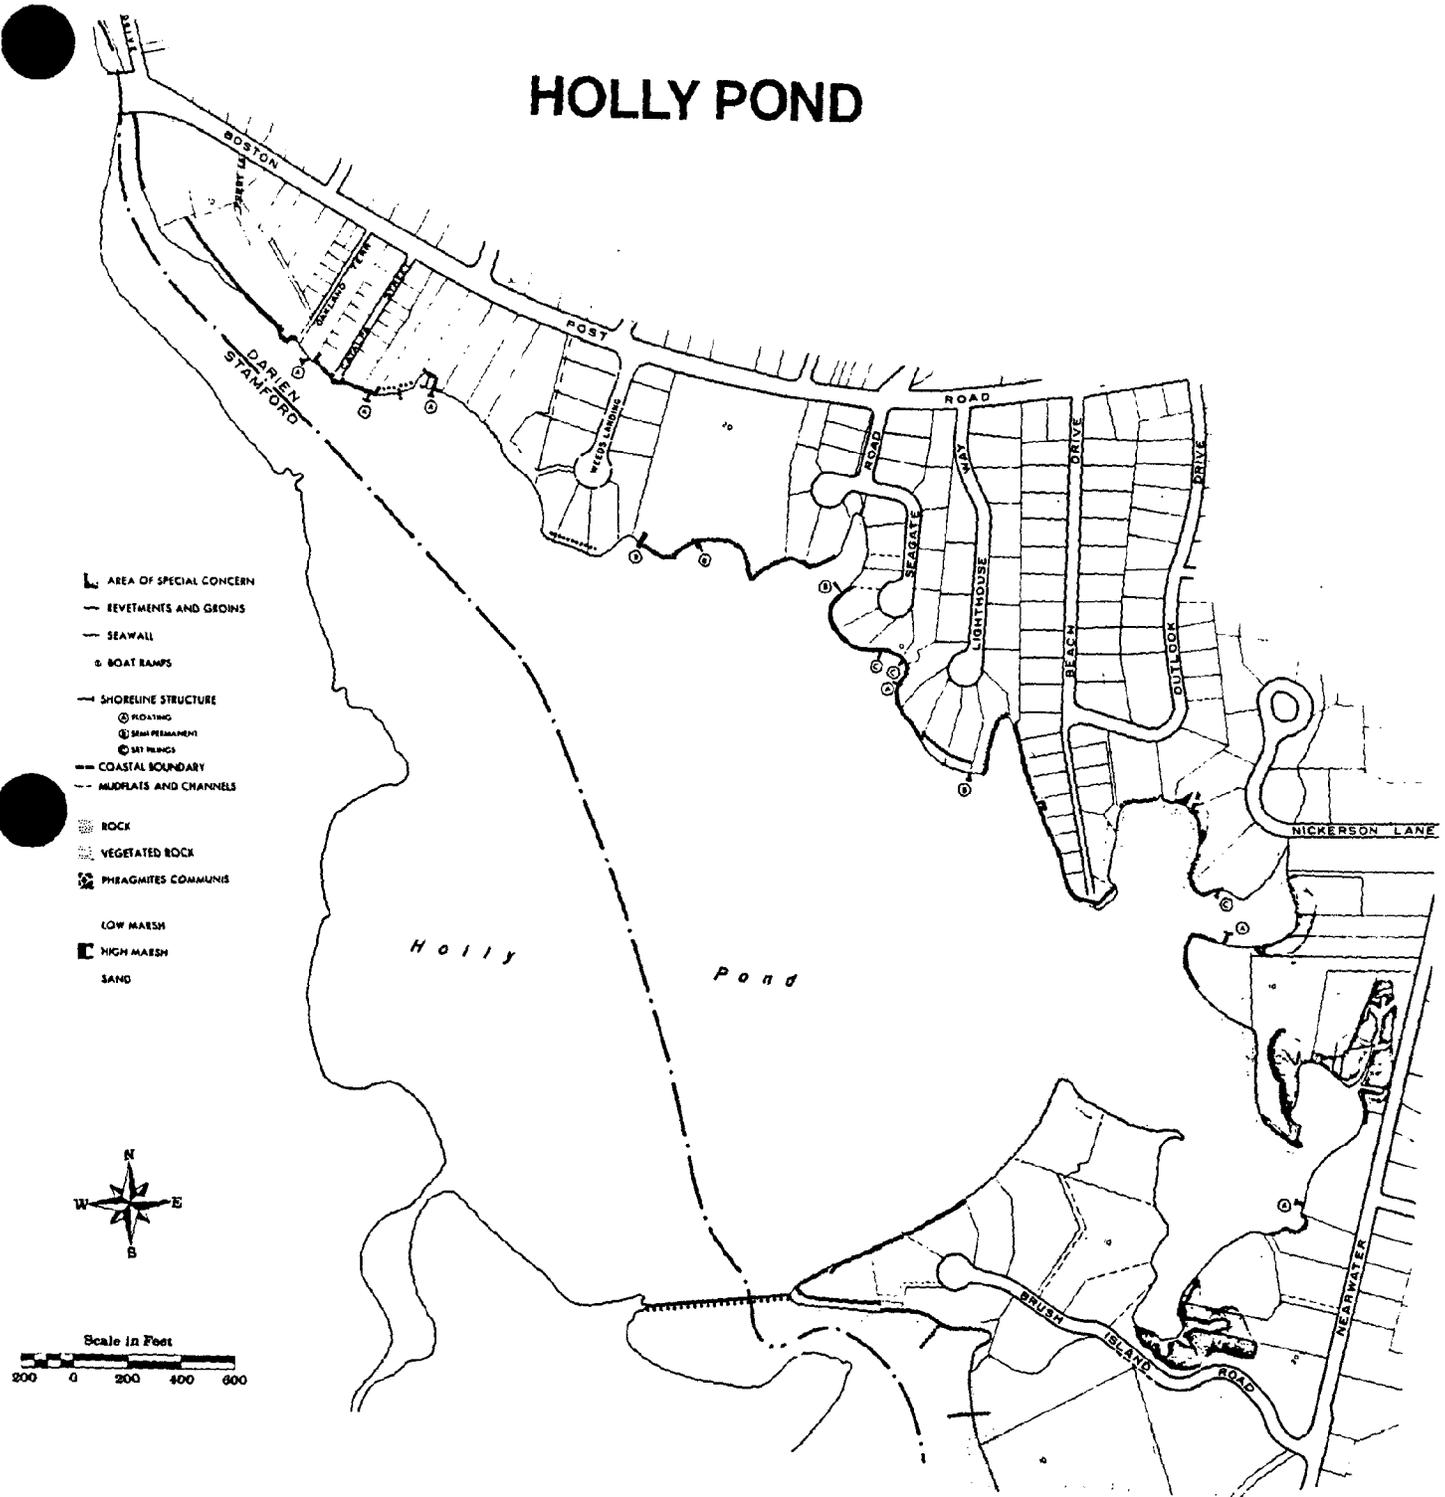
FIGURE 23

HOLLY POND

Midstream in the upper stretch of Holly Pond is a mudflat which is exposed by the change of tide. It is one of the few areas so exposed in Holly Pond, due to the small tidal fluctuations.

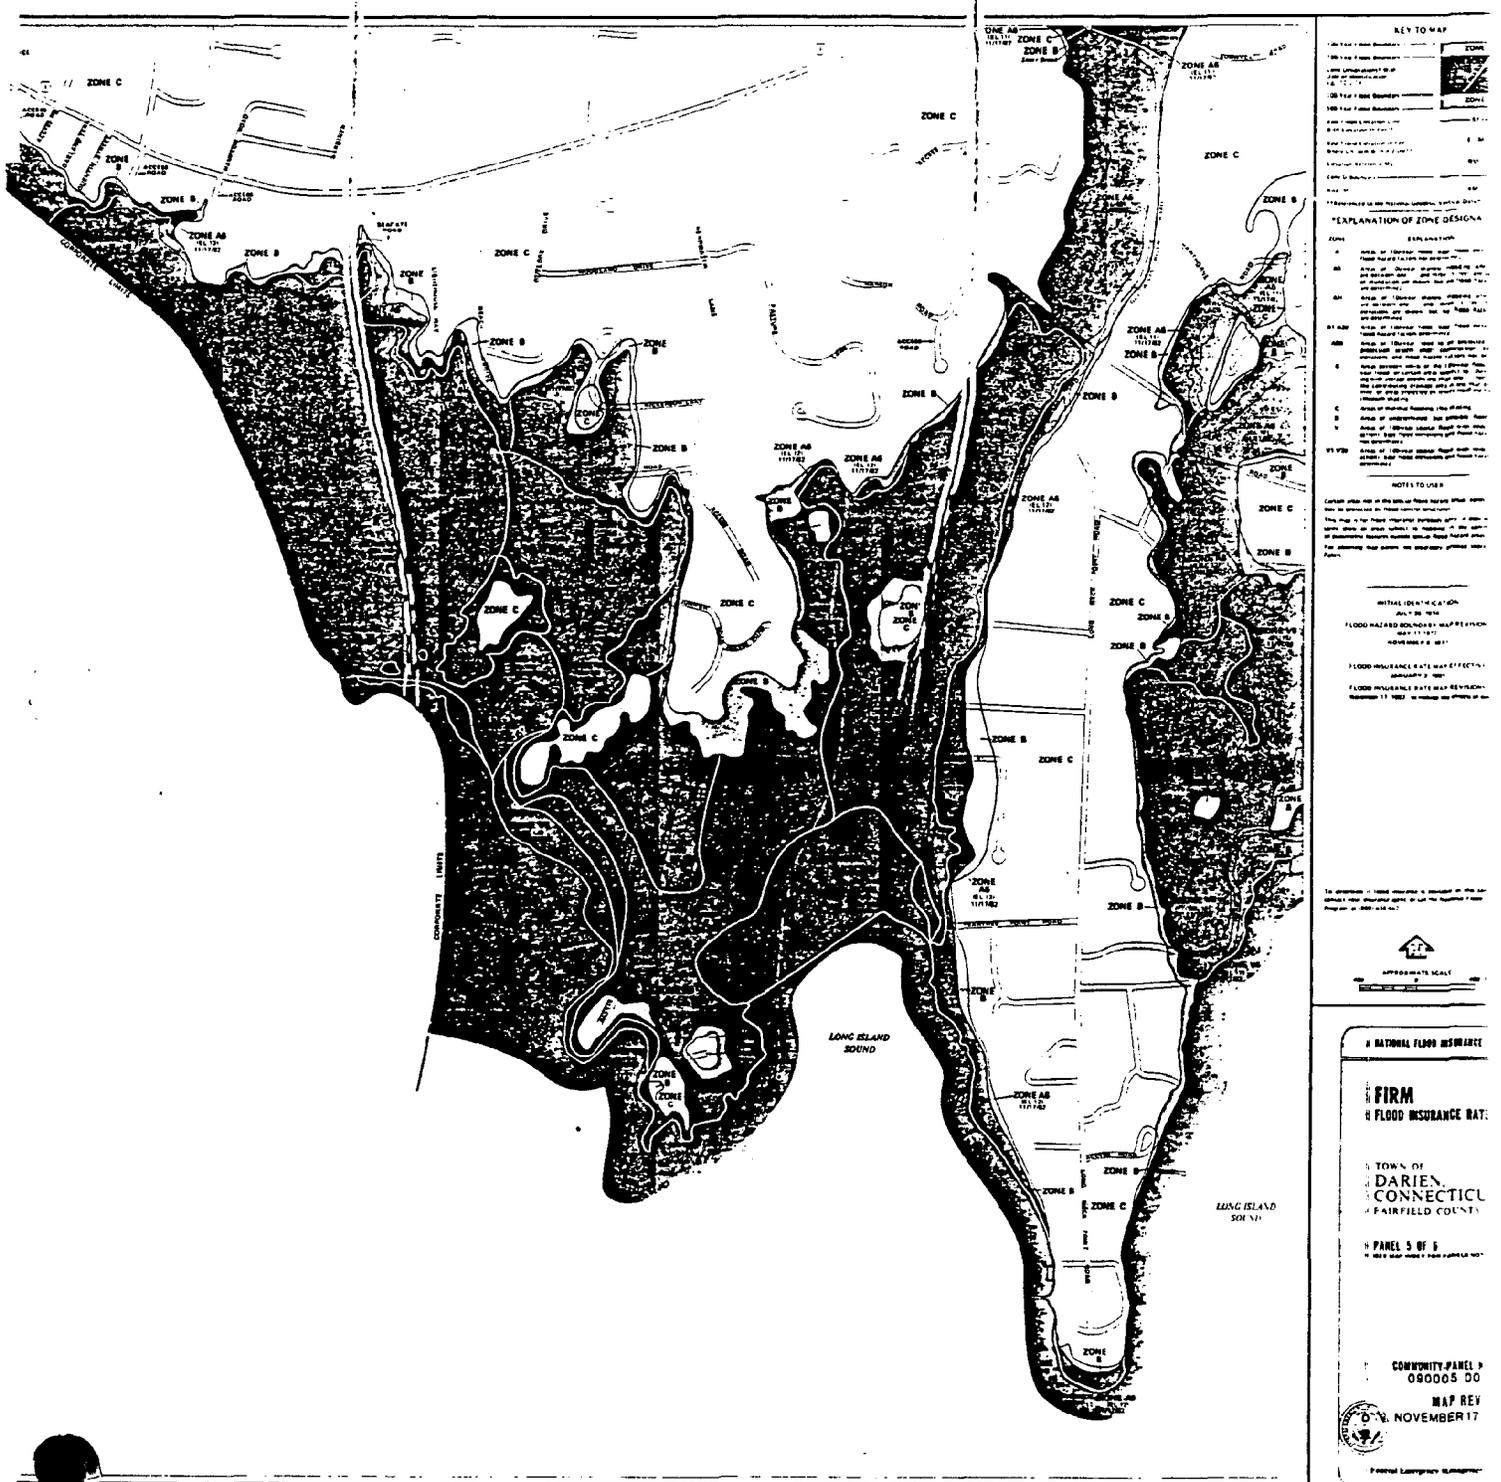
FIGURE 25

FLOOD MAP (EXAMPLE)

The cited maps also provide data on floodways, 100-year storm floodprone districts, 500-year storm floodprone districts, and other related factors including specific flood level elevations in critical areas. This information is applied in the administration of the regulatory program. The application of particular standards is based on the relationship of proposed activity to the specific location and may include: required elevations to be adhered to; needs for precise engineering design; the incorporation of special site development features; or other such measures.
