DRAFT
ENVIRONMENTAL ASSESSMENT
FOR
REPAIR, RECONSTRUCTION, AND MAINTENANCE
OF
KAHINAPOHAKU FISHPOND
MOANUI AHUPUA'A
MOLOKA'I HAWAII (TMK 5-8-01:2)

Aquaculture Development Program
Department of Land and Natural Resources

MBA International
1188 Bishop Street, Suite 3411
Honolulu, Hawaii 96813-3314
(808) 522-9711

January 1993

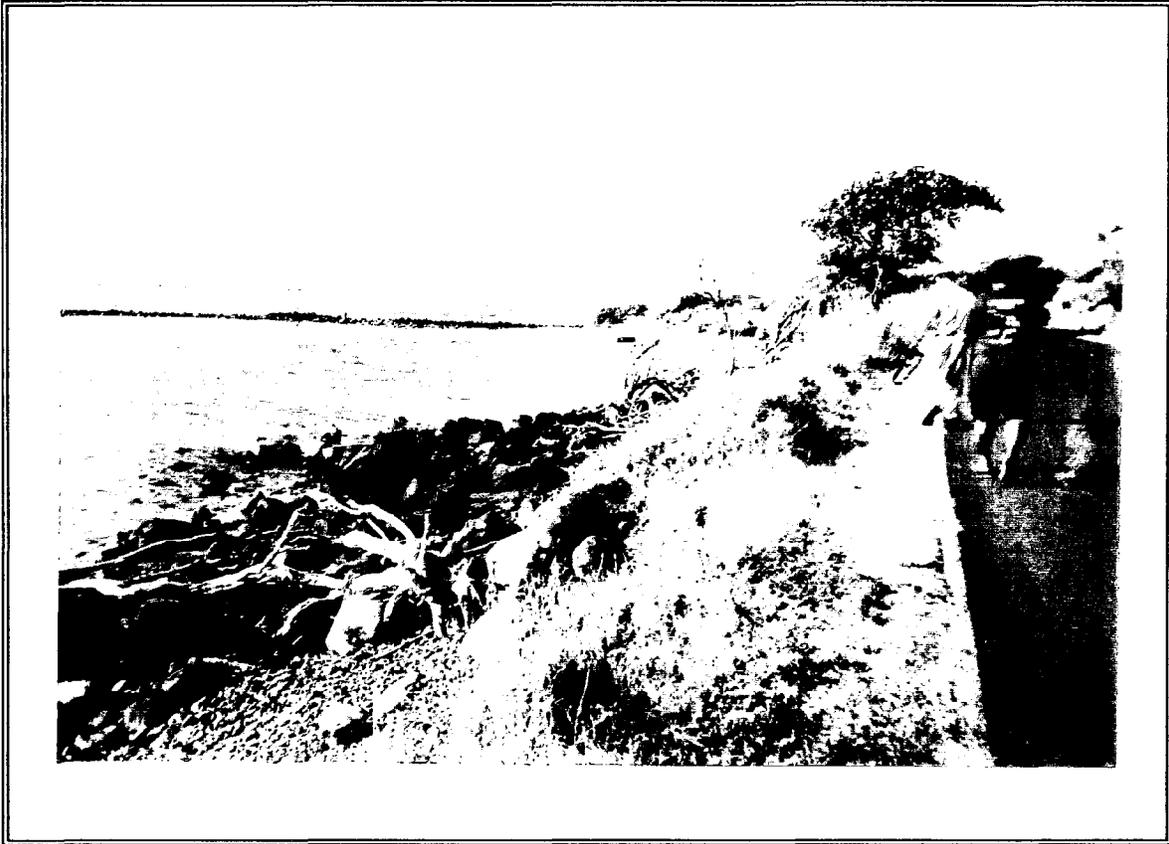
**EXHIBIT 2
KAHINAPOHAKU POND**

Partial view of nearshore portion of pond, looking towards the southwest.

The proposed project site is identified as TMK 5-8-01:2, and is located in East Moloka'i, roughly halfway between Waialua and Halawa Valley (Exhibit 1). The fishpond is situated within the Moanui *ahupua'a* and lies immediately adjacent to and below State Highway 450. It is separated from the highway by an irregular embankment that has been reinforced by a seawall constructed of basalt boulders. The project site consists of a 4.0-acre (1.6 hectares [ha]) fishpond that is delineated on its *makai* (seaward) margin by a deteriorating 1200-foot-long (366 meter-long) wall constructed of basalt foundation boulders, and on its *mauka* (landward) margin by a rock seawall and Highway 450 (Exhibit 2).
