[Docket No. FAA–2009–1253; Directorate Identifier 2009–NM–080–AD; Amendment 39–16629; AD 2011–06–05]

Airworthiness Directives; The Boeing Company Model 737–600, –700, –700C, –800, –900, and –900ER Series Airplanes

2011–06–05 The Boeing Company: Amendment 39–16629. Docket No. FAA–2009–1253; Directorate Identifier 2009–NM–080–AD.

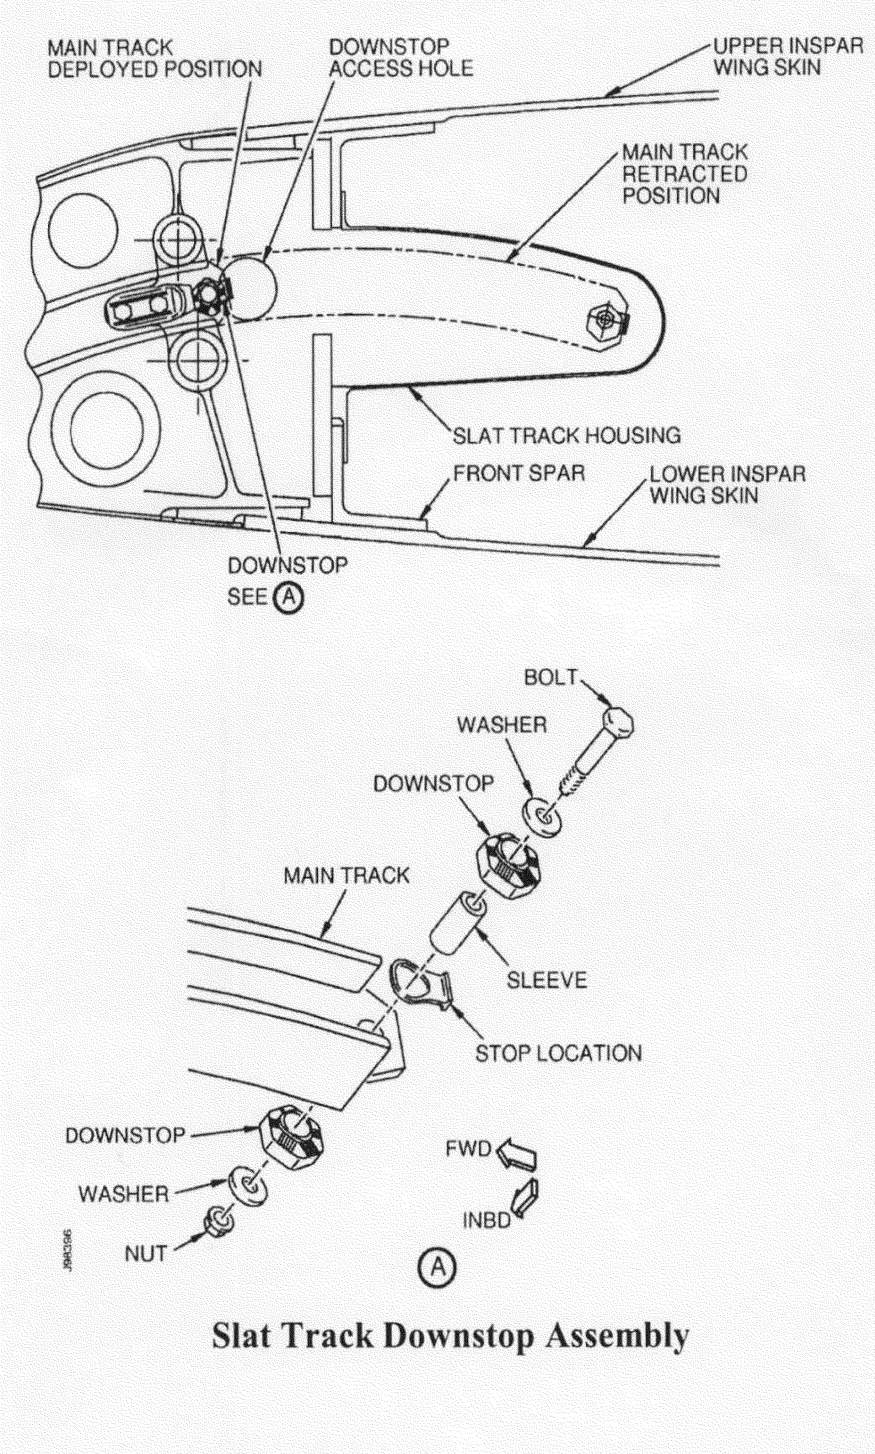
(g) Within 10 days after September 26, 2007 (the effective date of AD 2007–18–52): Do a detailed inspection or a borescope inspection of each main slat track downstop assembly to verify proper installation of the slat track hardware (*i.e.,* the bolt, washers, downstops, stop location, and nut shown in Figure 1 of Boeing Service Letter 737–SL–57–084–B, dated July 10, 2007, and in this AD). Proper installation of the sleeve need not be confirmed, and the stop location part may be installed on either the inboard or the outboard side of the slat track. If any part is missing or is installed improperly, before further flight, install a new or serviceable part using a method approved in accordance with the procedures specified in paragraph (j) of this AD; and do a detailed inspection of the inside of the slat can for foreign object debris (FOD) and damage. Before further flight, remove any FOD found and repair any damage found using a method approved in accordance with the procedures specified in paragraph (j) of this AD. Verify proper installation; install a new or serviceable part; and inspect for damage and FOD, and remove FOD and repair damage; in accordance with a method by approved by the Manager, Seattle Aircraft Certification Office, FAA; or in accordance with Boeing Multi Operator Message Number 1–523812011–1, issued August 25, 2007, or 1–527463441–1, issued August 28, 2007. Repeat the actions required by paragraph (g) of this AD thereafter at intervals not to exceed 3,000 flight cycles.

(h) Within 24 days after receipt of emergency AD 2007–18–51: Apply a torque between 50 to 80 inch-pounds to the nut. The bolt head must be held with the torque applied to the nut.
