[Docket No. FAA–2012–0807; Directorate Identifier 2011–NM–191–AD; Amendment 39–17888; AD 2014–13–12]

Airworthiness Directives; Airbus Airplanes

2014–13–12 Airbus: Amendment 39–17888. Docket No. FAA–2012–0807; Directorate Identifier 2011–NM–191–AD.

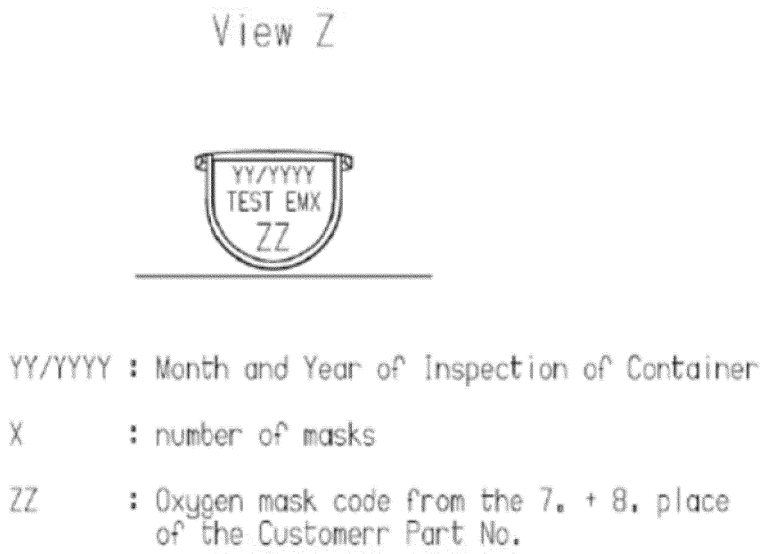
Picture A:

Figure 1 to paragraph (i)(7) of this AD – Design A of the Passenger Oxygen Containers Affected by this AD

Design A: The placard on the passenger oxygen container test button is as described in Picture A of Appendix 1 of this AD. The Mask configuration ("ZZ" in Picture A) is a number and the test button is as shown in Picture B.
