## VII. CASING JOINT DESIGN

(b) Probable Cause of Failure

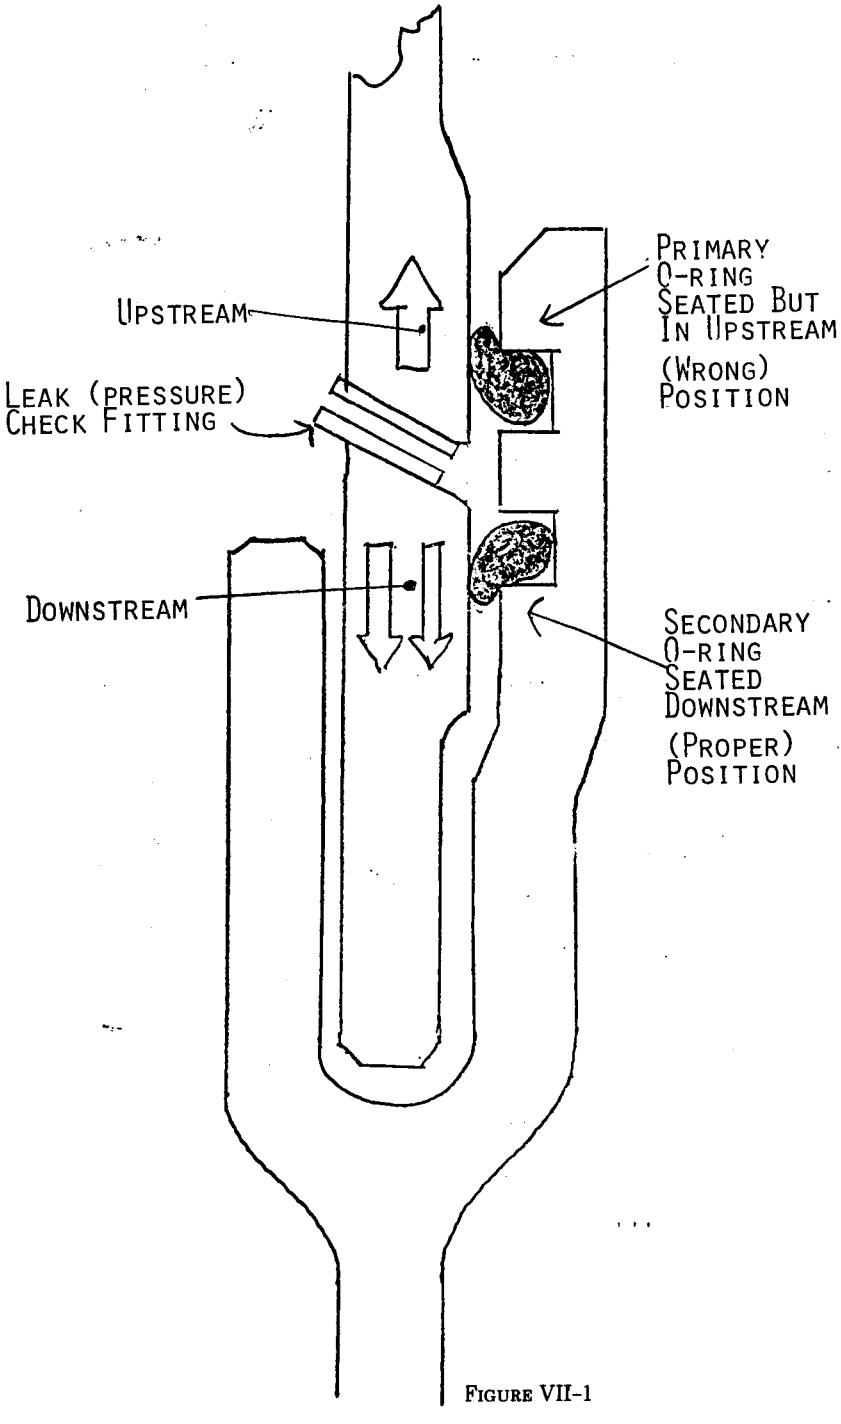
FIGURE VII-1

1. Both the primary O-ring and the secondary O-ring were seated when the steel casings were mated. The pressure check verified this fact. However, from experience, the primary O-ring was seated in the upstream position as had been previously recognized by NASA and Thiokol engineers. (See Figure VII-1.)

UPSTREAM
LEAK (PRESSURE)
CHECK FITTING
DOWNSTREAM
PRIMARY
O-RING
SEATED BUT
IN UPSTREAM
(WRONG)
POSITION
SECONDARY
O-RING
SEATED
DOWNSTREAM
(PROPER)
POSITION

But this design did not always answer the question: was the primary O-ring seated? Did it seal or not? Notice how the primary O-ring in Figure VII-1 (p. 176) is forced upward (shown by the single arrow). That is opposite to the normal direction that the propellant pressure acts (notice the double arrows). Even with an acceptable pressure check result, the primary O-ring would still be unseated for a fraction of a second when the motor pressure pushed the O-ring in the opposite direction from that which took place during the leak check.

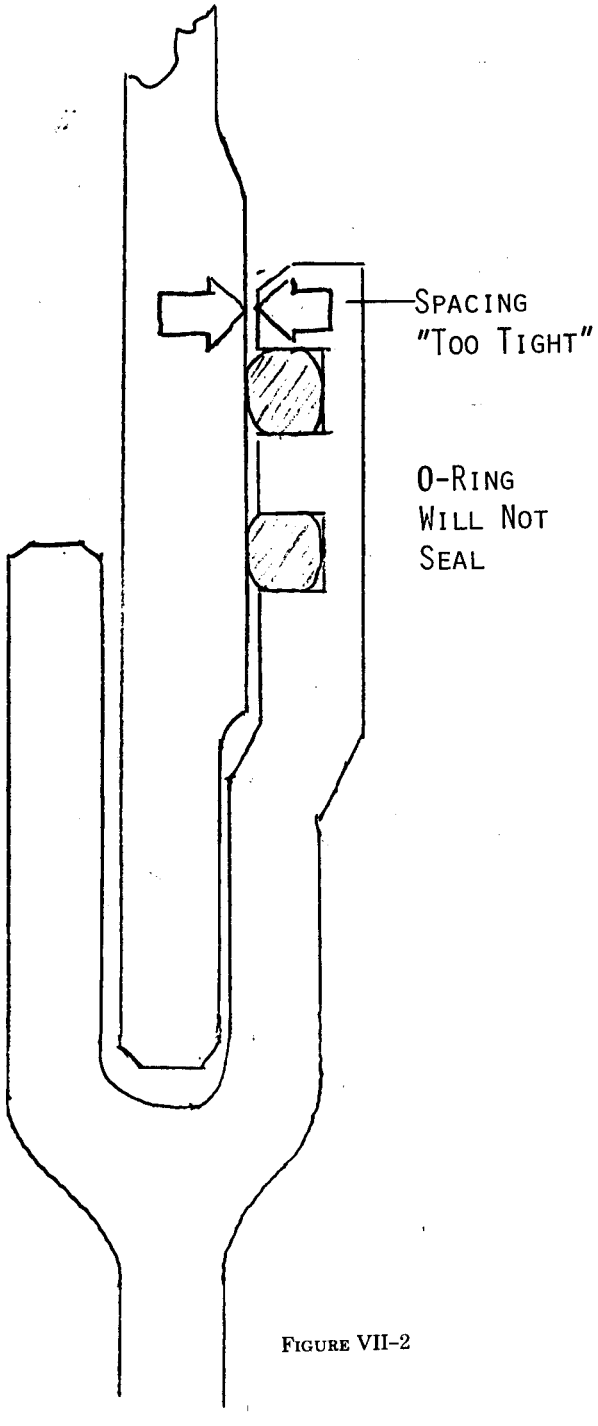
FIGURE VII-2

2. Upon ignition, the primary O-ring could not reseat at the 300 degree location in the downstream position, where it needed to be in time to prevent blowby. At this point there were too many deficiencies acting in unison which prevented the O-ring from reseating in that location. First, proper spacing between the inner face of the tang and the opposing face of the inner leg of the clevis approximately 0.020 inches, is critical. That spacing for Flight 51-L was too small, at the 300 degree location where the smoke was observed, to facilitate prompt reseating of the primary O-ring. Calculations of segment diameters indicate the gap spacing was only 0.004 inches, near metal-to-metal contact. The ignition gases passed the O-ring at this location (See Figure VII-2). This condition did not exist elsewhere in the joint around the casings since the primary O-ring was able to seat around the joint in other locations.

Second, the low temperature throughout the night prior to launch left the fluorocarbon elastomer primary O-ring stiff and lacking in ability to spring into the downstream (seated) position at the 300 degree location in time, relative to the buildup of motor pressure, to provide a tight seal. The temperature of the aft field joint at time of launch was calculated by Thiokol after the accident to be 16 degree F. Part of the reason for this low temperature was the heat transfer away from the joint, by conduction through the aft attachment strut. The conduction was driven by liquid hydrogen, which remained in the external tank overnight. The supercold fuel created a 430 degree temperature differential across the ship, drawing heat out of the joint and O-rings.

At ignition, blowby occurred, either with erosion of the primary O-ring or without erosion.

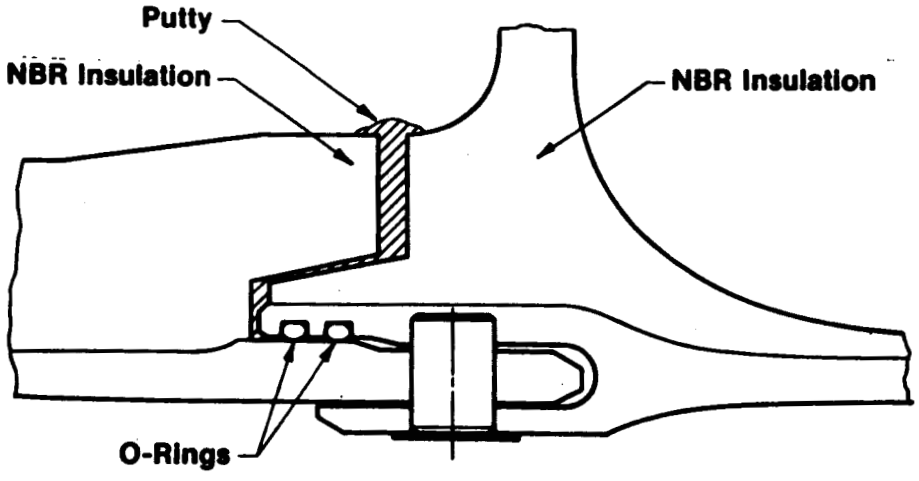
Figure 1

**SRM-HPM Field Joint**

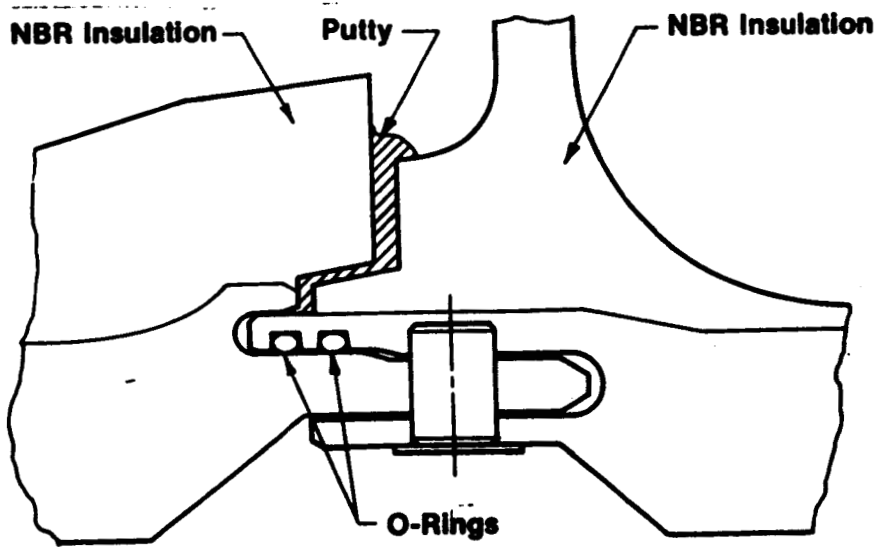
Figure 2

**FWC-SRM Field Joint**

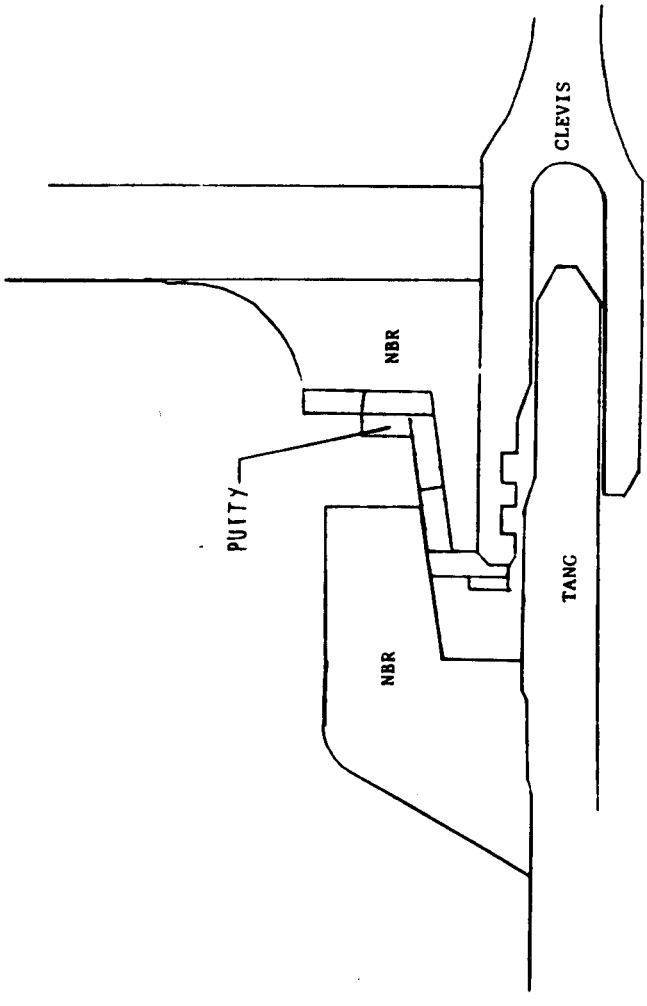
Figure 1

(2) Putty layup tests using the attached figure 1 layup concept.

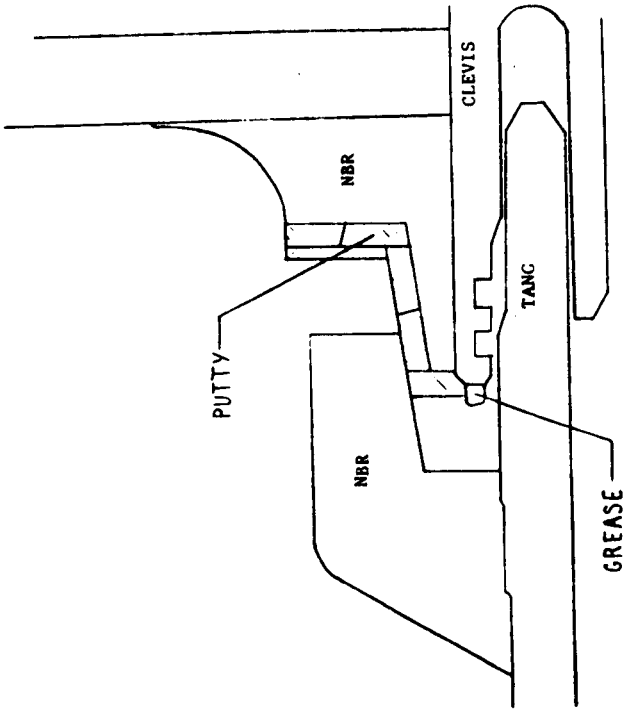
Figure 2

(3) Putty layup tests using the attached figure 2 layup concept.

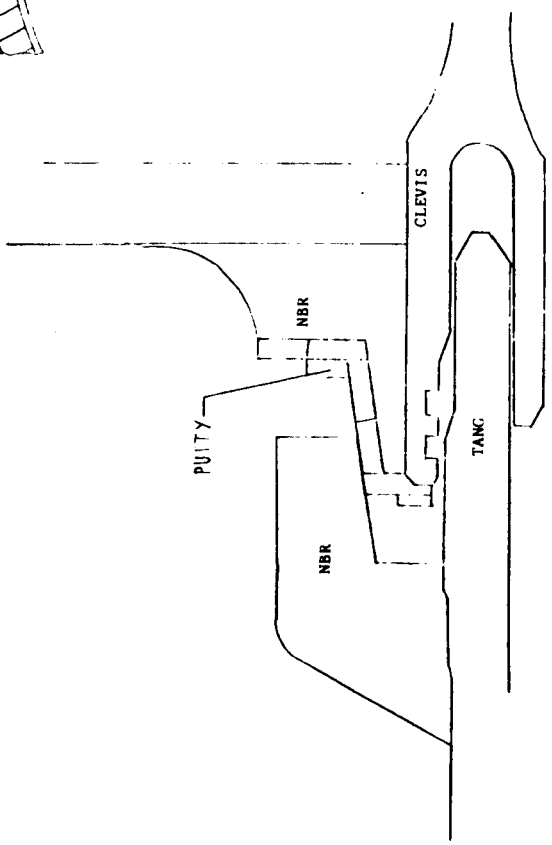
Figure 3

(4) Repeat tests (1) and (2) except with vent slots located at 120-degree interval around the circumference as shown by attached figures 3 and 4. The slots are designed to prevent air entrapment and resulting volcanoes. Evaluation of layup effectiveness should be performed with flow meters to determine cavity volumes.
