Weko Beach Shoreline Erosion Study

Bridgman, Michigan

September, 1981

WILLIAMS & WORKS
ENGINEERS/PLANNERS/ARCHITECTS
GRAND RAPIDS, MICHIGAN 49506

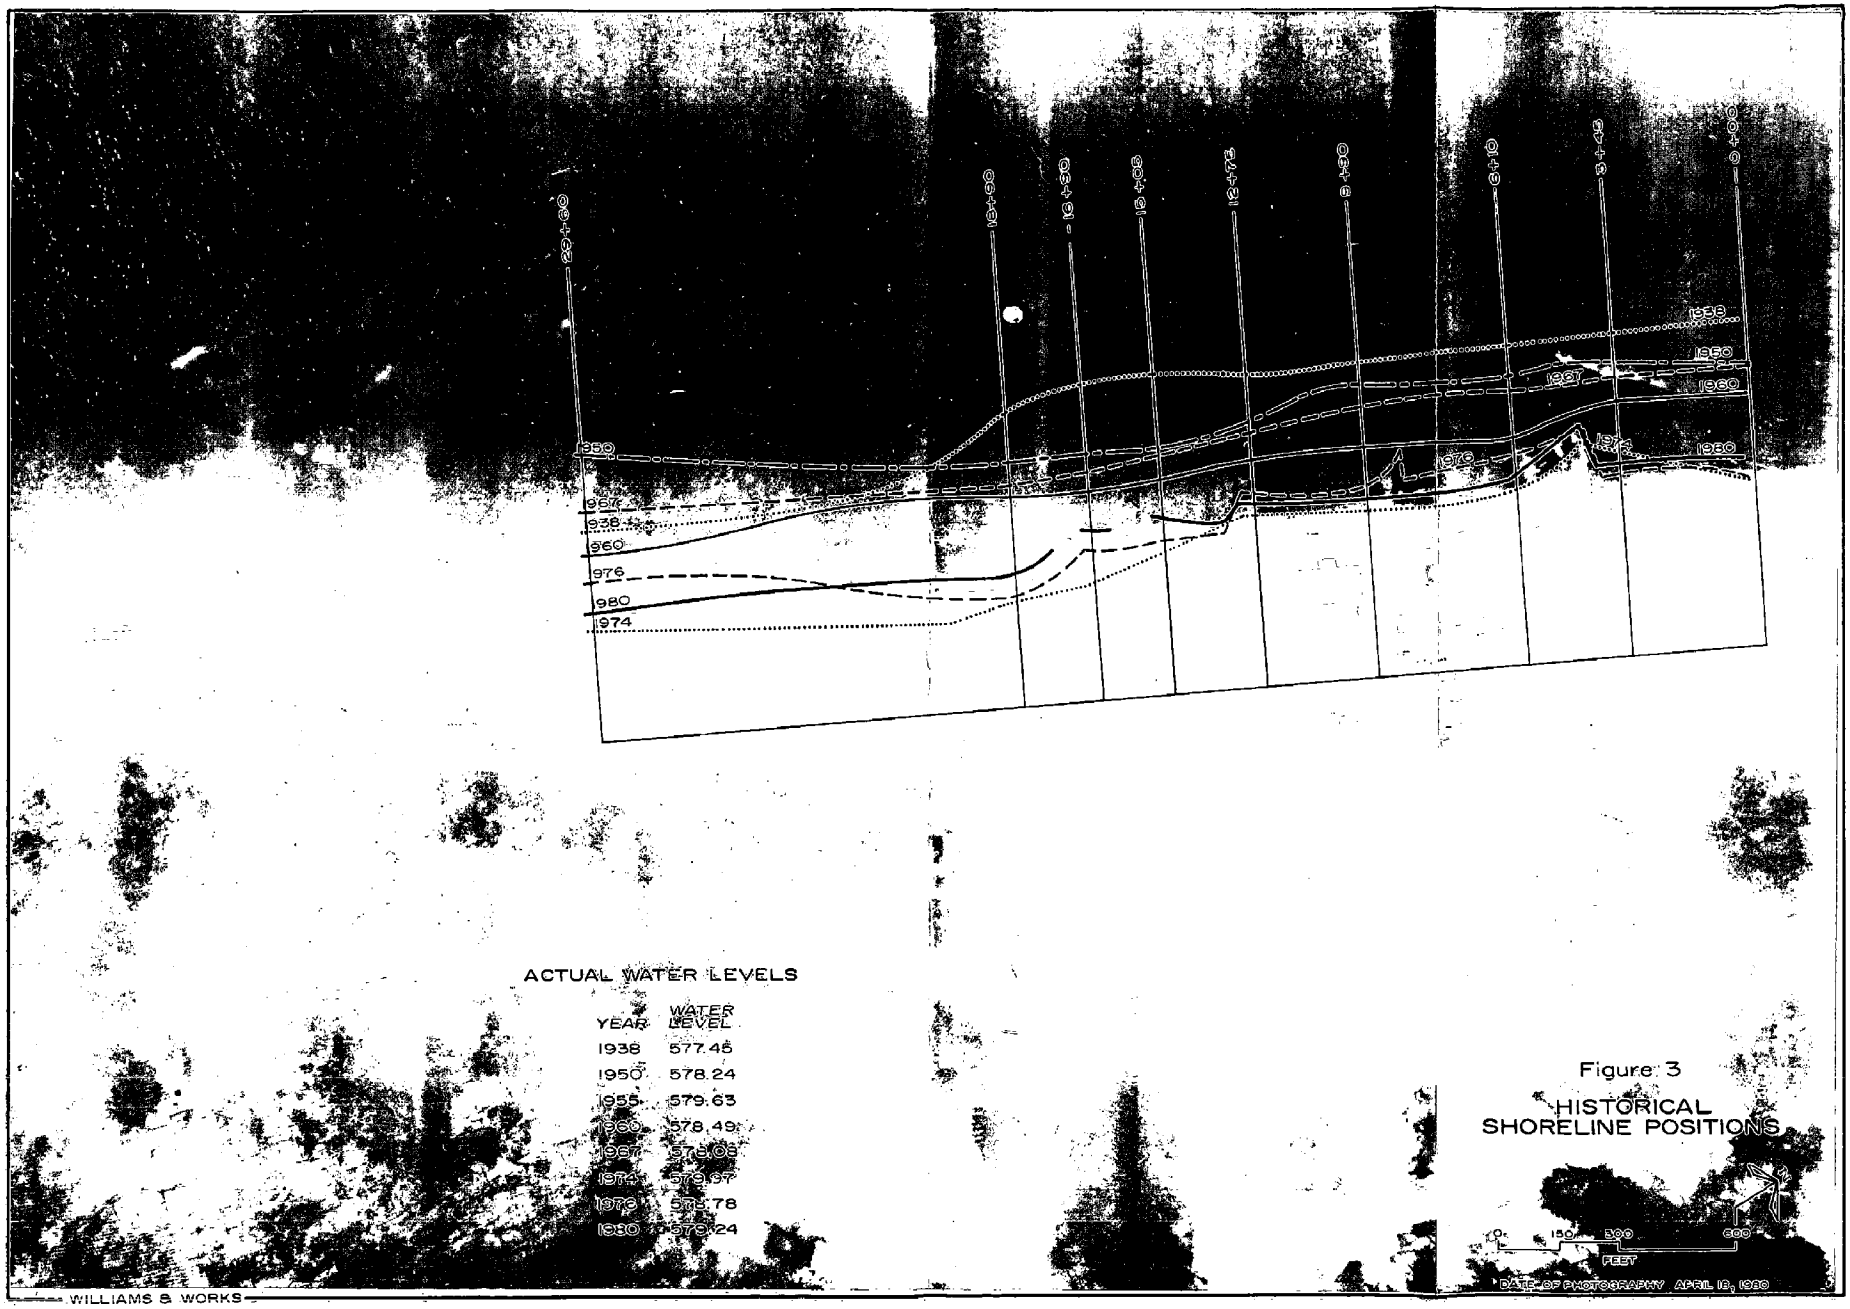
Figure 3

The third step involved adjusting the measured shoreline positions, photographed as they appeared at various lake levels, to a single lake level as a common basis of comparison. The mean Lake Michigan level of 578.3 was selected for this purpose. These adjustments were made assuming the slope of the shoreline did not change significantly over the years. These adjusted shoreline positions are shown in Figure 3.

One interesting observation from the recent aerial photographs is that the beach between stations 3+45 and 16+90 extends farther seaward than the adjacent shoreline. This indicates that the existing small structures at Weko Beach are serving their intended purpose. Without the two groins at stations 16+00 and 17+00, and the steel sheet-pile jetty at the launch ramp (3+50), the beach would be expected to erode up to 50 feet. This would threaten the beach house. Therefore, it is imperative that these structures remain intact.

The conclusion of this investigation is that the beach between stations 3+45 and 18+90 will remain stable for the forseeable future. The beach house will, therefore, remain unthreatened. It is of critical importance that the existing groins and sheet pile jetty remain in place. Even if Lake Michigan rises to 1973-74 levels, the shoreline structures will protect this reach. The stability of this beach section would be threatened if any major shoreline structures were built between Weko Beach and the Cook Nuclear plant.
