THE MISSISSIPPI RIVER GULF OUTLET:

A Study of Bank Stabilization

COASTAL ENVIRONMENTS, INC.
BATON ROUGE, LOUISIANA

December 1984

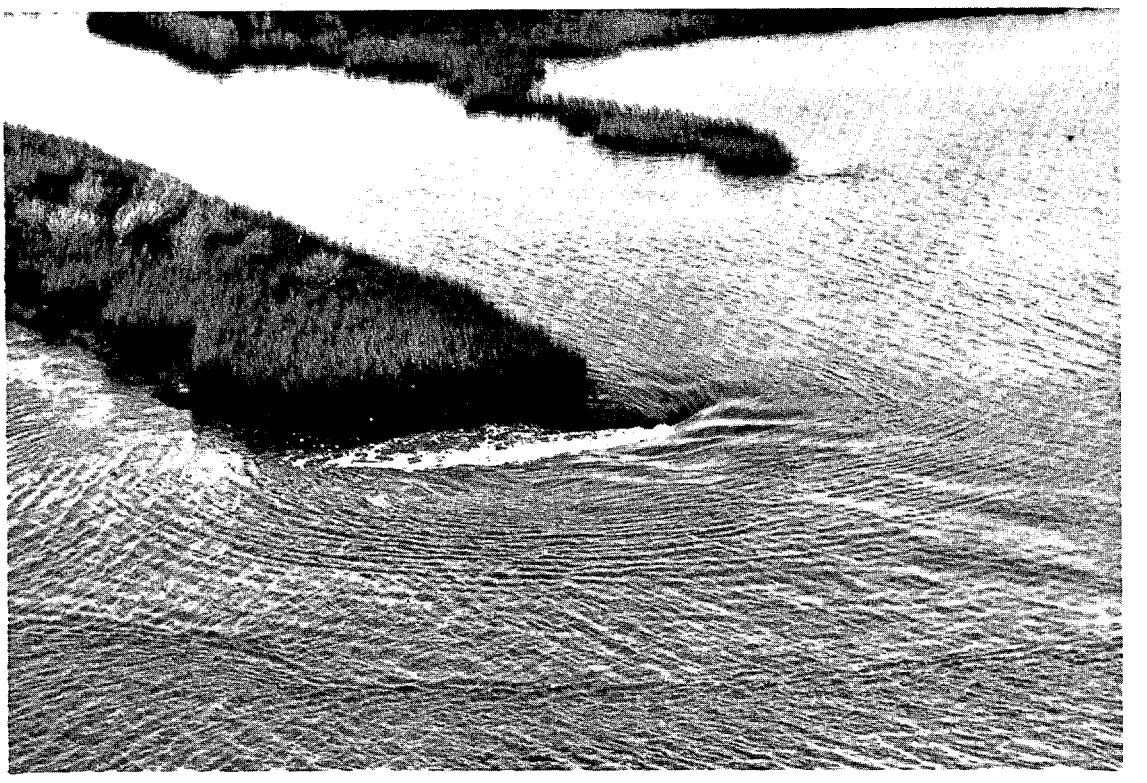
Figure 18. Low altitude oblique photograph of northeast shore of the MRGO at station 1095 as transverse wave from large displacement vessel causes drawdown. Note how bayou waters feed drawdown and thus mitigate wave activity in front of bayou.

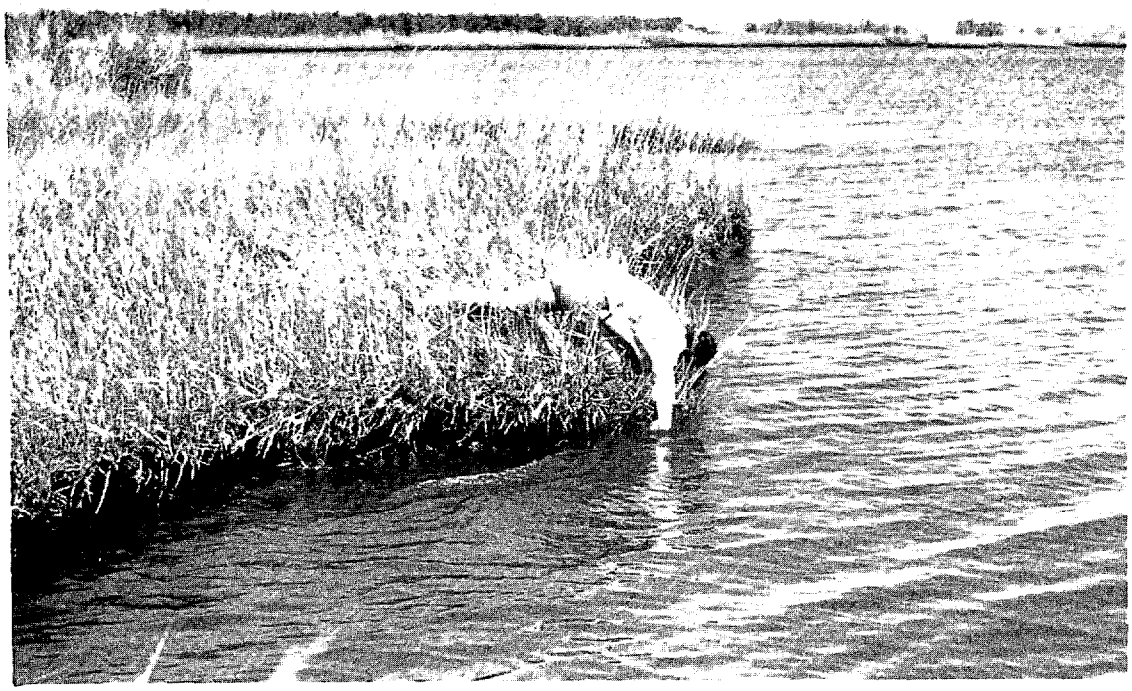
Figure 30. Undercutting of soft marsh substrate. Person is demonstrating degree of undercutting by extending forearm horizontally into void below root mat.

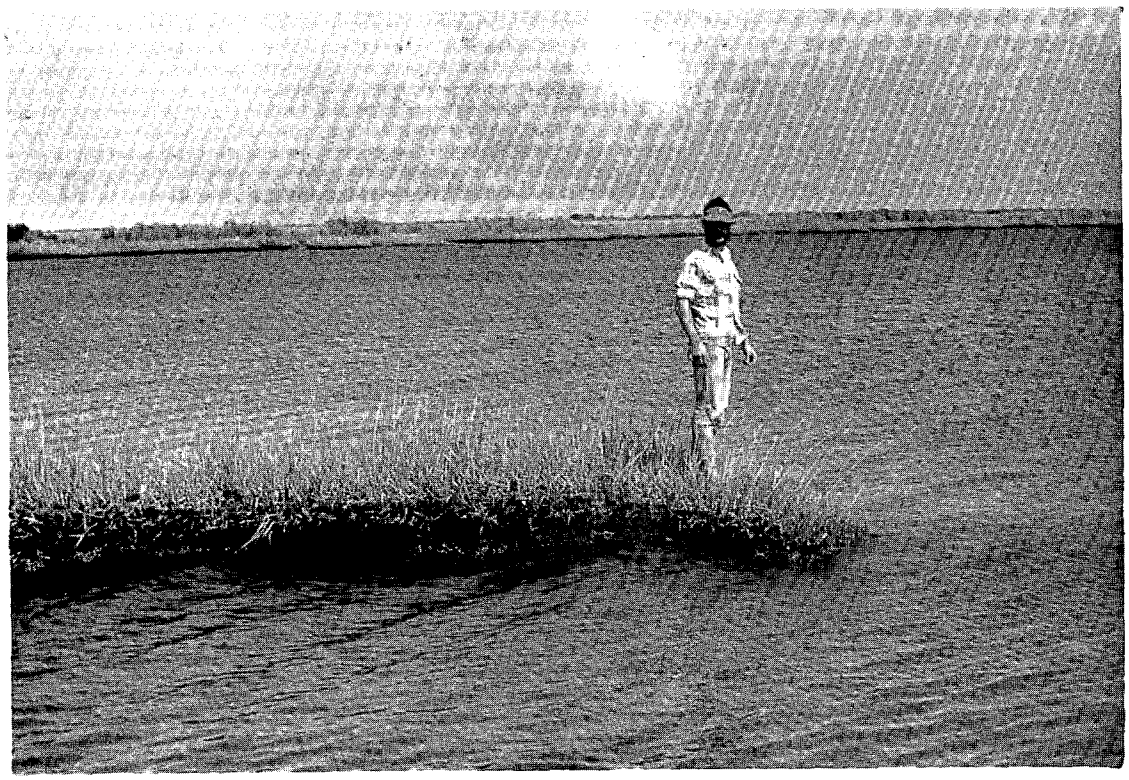
Figure 31. Failed marsh block in soft marsh area. Person is standing on fracture zone where marsh block has been undercut by ship waves and has fallen under its own weight.

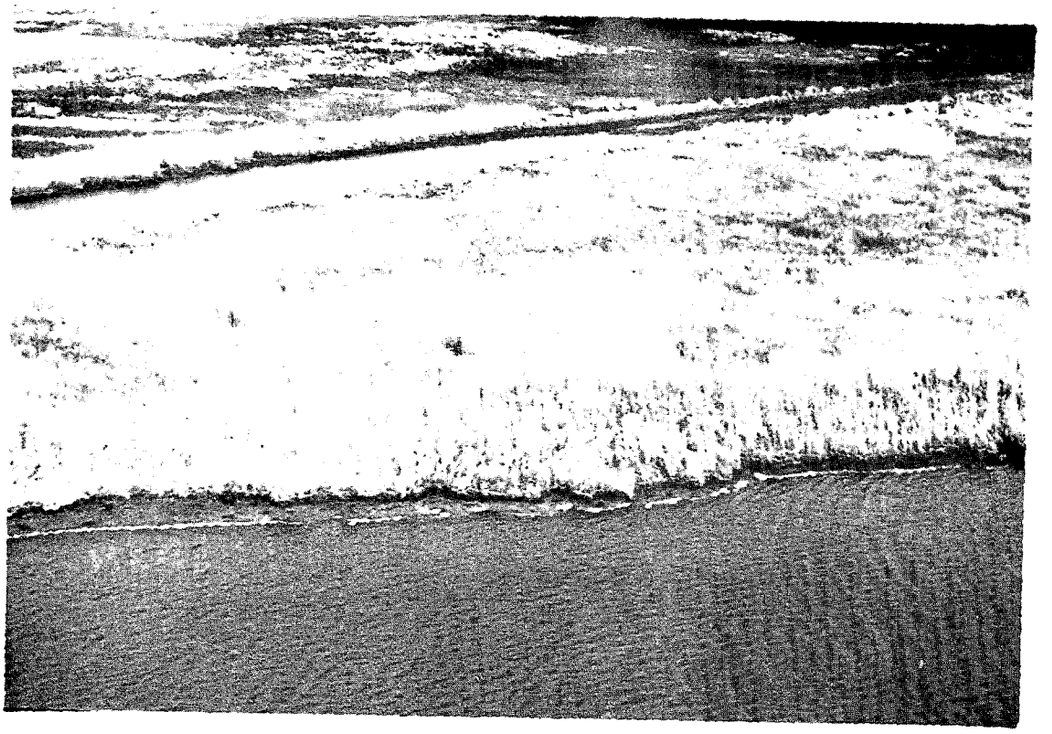
Figure 35. Oblique low altitude aerial photograph of typically straight-shaped firm marsh MRGO shore. This is station 725 where levee substrate provides slight elevation rise and support of roseaucane vegetation.
