WET-PIT MINING IMPACT ASSESSMENT: COASTAL ZONE OF PUERTO RICO

Andrea Handler Ruiz and Rojeanne Salles O'Farrill

Office of Coastal Resources Management (OCRM)
National Oceanic and Atmospheric Administration (NOAA)

Task 7.2
May 1988

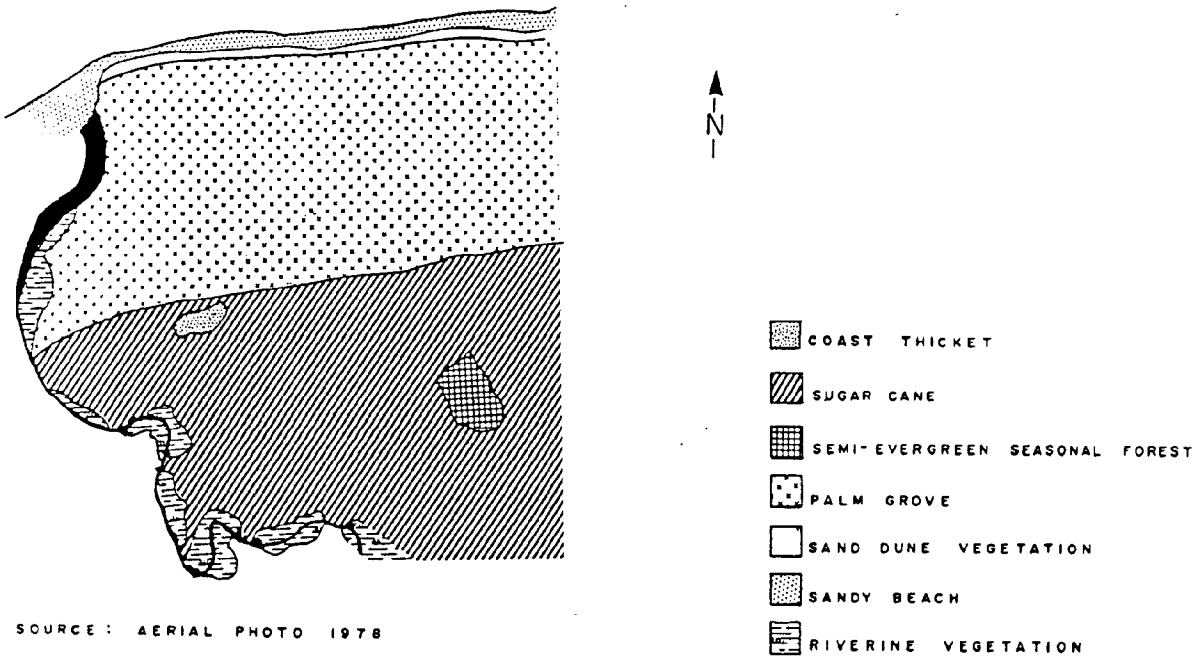
FIG.10. VEGETATION MAP OF AGUADA SITE

Site vegetation prior to the begining of mining behind the backdune area was an upland type consisting of a coconut palm canopy with a weedy herbaceous understory (Fig. 10, 11). This former upland was the center of mining operations for this site (Photo 2b). Figures 10, 11a, and 11b illustrate the changes in vegetation due to mining. Pioneer vegetation covered the backfilled areas as wet-pit development advanced (Photo 2c), although a great portion of the backfill is still unvegetated (Photo 2d).
