[Docket No. FAA–2006–25773; Directorate Identifier 2006–SW–16–AD; Amendment 39–14758; AD 2006–19–01]

Airworthiness Directives; Eurocopter Model AS350B, B1, B2, B3, BA, D, and AS355E Helicopters

ACTION: Final rule; request for comments.

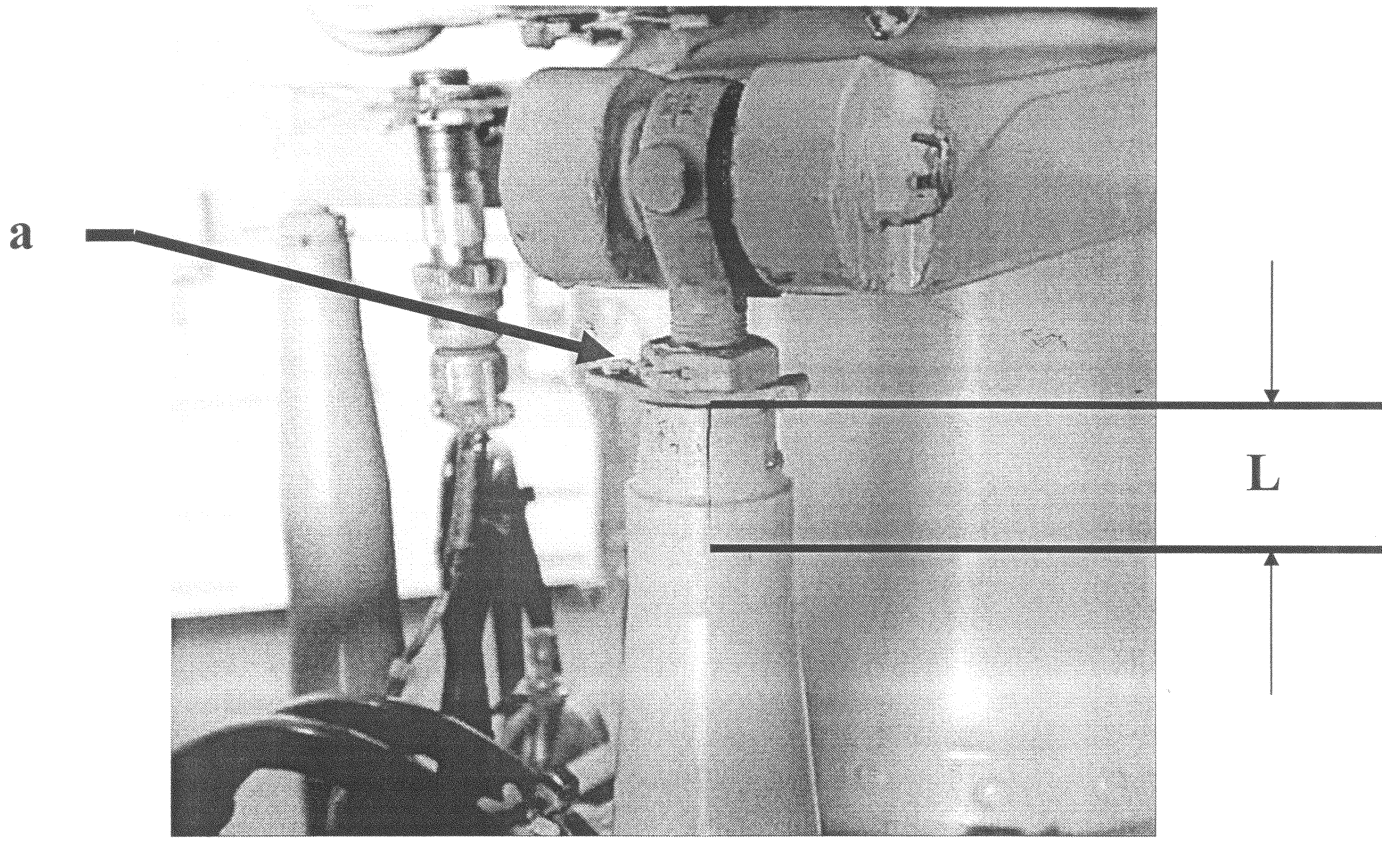
(3) Loosen attachment nut ''a'' shown in Figure 1 of this AD and lift the positioning lock washer under the attachment nut so the edge below the lock washer at the top of the tapered housing is visible around the entire periphery.

(4) Visually inspect each MSC tapered housing for a crack using a 10-power or higher magnifying glass paying particular attention to area ''L'' and to the edge of the tapered housing located under the lock washer under attachment nut ''a'' as depicted in Figure 1 of this AD.

(1) Adjust the tightening torque on the attachment nut that secures the upper ball end of the MSC to between 177–199 in-lbs (2–2.25 decanewton meters (daN·m)).

(c) If you find any crack (oblique, horizontal, or vertical), before further flight, replace the MSC with an airworthy MSC and adjust the tightening torque of the attachment nut to between 177–199 in-lb (2–2.25 daN·m)).
