[Docket No. FAA–2011–1158; Directorate Identifier 2010–SW–018–AD; Amendment 39–16847; AD 2011–22–05]

Airworthiness Directives; Eurocopter France Model AS350B, B1, B2, B3, BA, C, D, and D1; and AS355E, F, F1, F2, N, and NP Helicopters

2011–22–05 EUROCOPTER FRANCE (EUROCOPTER): Amendment 39–16847; Docket No. FAA–2011–1158; Directorate Identifier 2010–SW–018–AD; supersedes AD 2003–22–06, issued October 22, 2003 (68 FR 61608; October 29, 2003), Amendment 39–13354, Docket No. 2000–SW–12–AD.

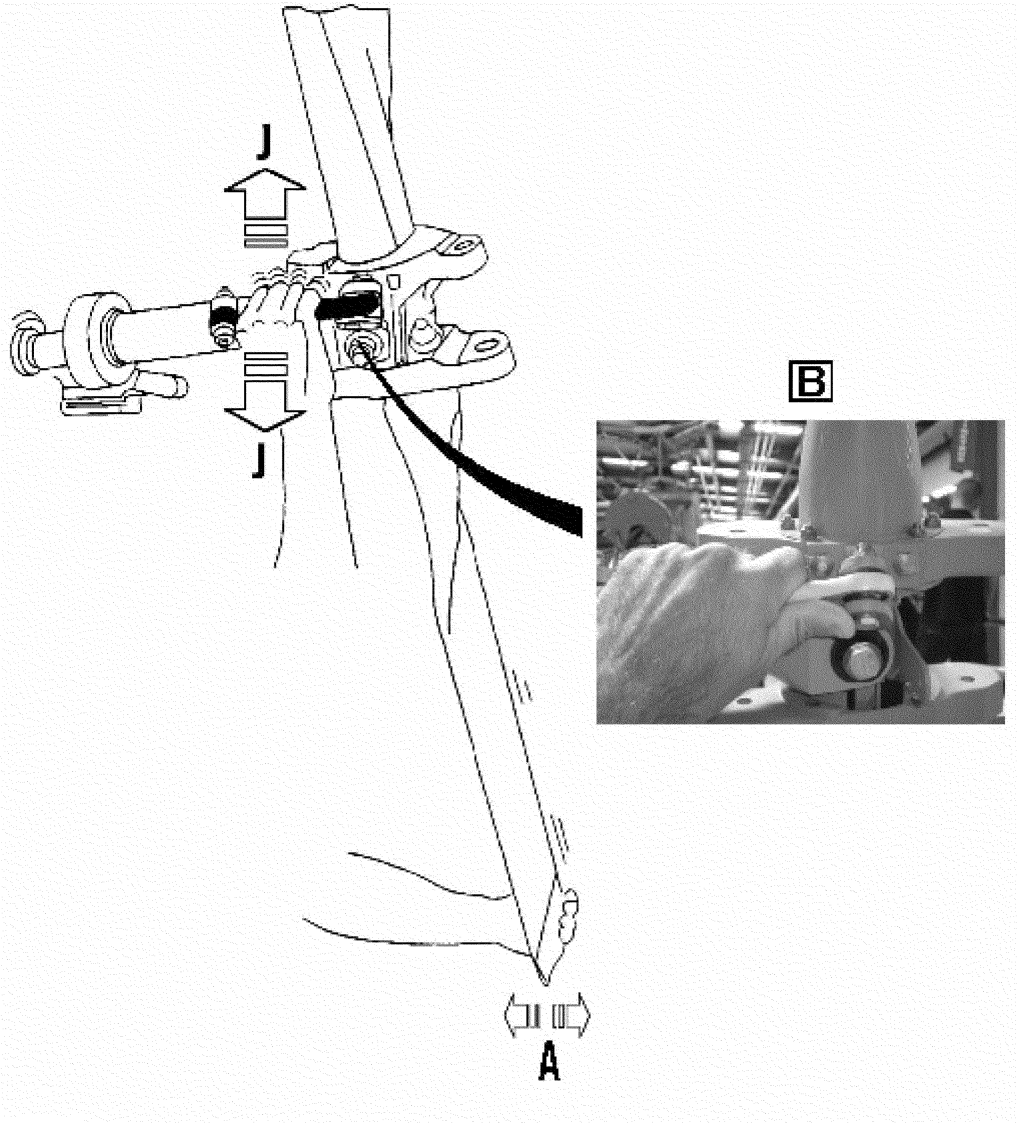
Figure 1: Manual Check for Play of the Tail Rotor Pitch Control Rod

(a) Before the first flight of each day, place the T/R pedals in the neutral position. If the helicopter is fitted with a T/R load compensator, discharge the accumulator as described in the rotorcraft flight manual. Check the control rod bearing (bearing) for play on the helicopter, by observation and feel, by slightly moving the T/R blade in the flapping axis while monitoring the bearing for movement. See the following Figure 1 of this AD. The actions required by this paragraph may be performed by the owner/operator (pilot) holding at least a private pilot certificate, and must be entered into the helicopter maintenance records showing compliance with this AD in accordance with 14 CFR 43.9(a)(1)–(4) and 14 CFR 91.417(a)(2)(v). The record must be maintained as required by 14 CFR 91.173, 121.380, or 135.439.

(b) If the Teflon cloth is coming out of its normal position within the bearing, totally or partially, or if there is discoloration or scoring on the bearing, before further flight, replace the control rod with an airworthy control rod.

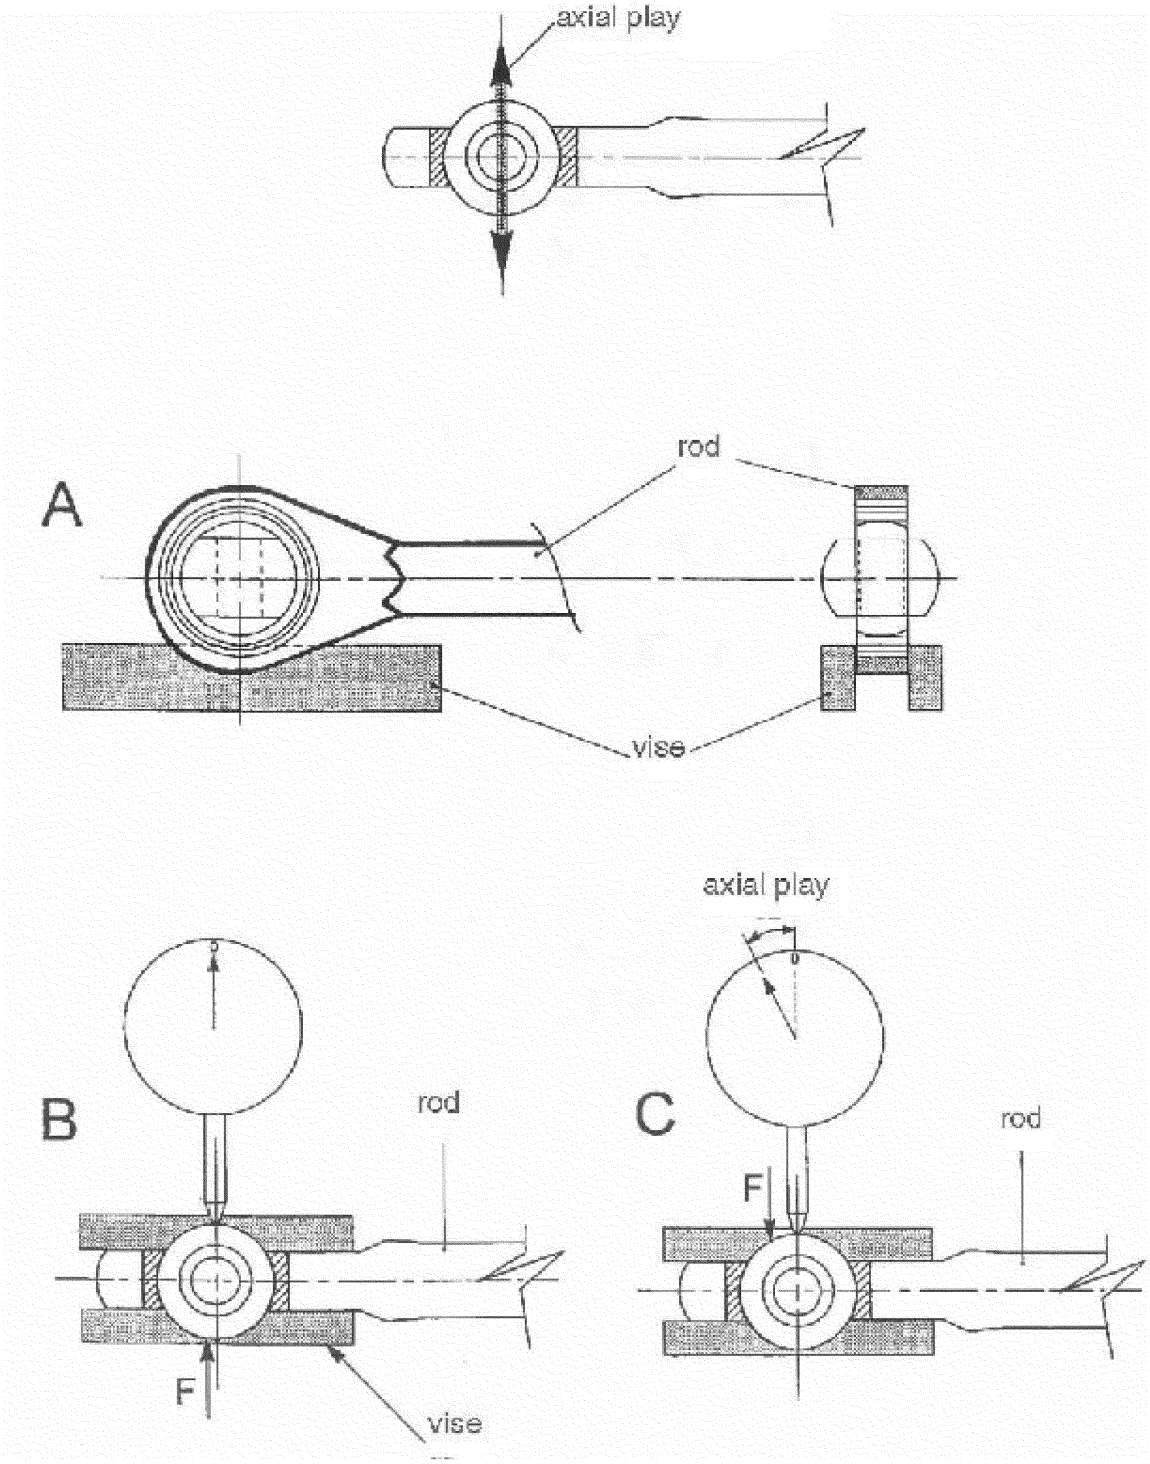
Figure 2: Measurement of the Axial Play (A) of the Bearing

(c) If a pilot or mechanic detects play, a mechanic must remove the control rod from the helicopter, and using a dial indicator, measure the bearing wear according to the following and as shown in Figures 2 and 3 of this AD:

(2) Mount the control rod in a vise as shown in Figure 2 of this AD.

(3) Using a dial indicator, take axial play readings by moving the spherical bearing in the direction F (up and down) as shown in Figure 2 of this AD.

(8) If the radial play exceeds 0.008 inch or axial play exceeds 0.016 inch, replace the control rod with an airworthy control rod before further flight.

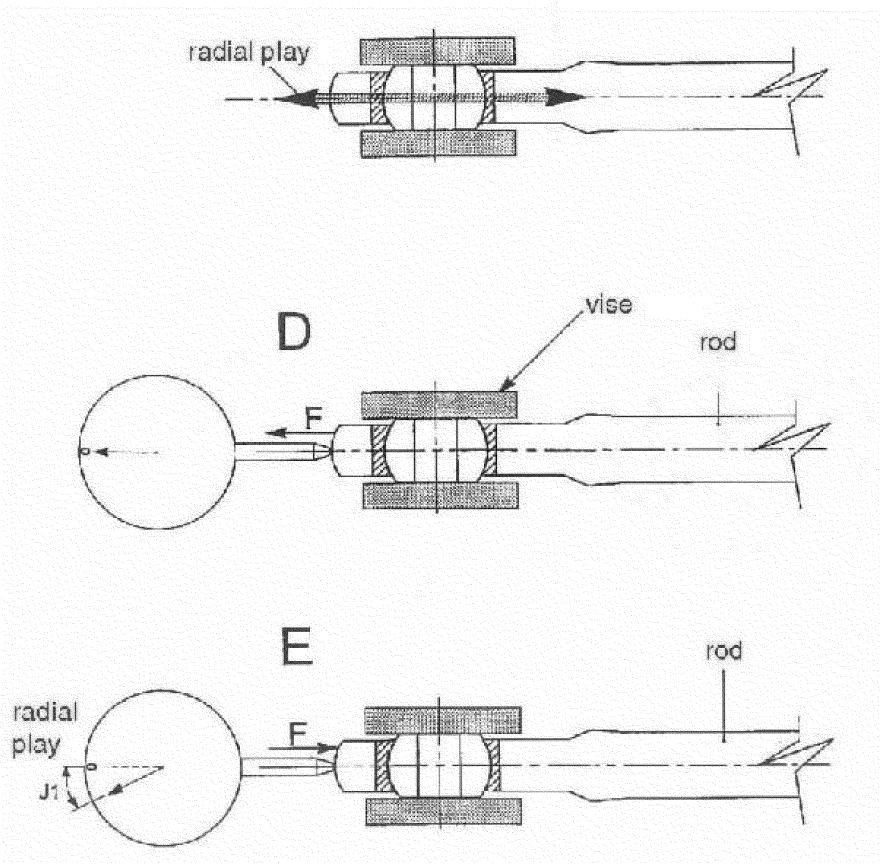
Figure 3: Measurement of the Radial Play (R) of the Bearing

(5) Mount the control rod and bearing in a vise as shown in Figure 3 of this AD.

(6) Using a dial indicator, take radial play measurements by moving the control rod in the direction F as shown in Figure 3 of this AD.
