[Docket No. FAA–2012–0896; Directorate Identifier 2010–SW–070–AD; Amendment 39–17173; AD 2012–17–10]

Airworthiness Directives; Various Restricted Category Helicopters

2012–17–10 Various Restricted Category Helicopters: Amendment 39–17173; Docket No. FAA–2012–0896; Directorate Identifier 2010–SW–070–AD.

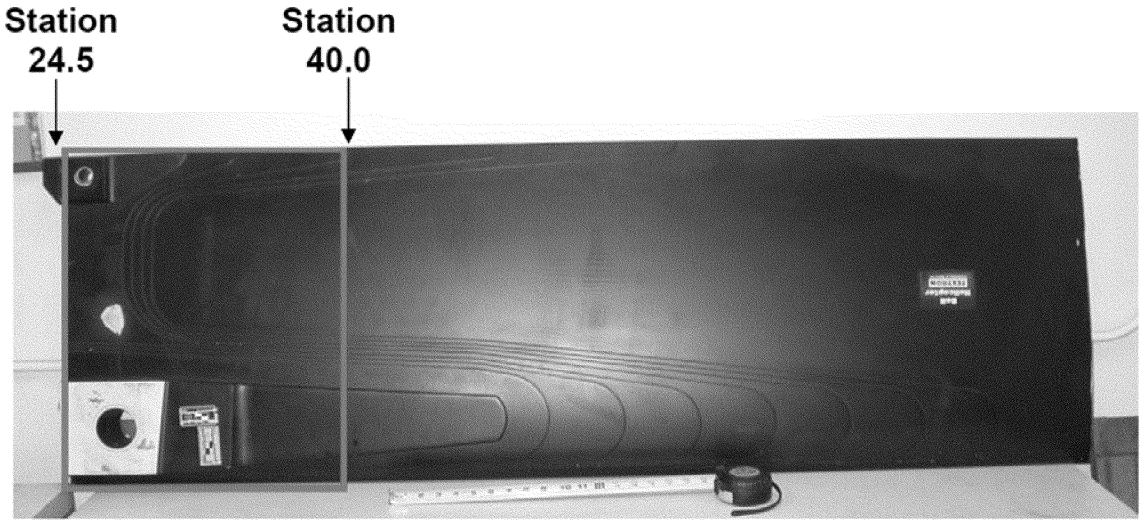
(ii) Using a 3x power or higher magnifying glass and a bright light, on each affected M/R blade, in an area from blade stations 24.5 to 40, including the entire width of the M/R blade chord, as depicted in Figure 1 to Paragraph (e) of this AD:

(A) Visually inspect the upper and lower grip plates and doublers of the M/R blade for an edge void, any corrosion, or a crack.

(B) Visually inspect the remaining upper and lower surfaces of the M/R blade for an edge void, any corrosion, or a crack.

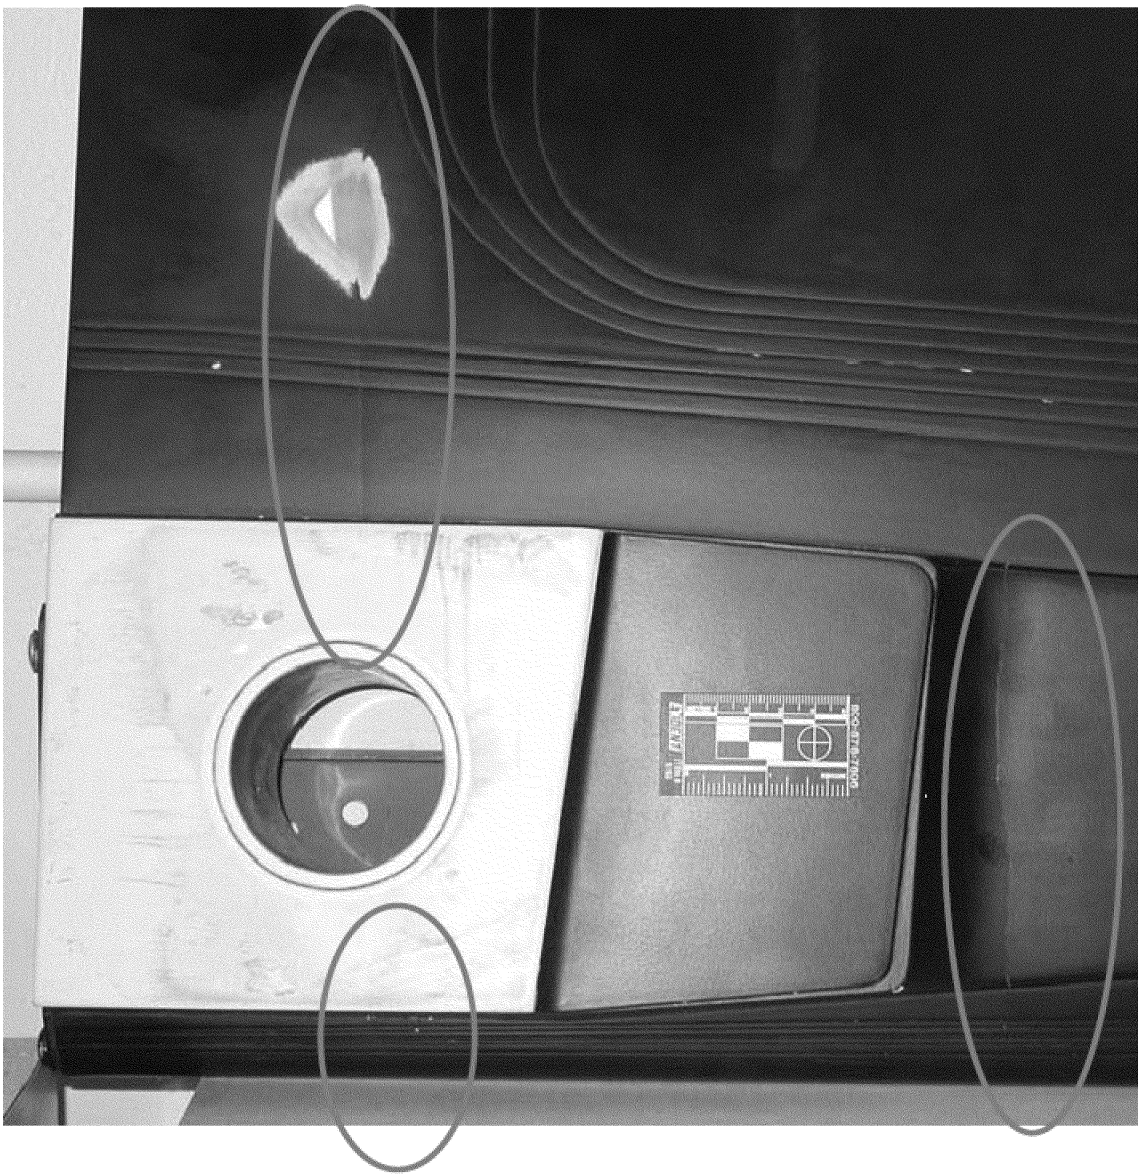
Note 2 to paragraph (e)(1)(ii): Crack indications on an actual M/R blade are shown in Figure 2 to Paragraph (e) of this AD.

(v) If there is a crack in any grip plate or doubler, replace the M/R blade with an airworthy M/R blade.

(vi) If there is a crack in the M/R blade skin, replace the M/R blade with an airworthy M/R blade, or repair the M/R blade if the damage is within the maximum repair damage limits.
