**HURRICANE KATRINA:
WHY DID THE LEVEES FAIL?**

COMMITTEE ON
HOMELAND SECURITY AND
GOVERNMENTAL AFFAIRS
UNITED STATES SENATE

NOVEMBER 2, 2005

Chapters 2 through 5 of this report present a summary of observations and preliminary findings to date associated with protective levee system performance in the (2) Orleans East Bank, (3) Ninth Ward/St. Bernard Parish, (4) New Orleans East, and (5) Plaquemines Parish protected areas, respectively. Chapter 6 briefly addresses observations regarding pumping and dewatering systems, and other aspects of the overall regional flood protection system. Chapter 7 describes LIDAR imagery data sets taken to capture three-dimensional representations of detailed ground surface conditions and configurations at a number of key sites. Finally, Chapter 8 summarizes a number of preliminary overall observations and recommendations.

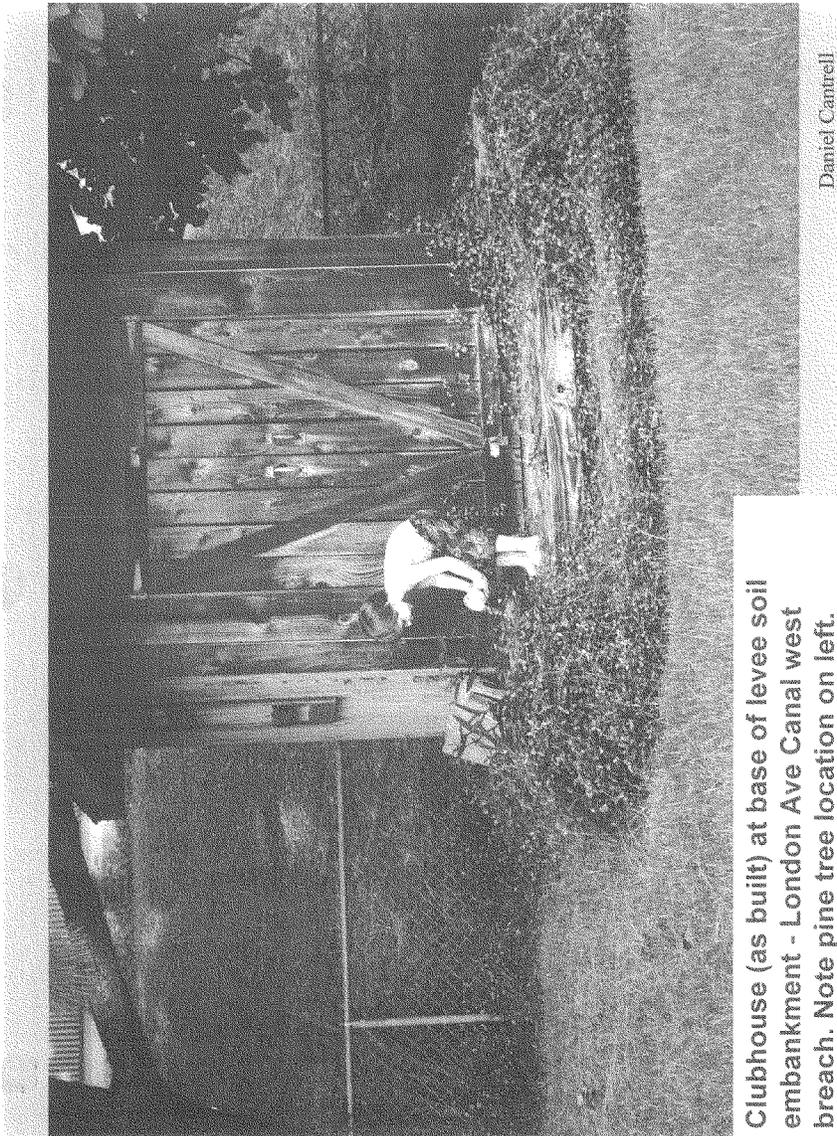
Clubhouse (as built) at base of levee soil embankment - London Ave Canal west breach. Note pine tree location on left.

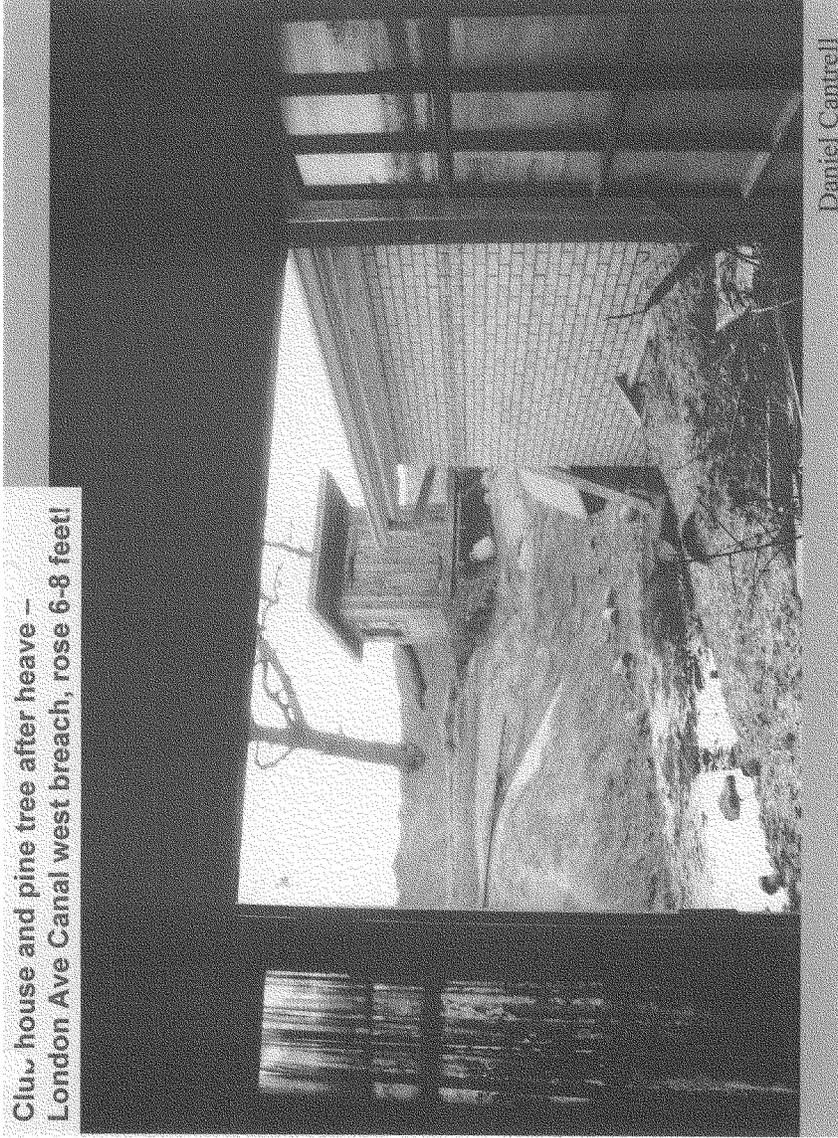
Clu, house and pine tree after heave –
London Ave Canal west breach, rose 6-8 feet!

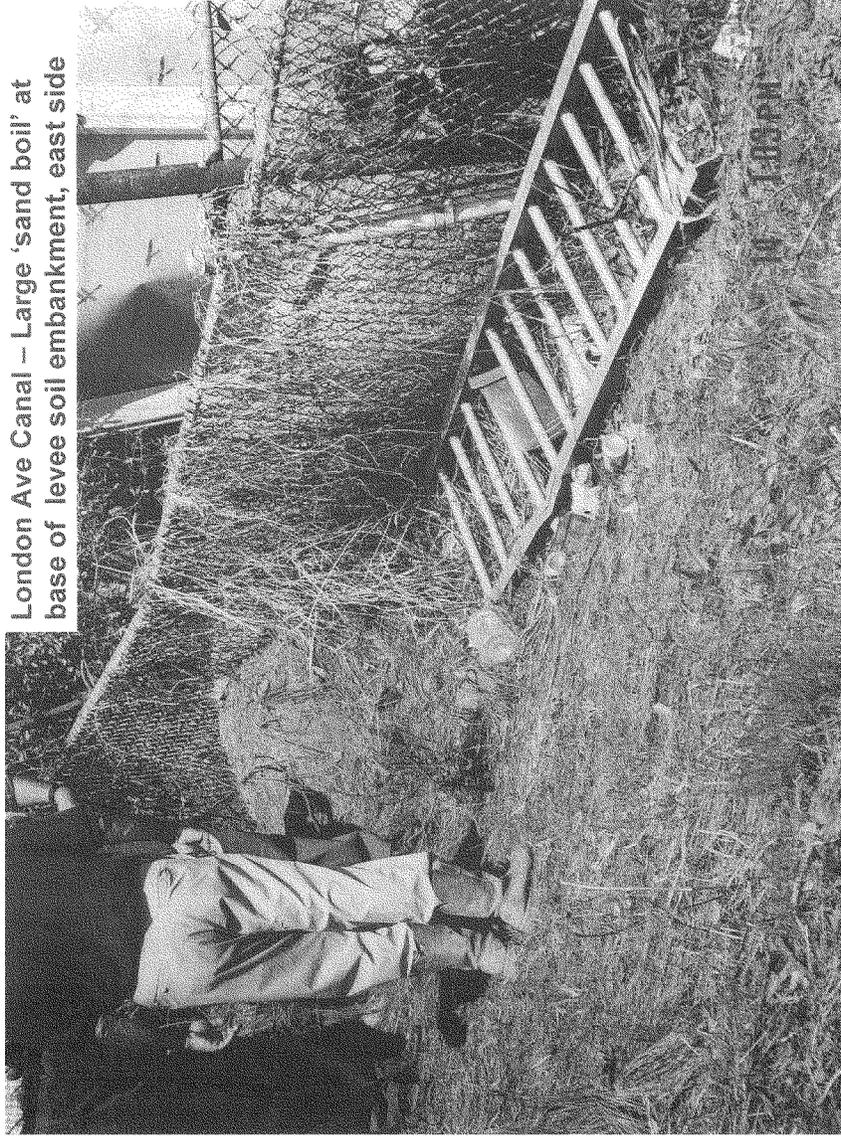
The east bank levee of the London Ave canal at Filmore is bowed, tilted back and cracked in a number of places. There is evidence of sand boils, heaves, and other signs of soil instability. The question could be asked why the walls did not fail at this point? It appears that the sheet piling was sunk to a depth of 26 feet on the east side of the canal at Filmore as against the 11.4 feet where the west breach occurred. This relative difference in sheet piling depth may indicate why the east side at Filmore did not fail, but nevertheless even sheet piling to a depth of 26 feet below sea level was not sufficient.

London Ave Canal bowed wall segments near Filmore Road, east side of canal

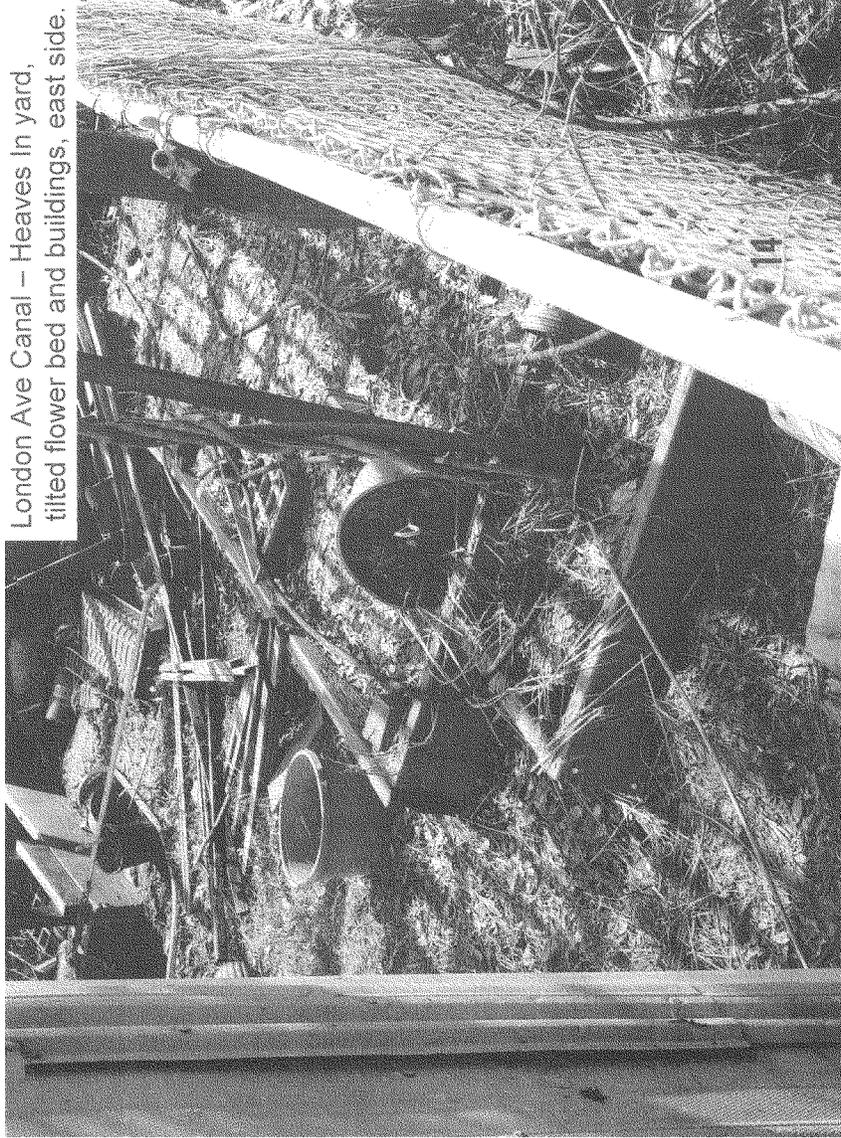
London Ave Canal – Large ‘sand boil’ at base of levee soil embankment, east side

London Ave Canal – Heaves In yard,
tilted flower bed and buildings, east side.

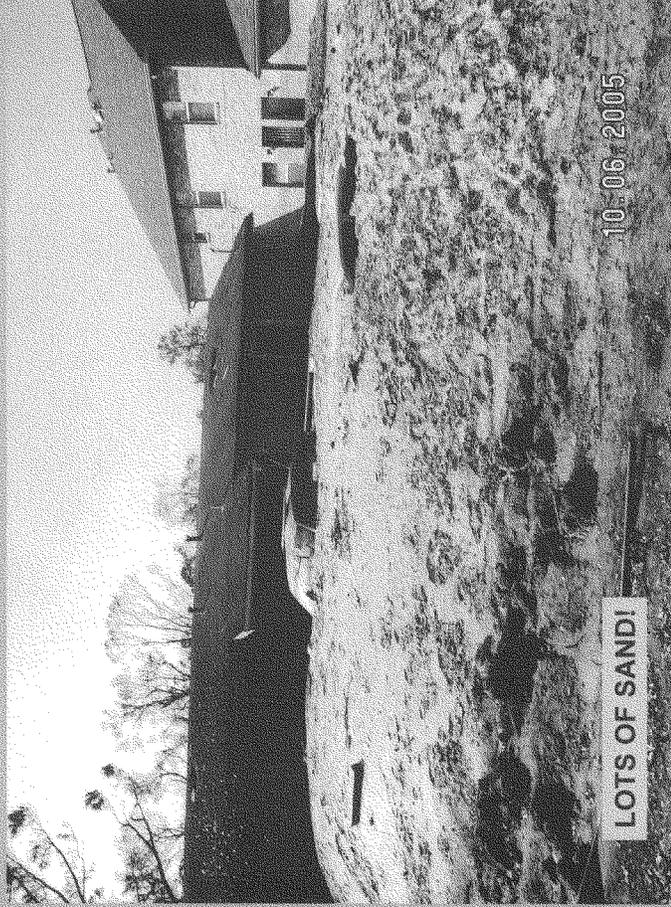
Mirabeau Break on London Ave.

LOTS OF SAND!

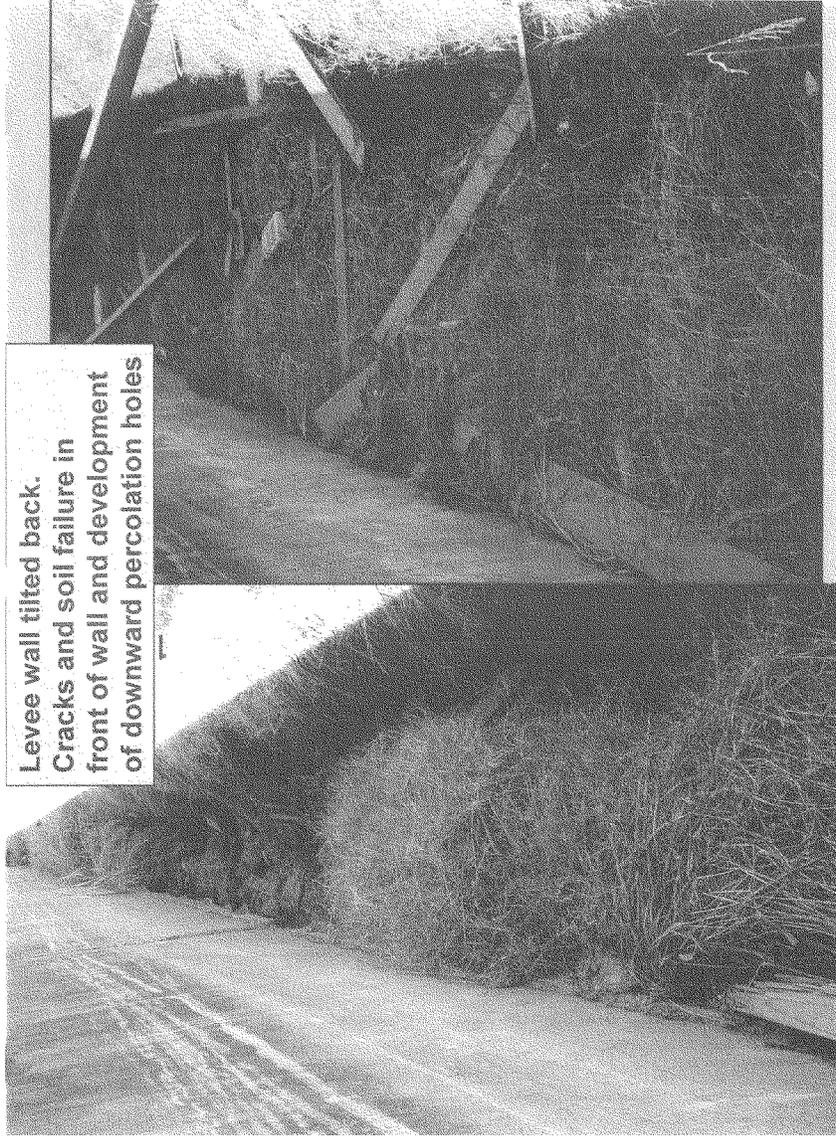
Levee wall tilted back.
Cracks and soil failure in
front of wall and development
of downward percolation holes

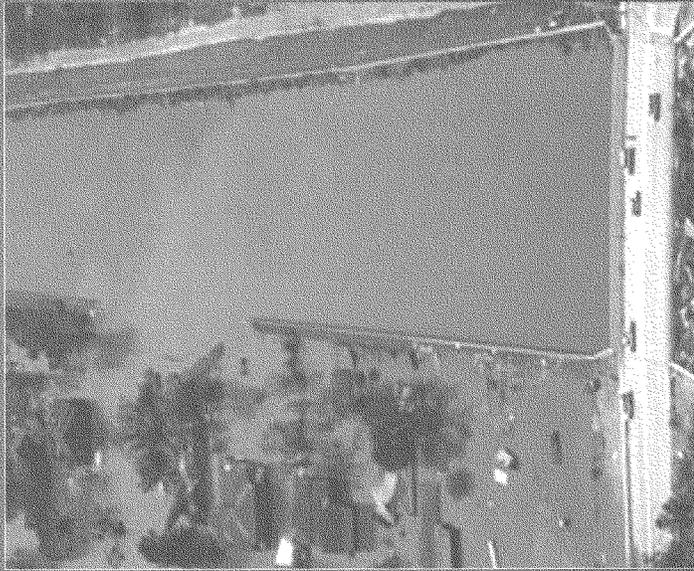
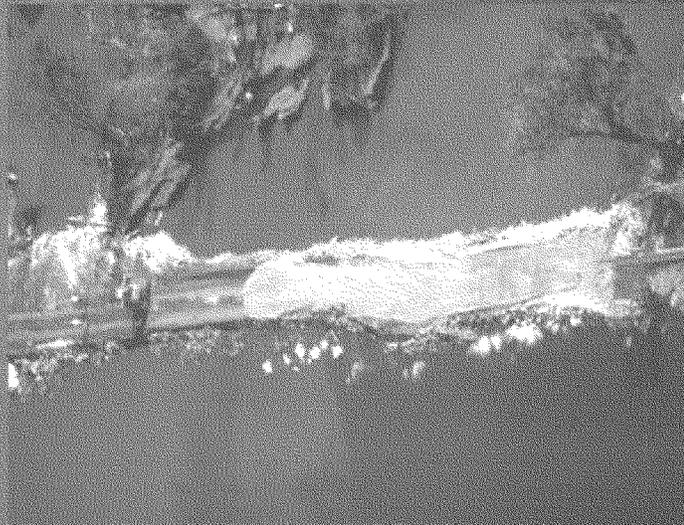
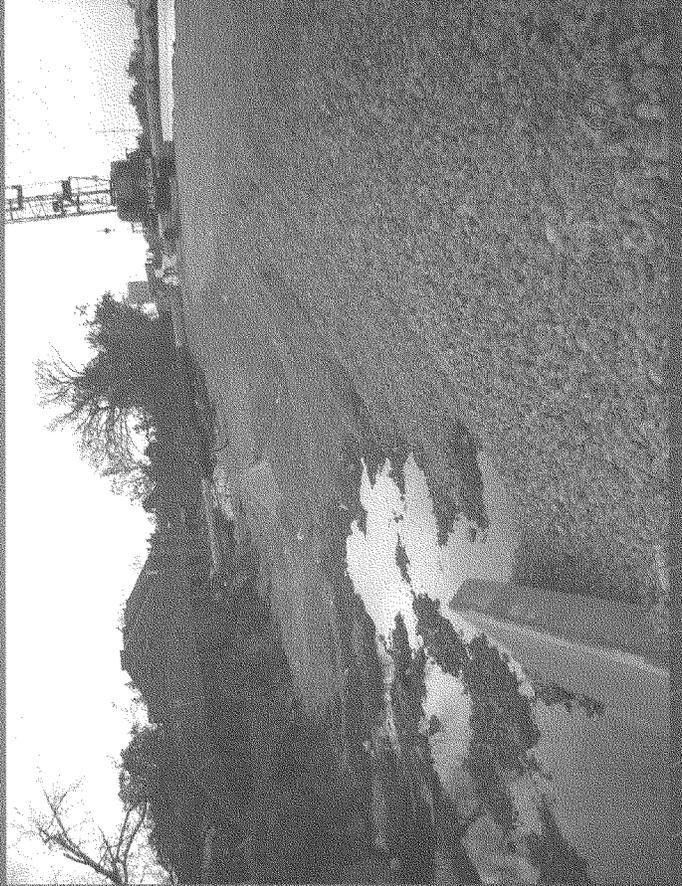
At the 17th Street Canal breach, we observed intact soil blocks that had experienced large translation and heave. This movement would be consistent with a failure either of

the soil embankment or the foundation soils beneath. There was no evidence of overtopping at this site. While we cannot yet determine conclusively the cause of the breach itself, this type of soil failure may well have been a significant contributing factor. Further investigation, together with analyses and review of the design and construction documents, should be of tremendous assistance in ultimately making these kinds of determinations.

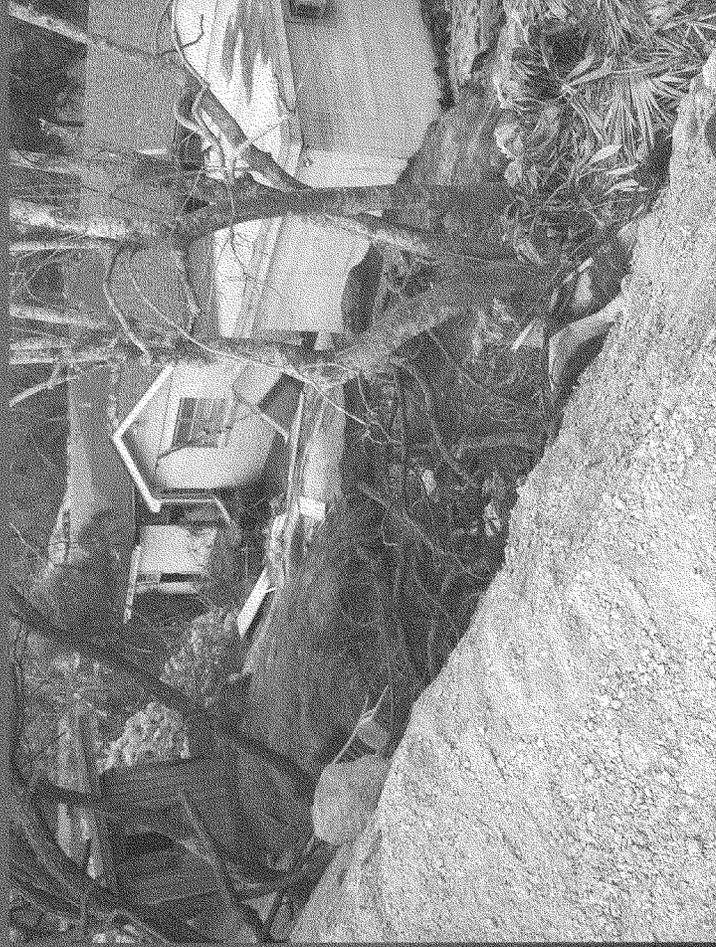
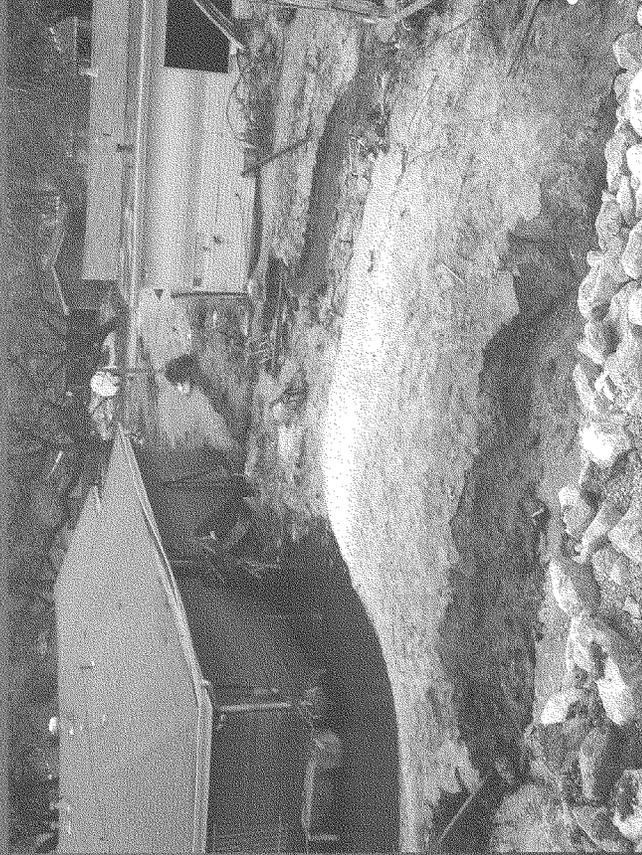
London Avenue Canal, North Breach

At the north breach on the London Avenue Canal, we observed a large displaced soil mass, which had been heaved nearly vertically over six feet, apparently indicating the toe of a rotational-type soil failure. Again, there was no evidence of overtopping at this site. Field inspection also showed a large amount of sandy soil deposited in the neighborhood landward of the breach, which is believed to be material from the foundation beneath the embankment together with material scoured from the canal bottom. This is consistent with the soil profiles provided to us which showed sand in the subsurface near this location. Under high water pressure, the flow through this type of material can be significant, which is known to cause internal stability problems.

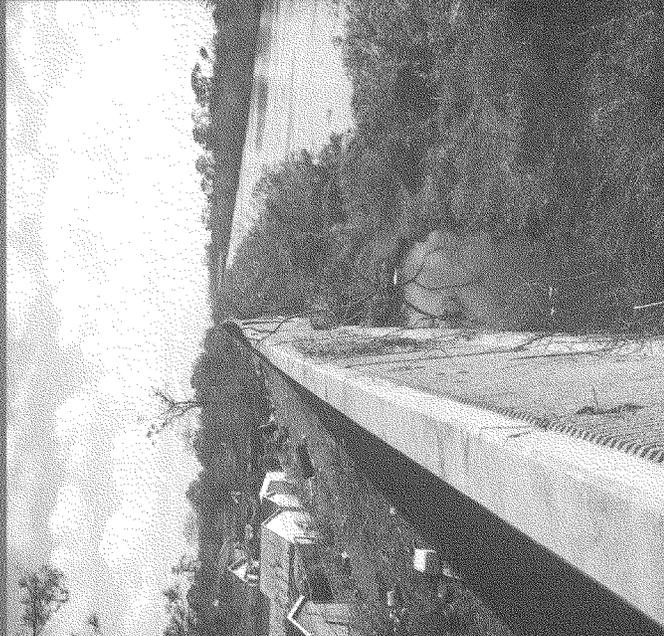
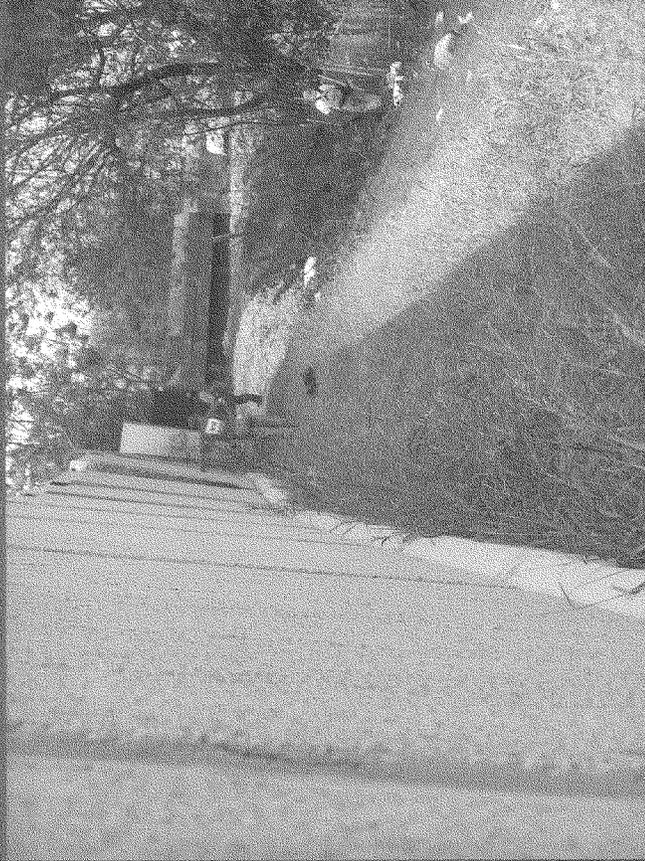
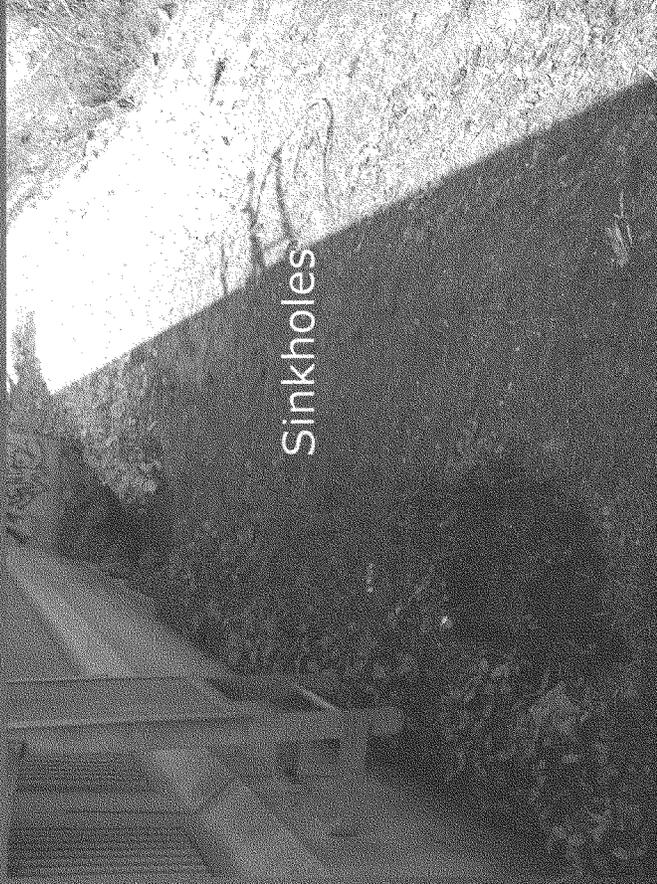
London Avenue Canal, North
Across from Breach

Of particular interest was the levee section almost directly across from the north breach on the London Avenue Canal, where we observed a floodwall and underlying embankment that was in severe distress.

This site provided an excellent case study demonstrating multiple, concurrent failure mechanisms. It was observed that this section of floodwall was distressed to the point that it appeared that it might have been approaching failure when the water loading was relieved as the other breaches occurred. The wall was badly out of alignment and tilting landward; as a result of the tilt, there were gaps between the wall and the supporting soil on the canal or waterside. Also observed were evidence of soil movement, seepage and piping, as indicated by a series of sinkholes near the crest, together with "boils"³ and heave at or near the inboard toe⁴ of the embankment.

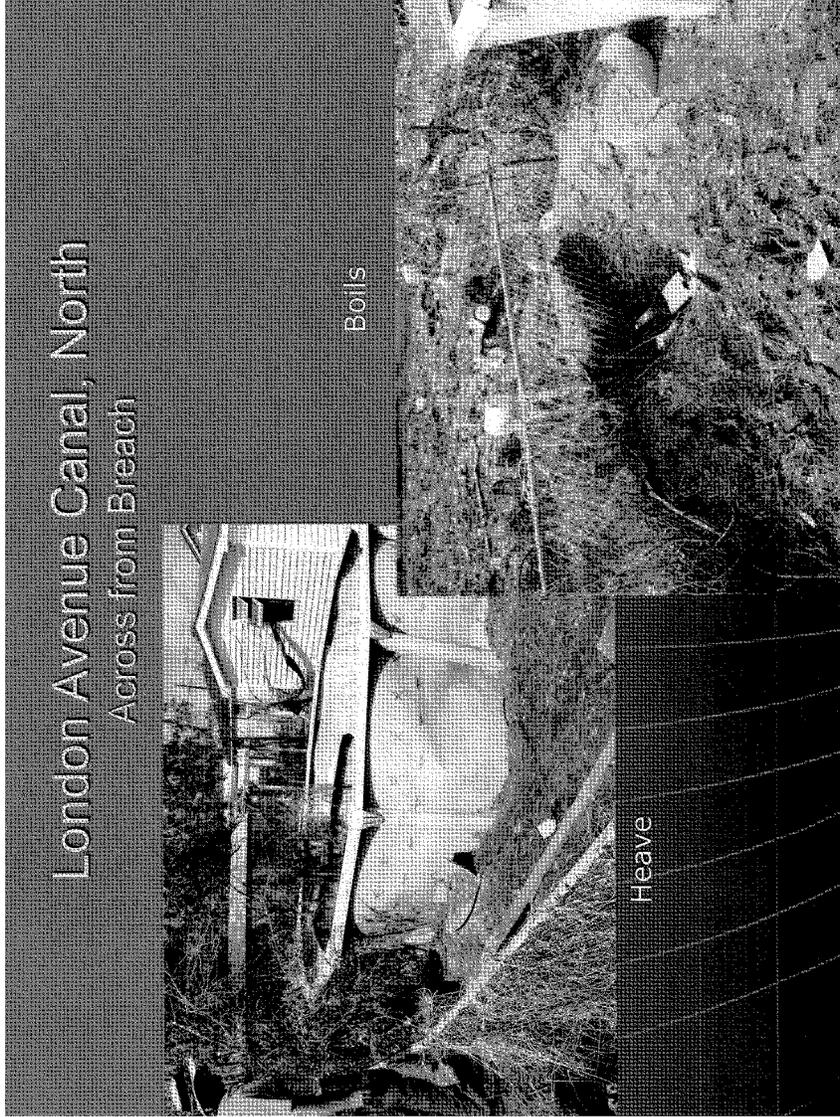
Sinkholes

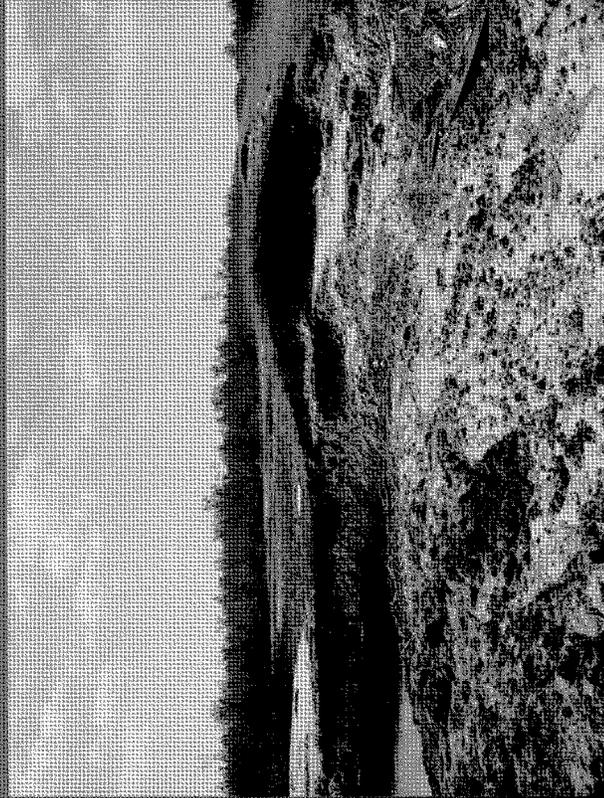
Overtopped Embankment (Sand Core)

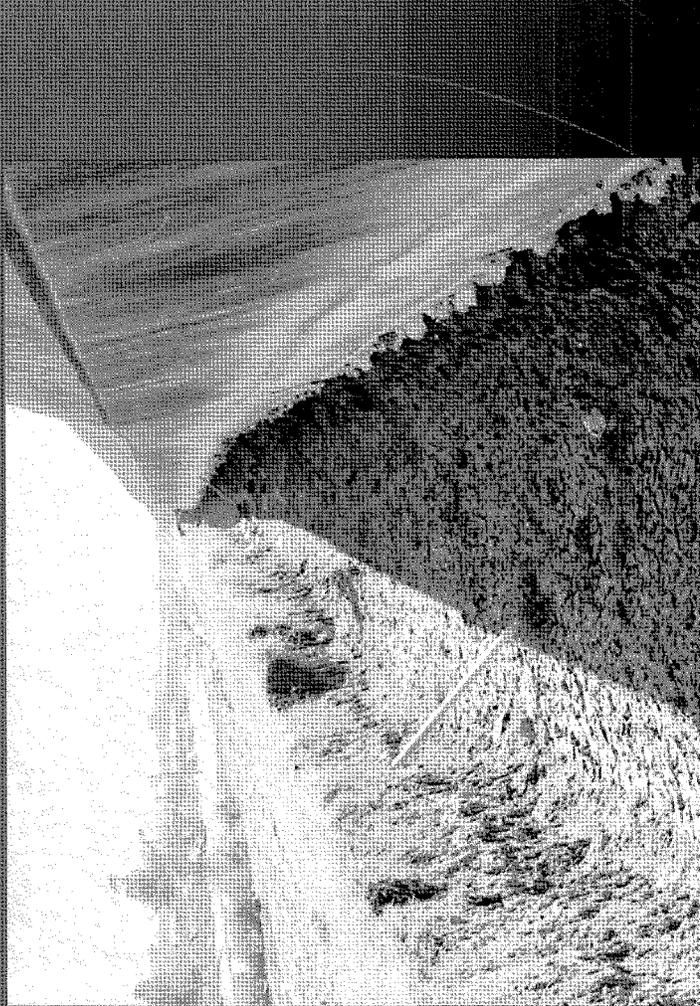
Inner Harbor Navigation Channel
Back Scour at Lower 9th Ward

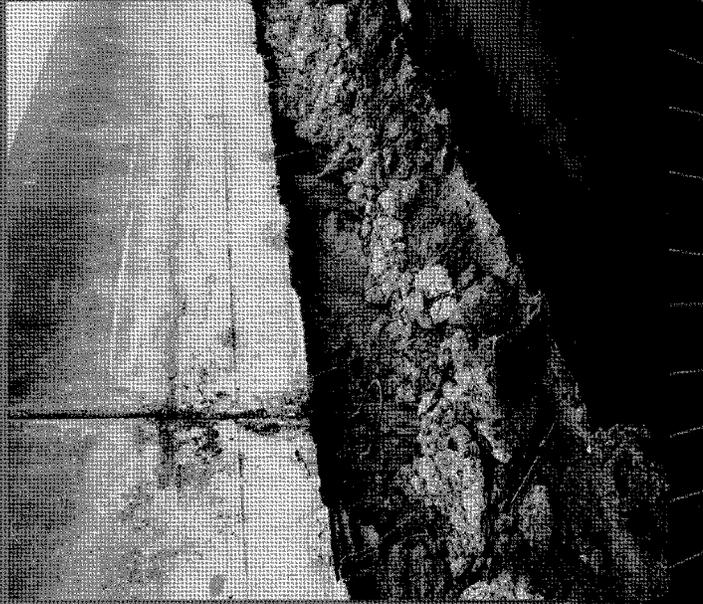
MRGO, North Bank (New Orleans East):
Overtopping Back Scour

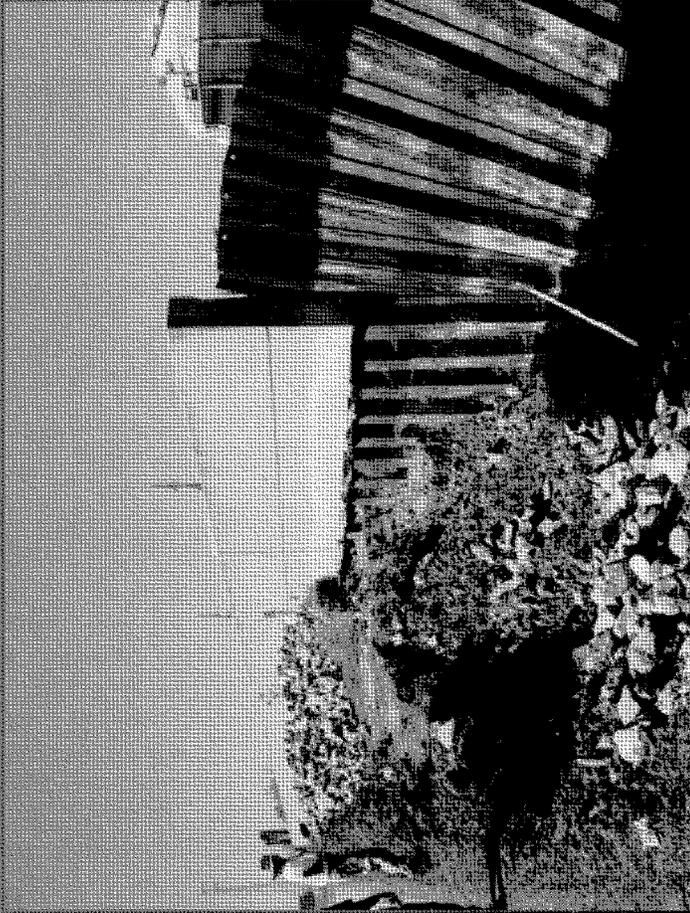
Common Transition Failures

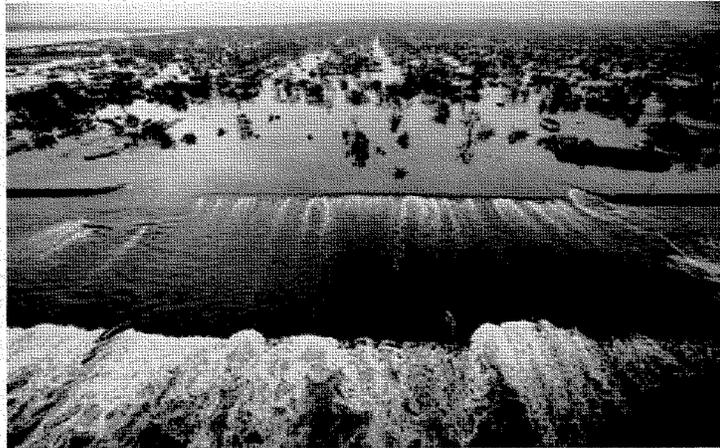
Figure 1.7: Flooding at the west end of the Ninth Ward, and outflow through levee breach as initial storm surge subsides.

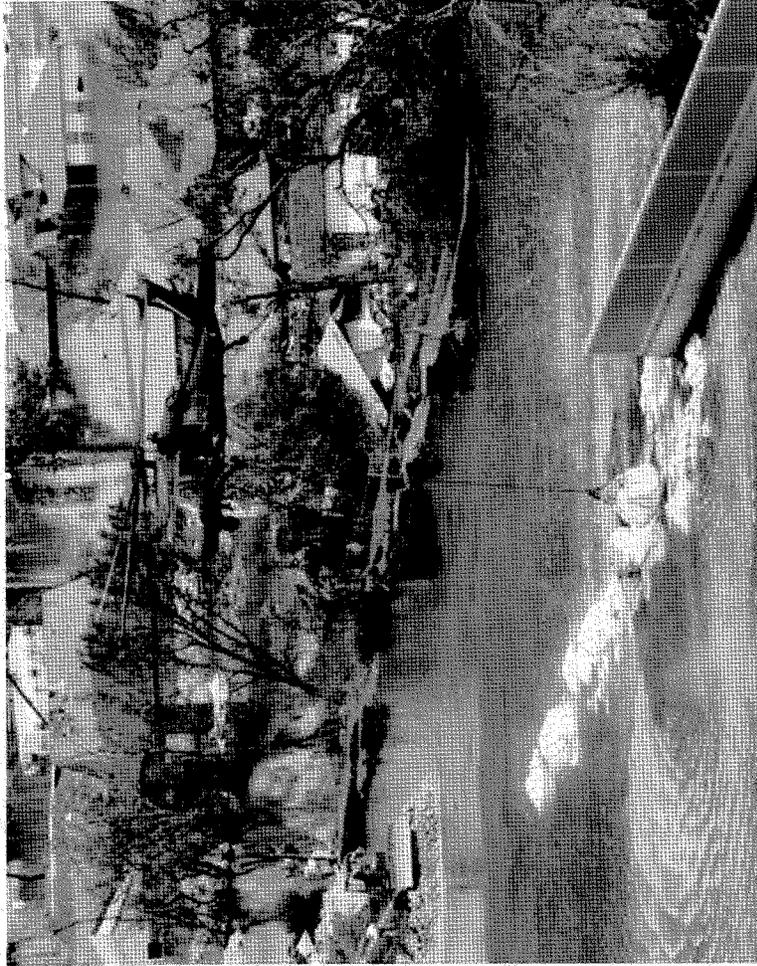
Figure 2.3(a) shows the major breach at the east side of the 17th Street Canal as it is being “plugged” with large sandbags being delivered by military helicopters in the wake of Hurricane Katrina. This photo is taken looking to the northeast. Figure 2.3(b) shows the same figure, but this time highlighting key features for discussion. The line of grassy soil units in the center of the photo are the inboard half of the southern end of the original levee embankment, and the chain link fence is remnants of the fence that passed along the inboard lip of the crest road, separating the crest from adjacent homeowner’s back yards. The southern end of the embankment has translated to the east, traveling laterally up to about 45 feet away from its original position. The northern end of the breached embankment section was largely eroded by scour after the breach opened.

Figure 2.3(a): The 17th Street Canal breach during initial breach closure.

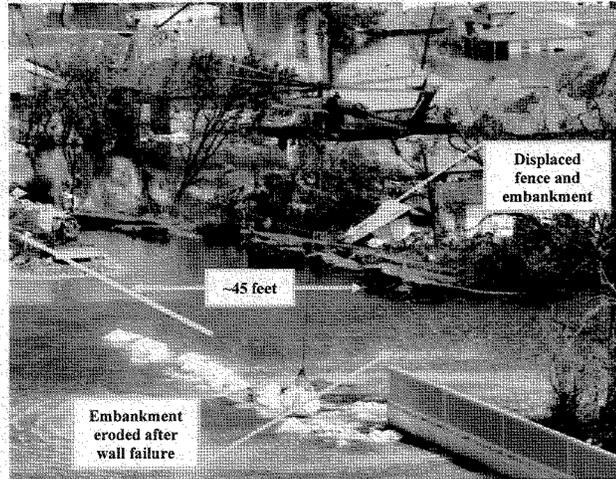
Figure 2.3(b): The 17th Street breach, highlighting key points for discussion

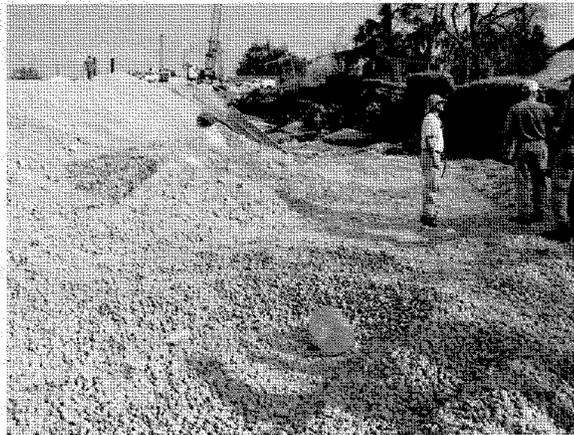
Figure 2.4 shows a second view of some of the details at this site. The relatively intact southern embankment sections translated laterally approximately 45 feet, and without significant rotation, as the trees and chain link fence remained vertical throughout this displacement. The laterally translating wedge of embankment (and possibly also some foundation) soil “plowed” into soft soils at the inboard toe, causing them to bulge upwards, heaving the largely collapsed shed and pushing it into the house.

Figure 2.4: View of the 17th Street breach section from the south.

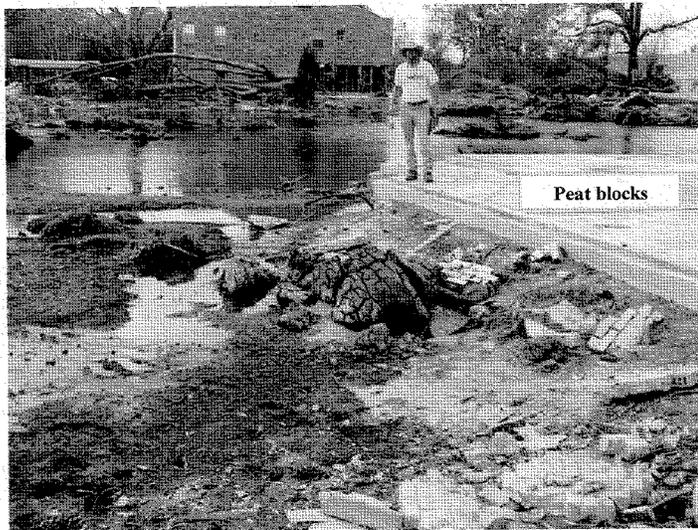
Figure 2.5 shows a view looking east across the zone through which the principal floodwaters flowed. Clearly evident in this photo are large blocks of peat scoured from the eroding foundation by the floodwaters.

Figure 2.5: View from crest of emergency embankment closure section at the 17th Street Canal breach, looking south across the floodwater scoured zone.

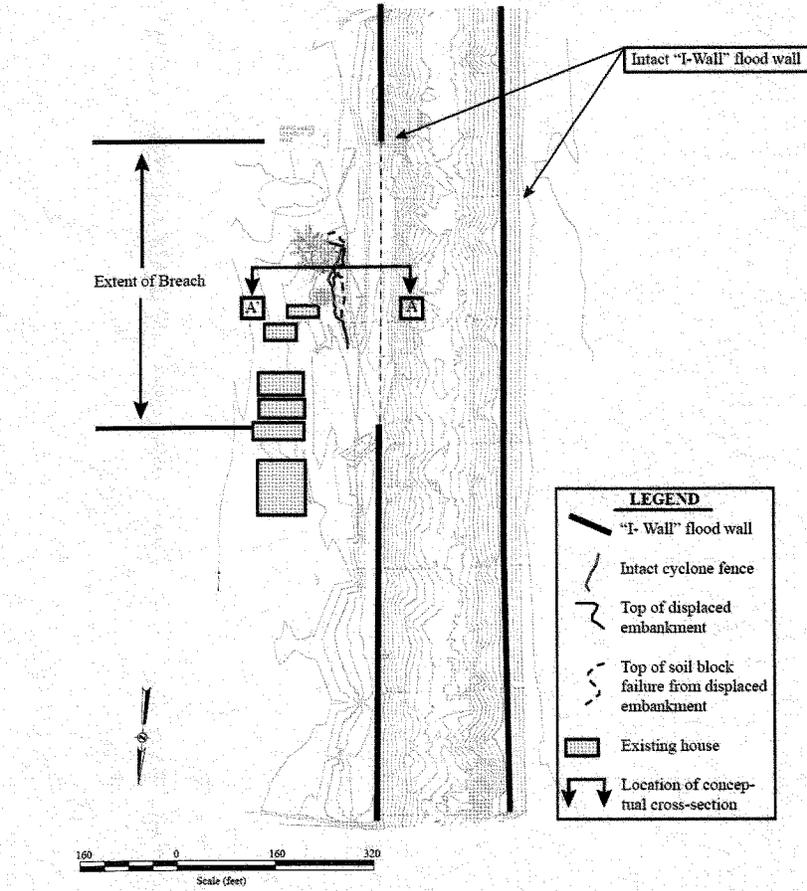
Figure 2.6 shows an approximate plan view of this site, highlighting key locations and objects of interest. The overall breach was 465 feet in width at the end of the flooding and scour, and the intact embankments and floodwalls immediately to the north and south of the breached section were largely undamaged.

Figure 2.6: Schematic plan view of the 17th Street Canal breach site. Results of LIDAR scan superimposed on base survey.

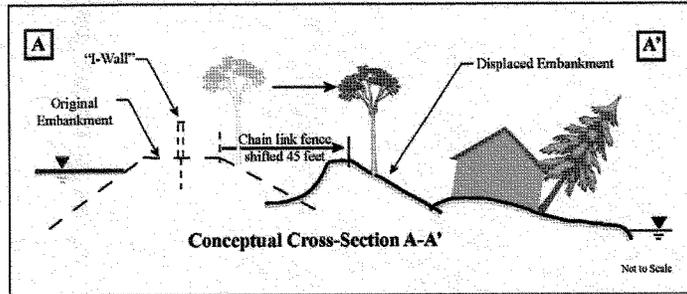
Figure 2.7 shows a simplified schematic cross-section through the site, roughly along Section A-A' in Figure 2.6. This shows the lateral translation of the inboard portion of the embankment, and the compression and heaving produced at the inboard toe by these movements.

The mechanism of failure at this site appears to have been a stability failure of the foundation soils beneath the earthen embankment. The embankment was pushed sideways, by about 45 feet, by storm surge induced water pressures acting against the front face of the sheetpile/l-wall vertical barrier. The actual depth at which foundation soil shear failure occurred is not yet known, and this remains to be investigated. Also still to be determined is the actual soil unit or strata that provided the weak sliding plane, and the precise mechanism of weakness that was most critical.

Figure 2.7: Schematic cross section at the 17th Street breach section.

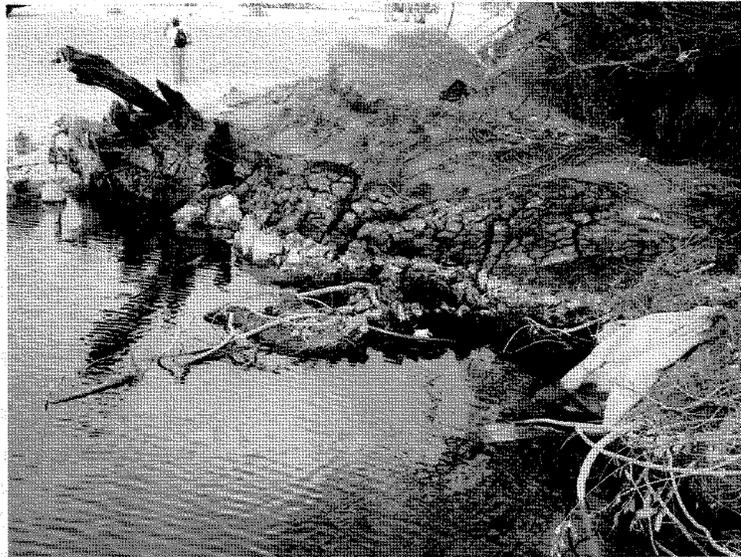
Foundation soils at this site were known to consist of a layer of organic, peaty material. The peats were interbedded with occasional thin, soft clayey layers, probably periodic overbank flood deposits, and one such clay layer within the peat unit was exposed at the southern end of the breach opening, as shown in Figures 2.8 and 2.9. A torvane performed in the field during our visit indicated an undrained shear strength of approximately 200 lb/ft² for this weak material, which varied in thickness from about 1 to 4 inches over several feet laterally at this location.

Figure 2.8: Location at which clay seam interbedded within the peat at the toe of the translated levee embankment was sampled.

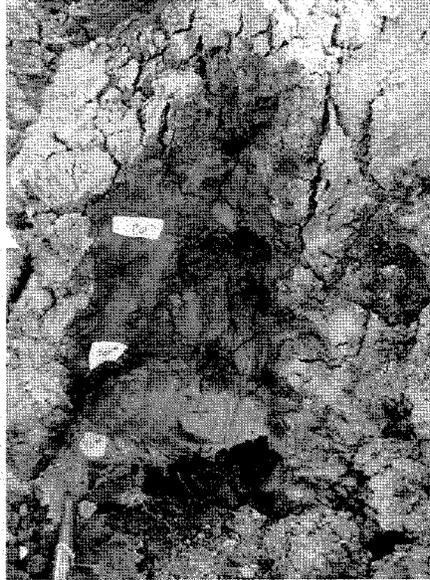
Figure 2.9: Clay seam (light gray layer) underlain by darker lean clay, and overlain by fibrous peat.

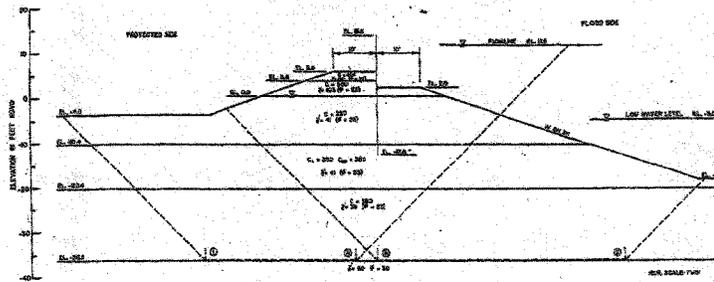
Figure 2.10 shows the approximate configuration of the levee, and its sheetpile curtain and concrete floodwall. As shown in Figure 2.10, the sheetpiles do not penetrate very deeply into the poor foundation soils, and they do not provide a full cut-off for underseepage through the pervious foundation soils.

Figure 2.10: Design cross-section at the 17th Street breach.

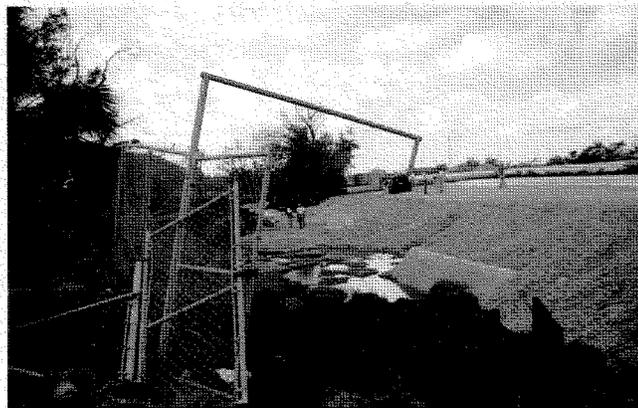
At the time of our field teams' initial visit (October 3, 2005) an embankment fill had been placed over the core of large sandbags and large stone used to effect the initial closure. Additional gravelly fill had been placed at the inboard toe to provide a working mat. The conditions at this time are shown in Figure 2.12. The fill used as a covering veneer was a gap graded sandy gravel known locally to be internally unstable with regard to erosion, and our site team noted four sinkholes at the outboard lip of the crest of the temporary levee section, as shown in Figure 2.13. Three of these could be observed to be curving inward toward the center of the embankment section, and running water could be clearly heard in one of these.

Figure 2.12: Temporary closure section embankment on October 3rd, 2005.

The USACE was notified of the apparently unstable condition, with evidence of ongoing internal erosion of the fill, and the section was covered the next day, initially with a three foot thick layer of open graded stone (6-inch to 24-inch stone), which was then covered at the crest by a five to seven foot (uncompacted) lift of better graded silty sand, as shown in Figure 2.14. Both the open-graded stone, and the covering veneer silty sand fill can be clearly seen in this photo. The silty sand was also pushed down the inboard and outboard faces of the embankment providing a covering veneer of several feet on both sides of the emergency embankment section. The USACE was again notified that this did not appear to represent a hydraulically stable (or well filtered) embankment configuration; and the rapid placement of additional competent fill as an inboard berm, to be quickly followed by installation of a sheetpile cut-off wall, was recommended.

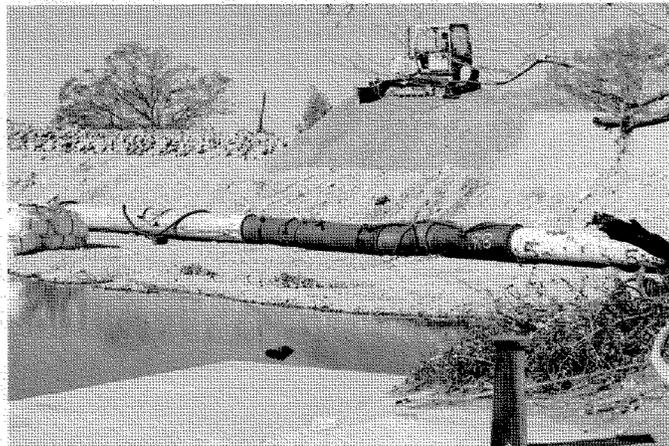
Figure 2.14: Placement of silty sand fill at the crest and on both the inboard and outboard faces of the temporary embankment closure section on October 6, 2005.

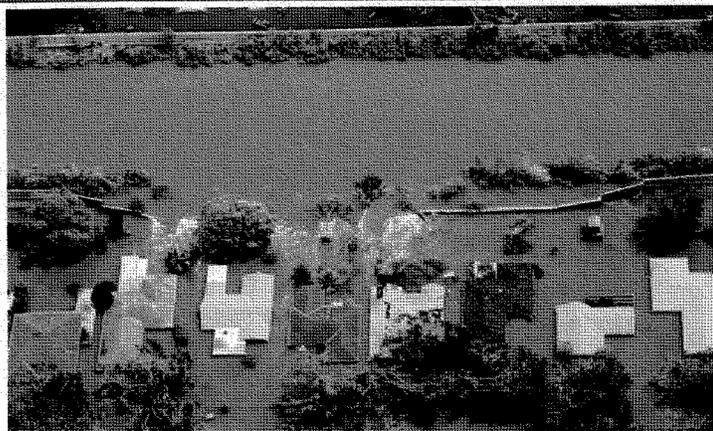
Figure 2.15: The breach section at the west side of the London Avenue Canal (North).

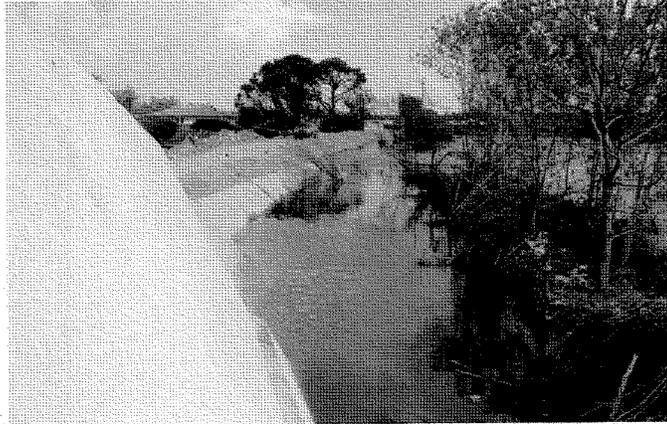
Evidence at this site strongly suggests that the breach occurred as a result of the sheetpile/floodwall being pushed backwards by the elevated water pressures on the outboard side, and that support on the inboard side of the sheetpile/floodwall was reduced as a result of soil failure at or beneath the base of the earthen levee embankment. The severe distress of the similar levee and floodwall directly across the canal (on the east bank), and its similar foundation conditions, provide additional evidence here.

Figure 2.17: The toppled floodwall/sheetpile walls at the London Avenue Canal (North) breach site.

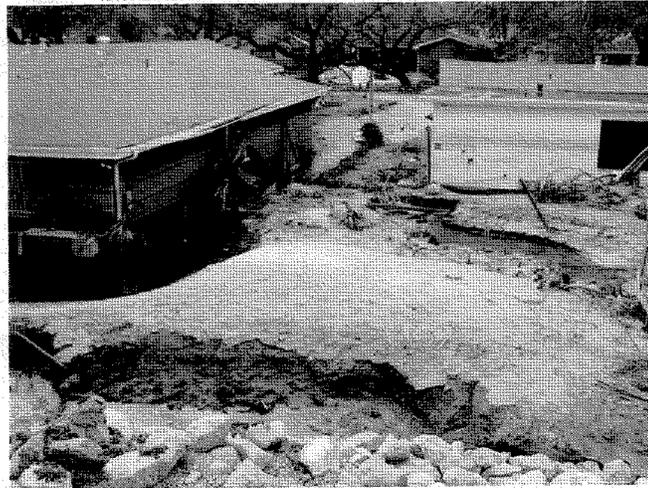
Significant deposits of sediment occurred inboard of this breach, and these appeared to represent a mix of soils scoured out from the breached embankment section and its foundation soils, as well as sediments from the canal outboard of the failed section (see Figure 2.18.)

Figure 2.18: Sediment from the London Avenue Canal was deposited inboard of the levee break. High water marks (from long-term ponding) are visible on the exteriors of the residential homes.

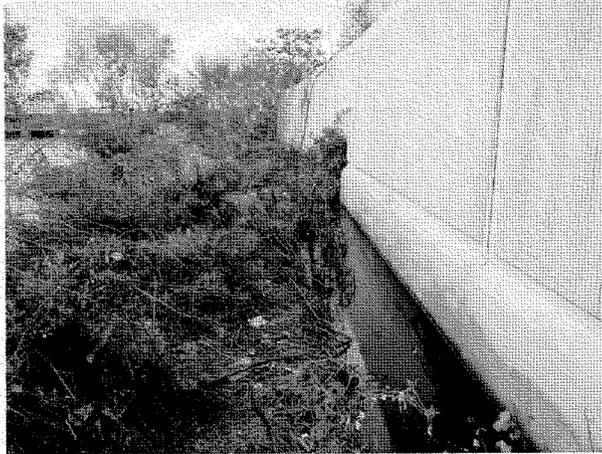
Figure 2.19 shows the floodwall of the “distressed” section directly across the canal, on the east bank. This photo shows the outboard side of the floodwall, which has been pushed laterally, opening an extensional crack as wide as approximately 18 to 28 inches at its original outboard side base contact with soil at the levee embankment crest.

Figure 2.19: Gap at the base of the floodwall on the canal side of the East Bank "distressed" section.

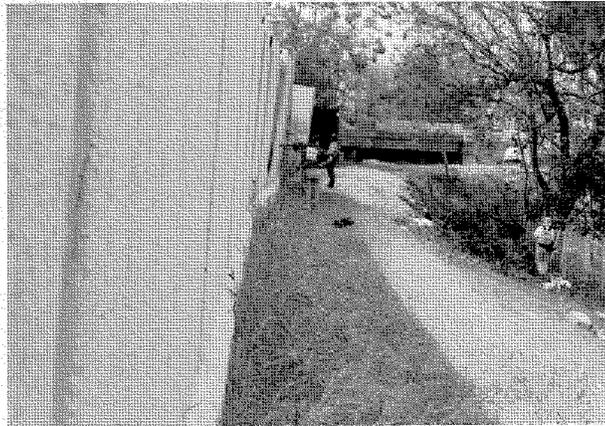
Figure 2.20 shows conditions on the inboard side of the east bank distressed section, directly on the other side of the wall shown in Figure 2.19. The wall has been pushed towards the inboard side, and now leans inwards (to the right) by about 5° off vertical in this photo. Figure 2.21 shows a closeup view of part of a line of sinkholes noted at the inboard toe of the wall, along the section shown in Figure 2.20. These appear to have been related to underseepage and resulting erosion and piping. Figure 2.23 shows the “boil” outlet of one erosional “pipe” at the inboard toe of the embankment at this location.

Figure 2.20: View of the inboard side of the floodwall and earthen levee embankment.

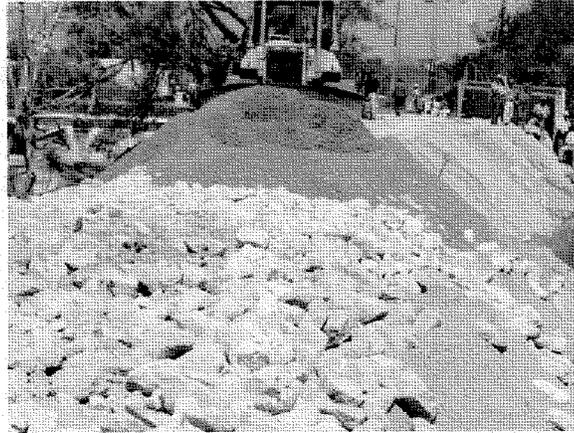
Figure 2.23: Photo during construction of the emergency breach repair embankment at the London Avenue Canal (North) breach site.

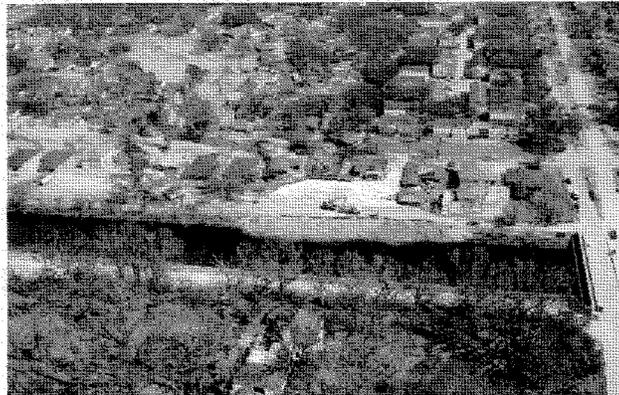
Figure 2.24: Aerial view of the breach section at London Avenue Canal (South).
