**HURRICANE KATRINA:
WHY DID THE LEVEES FAIL?**

COMMITTEE ON
HOMELAND SECURITY AND
GOVERNMENTAL AFFAIRS
UNITED STATES SENATE

NOVEMBER 2, 2005

Chapters 2 through 5 of this report present a summary of observations and preliminary findings to date associated with protective levee system performance in the (2) Orleans East Bank, (3) Ninth Ward/St. Bernard Parish, (4) New Orleans East, and (5) Plaquemines Parish protected areas, respectively. Chapter 6 briefly addresses observations regarding pumping and dewatering systems, and other aspects of the overall regional flood protection system. Chapter 7 describes LIDAR imagery data sets taken to capture three-dimensional representations of detailed ground surface conditions and configurations at a number of key sites. Finally, Chapter 8 summarizes a number of preliminary overall observations and recommendations.

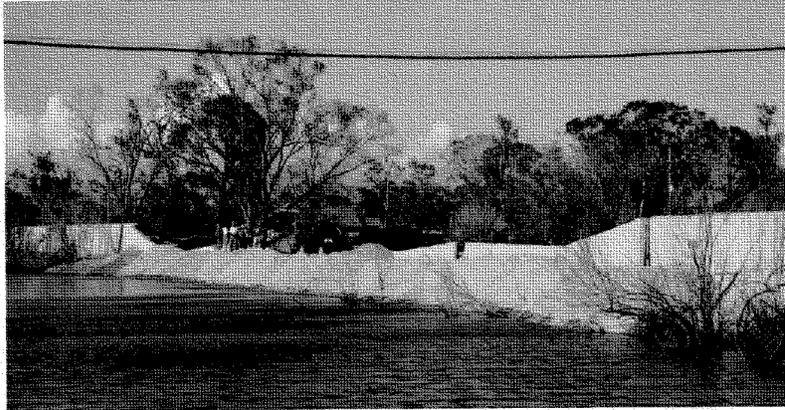
Figure 2.25: View of the crest of the temporary embankment closure section at the London Avenue Canal (South) breach.

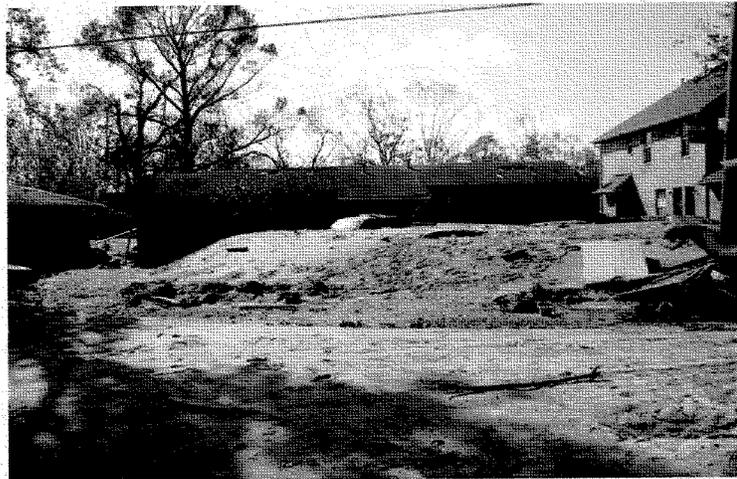
Figure 2.26: Significant quantities of sediment were deposited in the residential neighborhoods on the east side of the London Avenue Canal. More than five feet of sediment was deposited around this home.

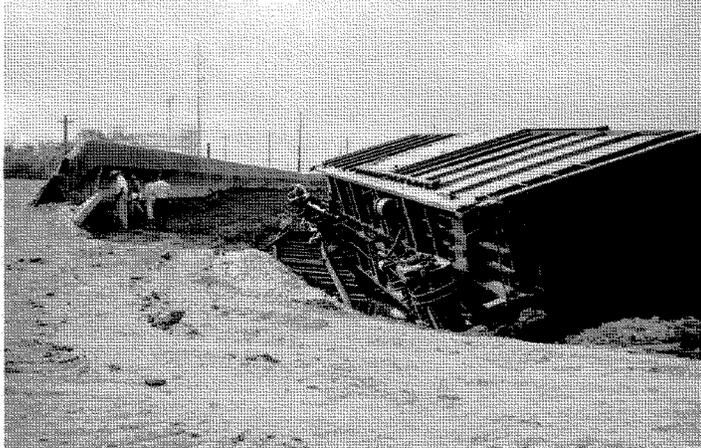
Figure 2.27: Breached levee floodwall section at Location "A" along the west side of the INHC.

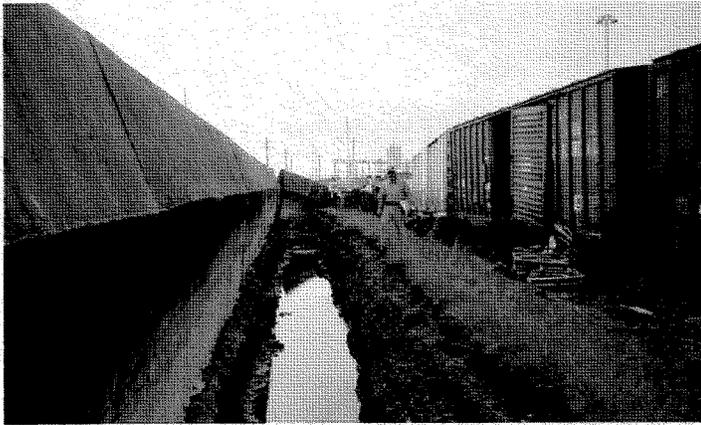
Figure 2.28: Erosion at the inboard toe of concrete floodwalls at Location "A" along the west side of the INHC, adjacent to the breached section shown previously in Figure 2.27.

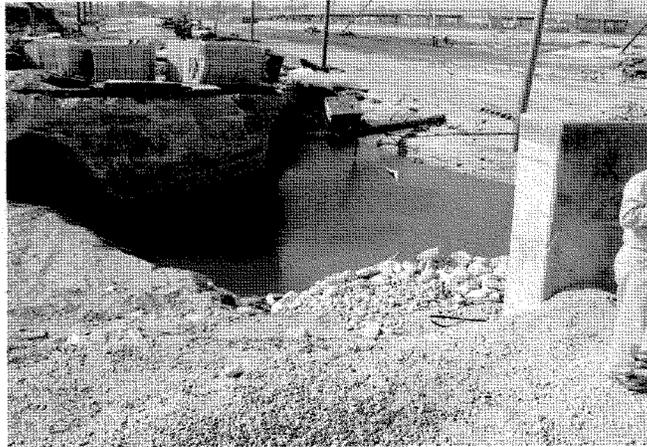
Figure 2.29: Erosion at a “transition” between a concrete floodgate wall and the adjacent earthen embankment section.

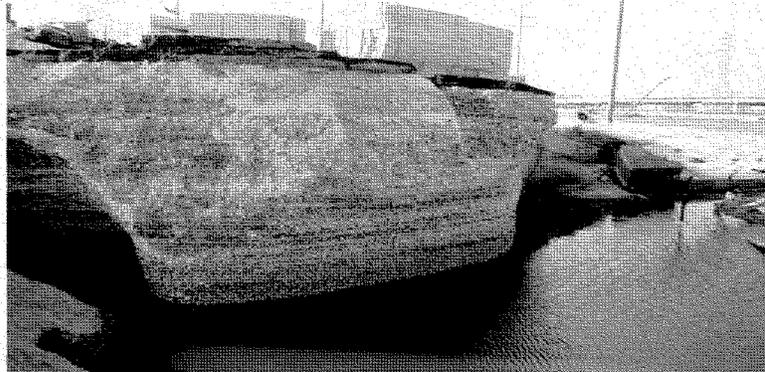
Figure 2.30: View of the structural wall and floodgate structure from Figure 2.29.

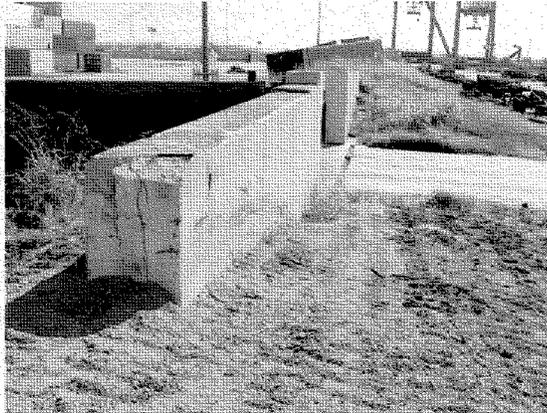
Figure 2.31: Close-up view of sandy "shell" fill at the scoured edge of the breach shown previously in Figure 2.29.

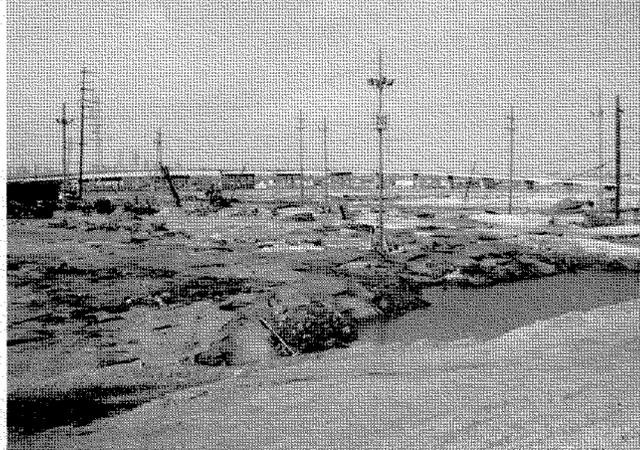
Figure 2.32 shows an additional example of this type of “transition” deficiency between a structural (concrete) wall and adjacent earthen levees, just a bit farther to the east at Location “C” in Figure 2.1(a).

Figure 2.32: Common structural wall (with flood gate) and earthen levee transition problem with erosion at the contact between the earth and concrete sections.

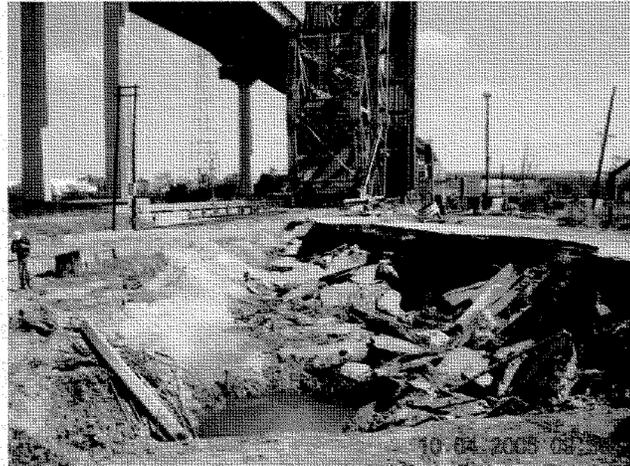
Figure 2.33: Scour hole and deposits of sediment and shells, inboard of the breach shown previously in Figure 2.32.

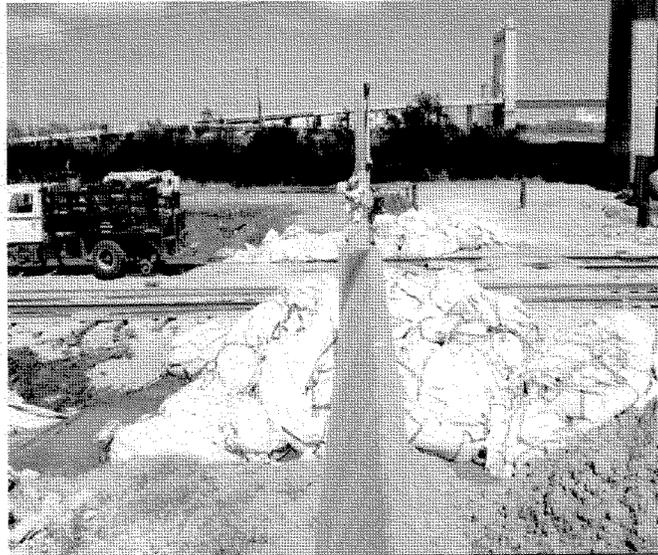
Figure 2.34: A complex “transition” involving several overlapping operations and penetrations through the flood protection levees immediately south of the I-10 bridge across the IHNC.

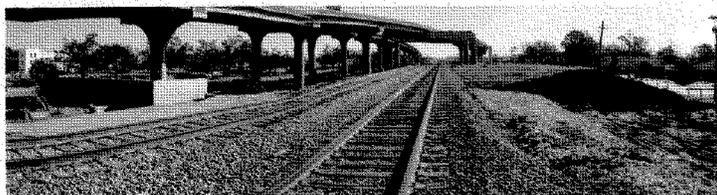
The Lakefront Airport is located at the northwest corner of the New Orleans East polder on Lake Pontchartrain near the entrance to the IHNC. Evidence of surge/wave overtopping was observed here along with a breach at a complex transition that combined levee sections of varying floodwall/levee heights and materials. Figure 3.2 shows a panorama

of this distressed transitional area. The problems observed here were: 1) a concrete floodwall higher than adjacent roadway over an earthen material adjacent to; 2) railroad tracks laid over highly pervious ballast, with tracks at approximately the same elevation as the top of the floodwall, adjacent to; 3) an earthen embankment levee. The breach that occurred at this location was, in fact, two breaches. One was a scour of the roadway section next to the higher concrete wall, while the other occurred through the embankment levee immediately south of the railroad embankment. It is difficult to assess the role the pervious ballast beneath the tracks played, if any, to the problems observed at this site.

Figure 3.2: Complex transition near Lakefront Airport consisting of various flood protection heights, differing materials and junctures between various jurisdictional organizations. These types of complex transitions were found to be associated with several of the levee flood protection problems.

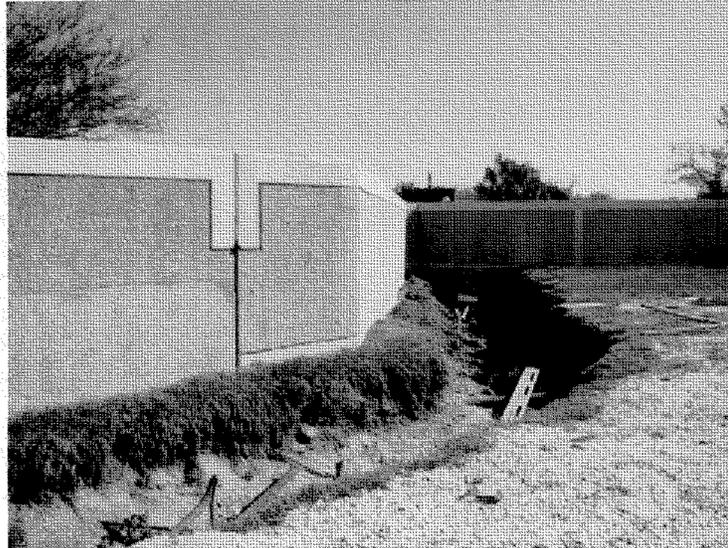
Figure 3.3: I-wall adjacent to the Lakefront Airport showing deep back-scour but no evidence of distress to the wall.

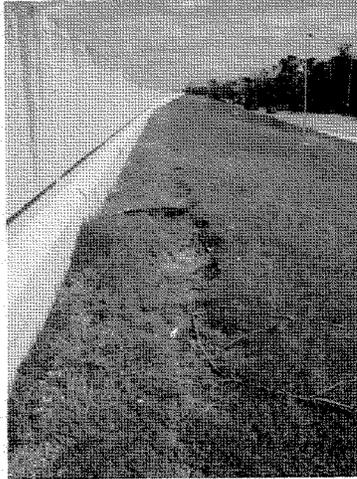
Figure 3.4: Beginning of overtopping scour along lakefront flood wall suggests moderate overtopping at this location.

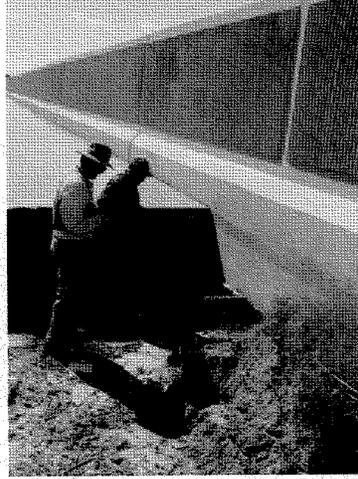
Figure 3.5: Concentrated scour due to presence of concrete apron. Area in the background is a good example of the benefits of armoring the base of the flood walls.

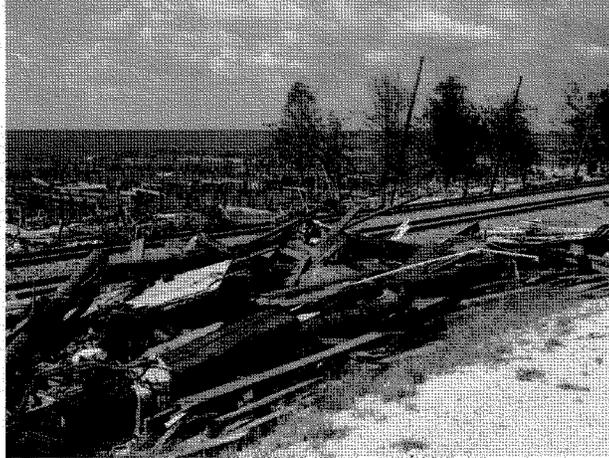
Further to the east, beyond Paris Road, the lakefront community of Little Woods located lakeside of the levee was almost completely demolished by the wind and storm waters (Figure 3.7). Figure 3.8 shows debris from the demolished structures left very near the levee crest, indicating a high water level consistent with other water lines we observed in the lakefront area. Debris from the houses was also strewn on the landside of the levee in a pattern that suggested wind transport. Figure 3.9 shows the only surviving structure at Little Woods, which was noticeably elevated on piles. It appears intact except for the absence of stairs to reach the elevated balcony, suggesting that the building industry can construct structures that resist storm forces like the ones experienced during Hurricane Katrina at Little Woods.

Figure 3.7: The lakefront community of Little Woods destroyed by wind and water (N 30° 04' 70.5", W 89° 56' 44.0")

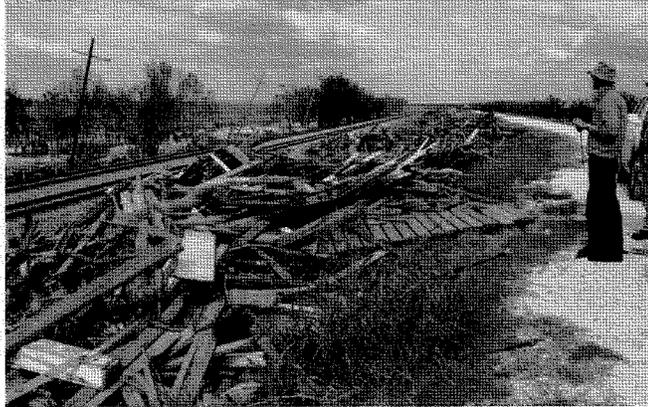
Figure 3.8: Debris from the Little Woods houses accumulated near the crest of the earth levee indicates the level of the lake waters during the storm. (N 30° 04' 70.5", W 89° 56' 44.0")

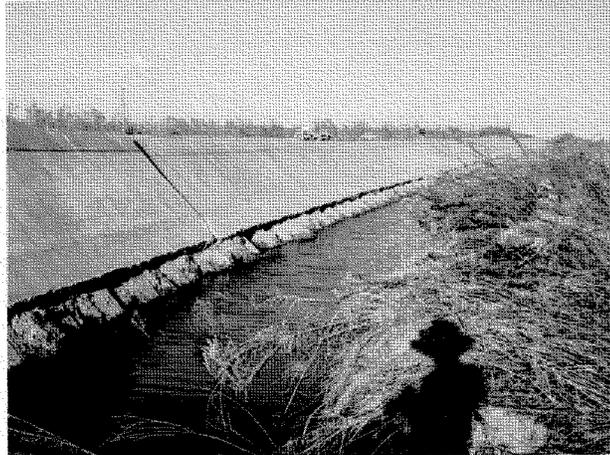
Figure 3.10: Undamaged T-wall in foreground and damaged I-wall in background along the IWW/MRGO. Severe scour on the landside and distress of the I-wall (N30.00030 W89.99459).

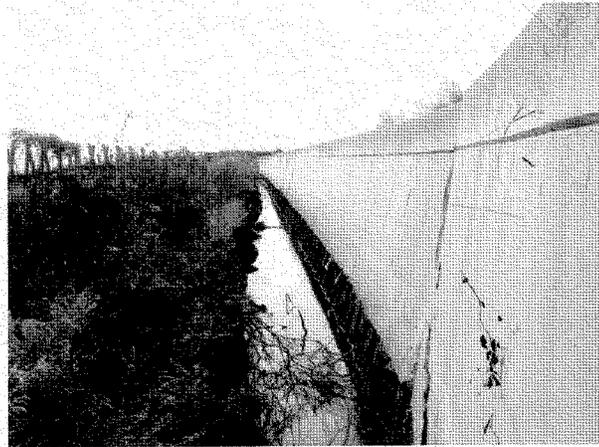
Figure 3.11: Severely distressed I-wall after overtopping from the water side along the IWW/MRGO.

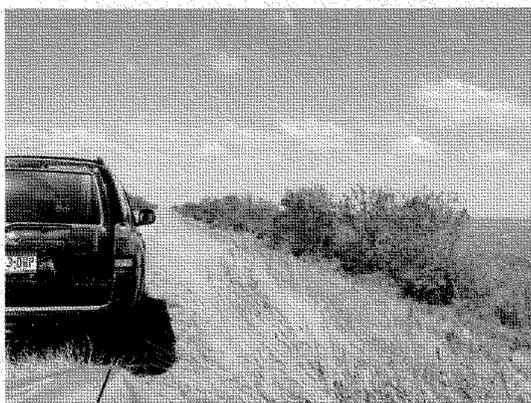
Figure 3.15: Embankment along the IWW/MRGO that survived although somewhat scoured.

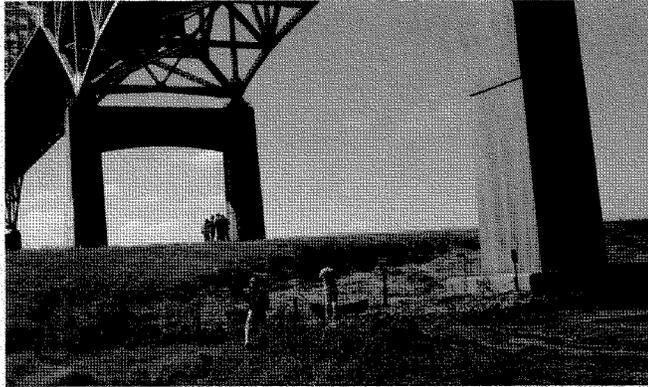
Figure 3.16: Virtually unscathed earth embankment levee on the eastern edge of the protected area of New Orleans East

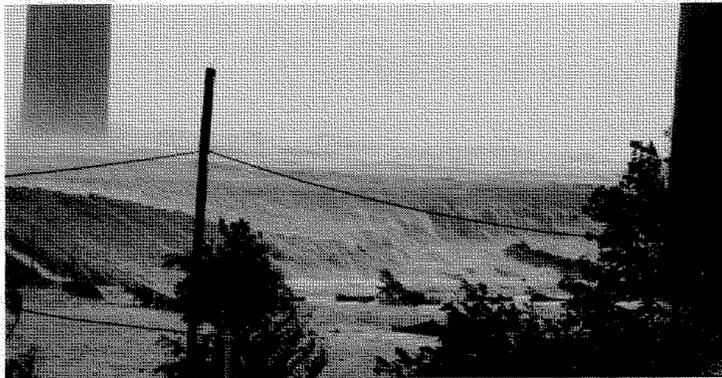
The earth levee along the north bank of the Intracoastal Waterway under the Route 47 Bridge stands as an example of satisfactory performance despite hydraulic conditions that far exceeded the design criteria. Figure 3.17 shows the erosion damage on the landside slope of the levee due to the overtopping. Figure 3.18, taken from the Entergy Michoud Generating Plant, shows the area in Figure 3.17 under storm conditions. Given the ferocity of the storm as evidenced in Figure 3.18, the relatively modest damage to the earth levee represents satisfactory performance.

Figure 3.17: Earth levee beneath the north abutment of the Route 47 Bridge over the IWW/MRGO, next to the Entergy Michoud Generating Plant, looking south. Despite considerable damage, the levee performed satisfactorily during and after overtopping.

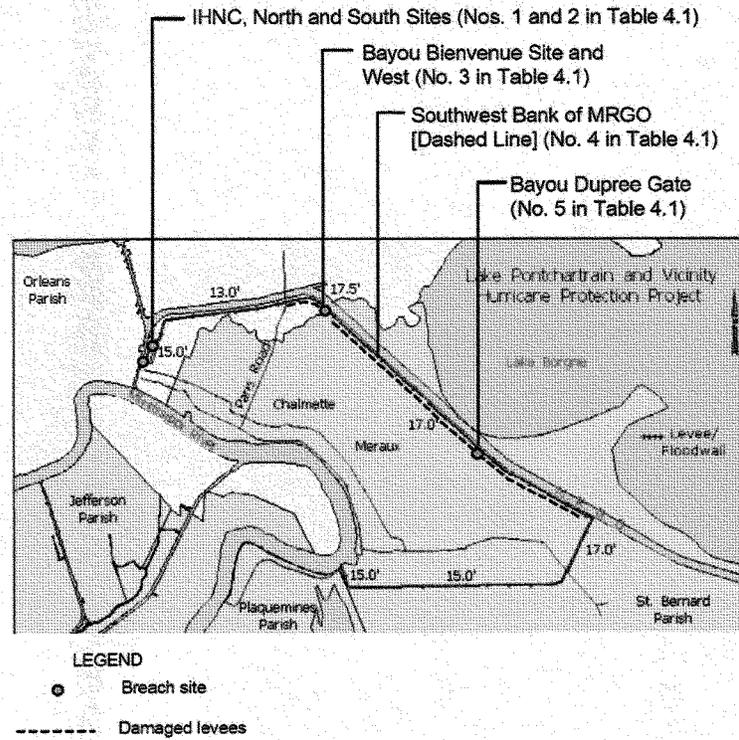
Figure 4.1: Overview map of the Lower Ninth Ward/St. Bernard Parish Polder showing the locations of damage to the primary levee system. Sites nos. 1 through 4 are summarized in Table 4.1. The elevations shown correspond to the top of the levee system at each location (after USACE).

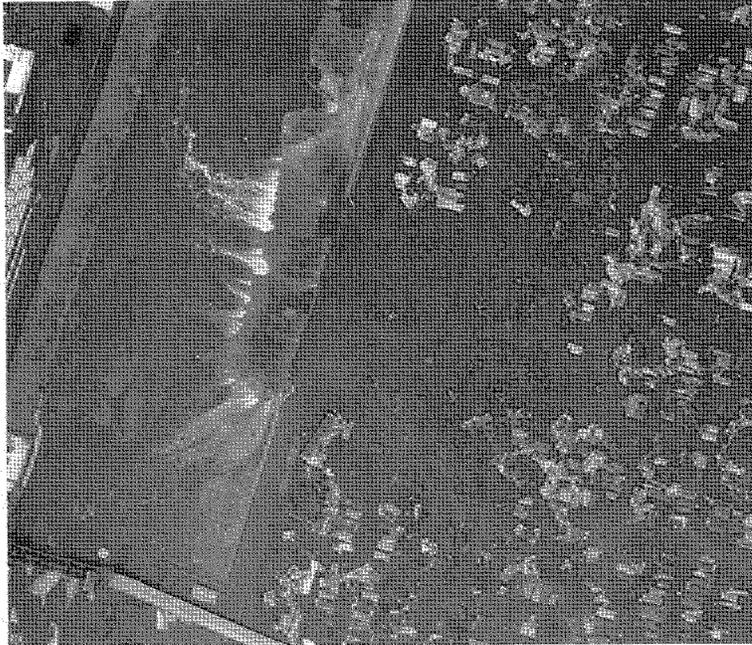
Figures 4.2 and 4.3 show aerial views of an approximately 900 feet long levee breach located 850 feet north of the Claiborne Avenue Bridge. The breach initially resulted from the Hurricane Katrina storm surge in the IHNC. An emergency repair was made shortly after the breach occurred. This repaired portion of the breach was later re-breached on September 24 by a storm surge caused by Hurricane Rita, which flooded the Lower Ninth Ward for a second time. This second flooding incident was reportedly much less severe than that caused by Hurricane Katrina (floodwaters reached a depth of about 3 feet), and as such, it is likely that it caused relatively little, if any, additional damage to the levee system at this location.

Figure 4.3: Airborne digital imagery of the south breach at the Lower Ninth Ward. Water is shown flowing back into the IHNC (courtesy NOAA, August 31, 2005).

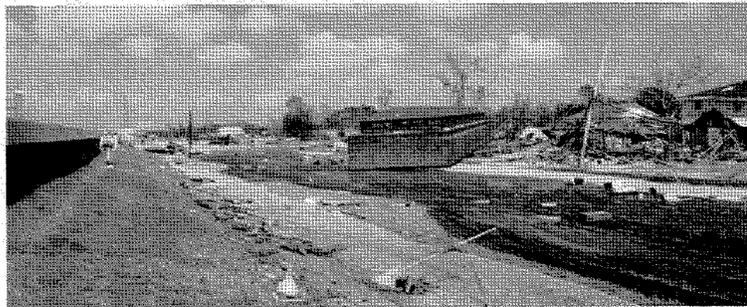
Figure 4.5 shows a unique feature of the failure site: a large barge that was drawn through the breach and came to rest on the landside of the levee as floodwaters receded. The barge was reportedly docked in the IHNC and became unmoored during Hurricane Katrina. Note the crushed school bus under the right side of the barge. Review of press photographs indicate that the barge initially came to rest further inland as floodwaters from Hurricane Katrina receded. The barge was later refloated as the Ninth Ward flooded a second time during Hurricane Rita. The barge drifted back toward the breach and came to rest upon the school bus as the Lower Ninth Ward was later unwatered.

Figure 4.5: A barge was drawn through the south breach of the Lower Ninth Ward (J. Wartman, October 4, 2005).

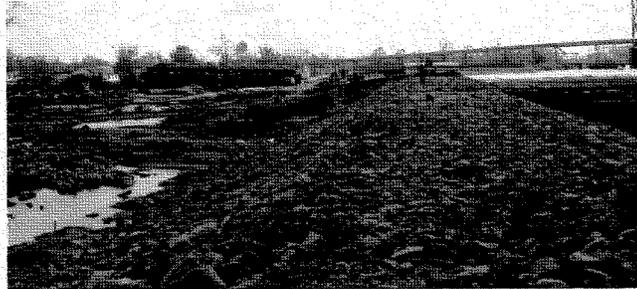
Figure 4.6: South view of the south breach repair at the Lower Ninth Ward (J. Wartman, October 4, 2005).

Figure 4.6 shows the emergency repair of the breach, which consists of a core of large sandbags overlain by embankment fill. Additional gravelly fill had been placed along the top of the embankment to serve as a working mat. The sandbags were airlifted into place, while the stone was placed from land. There was no significant seepage noted at the time of site visits on October 4 and during the week of October 9.

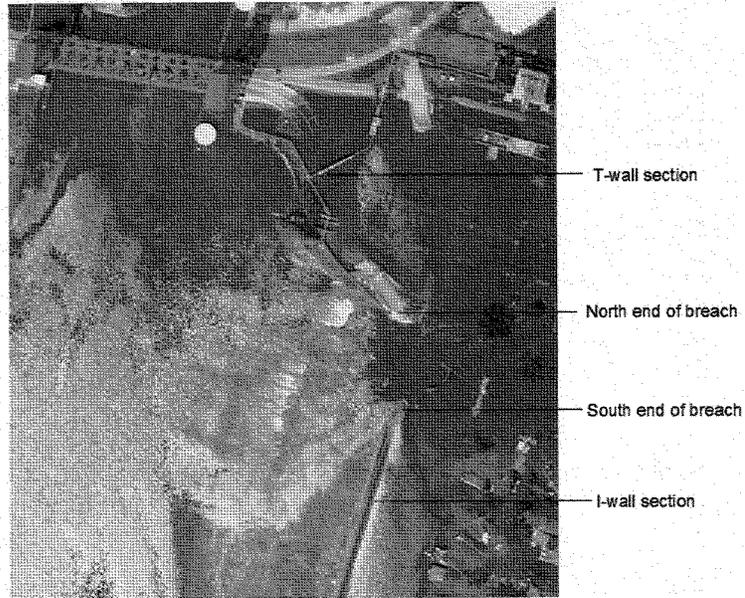
The flood protection system in the vicinity of Florida and Surekote Avenues near the northwest corner of the Lower Ninth Ward consists of I-walls/earthen levees that transition to T-wall sections near an adjacent flood gate (Figure 4.7). The I-walls at this location are the same as those found at the south breach location. Figure 4.8 shows a T-wall levee system at the site. The T-wall system at the site is generally similar to that discussed earlier in Section 2.4. Subsurface conditions at the site are similar to those found at the south breach site, with very soft clays overlying soft peats at shallow depths.

Figure 4.7: Airborne digital imagery of the north breach at the Lower Ninth Ward. Water is shown flowing back into the IHNC (courtesy NOAA, August 31, 2005).

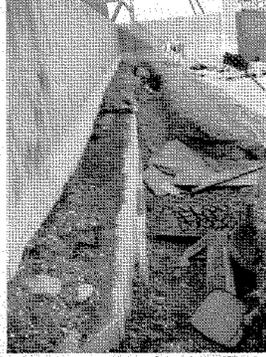
The unbreached portions of the I-wall system located immediately south of the failure were tilted inward (landward). The tilted I-walls reached their maximum inclination of approximately 3 degrees near the breach and gradually tapered to close to vertical at further distances to the south. Scour trenches at the landside toe of the floodwall (protected side) were found along the entire length of the intact I-wall section. The scour trenches were typically about 5 feet wide at the top and extended to depths of approximately 3 to 4 feet. As with the south breach, the scour trenches were wide and u-shaped near the breached area and gradually became narrower, v-shaped and incised at greater distances. Scour was also noted along the landside of the T-wall levee sections (Figure 4.8).

Figure 4.8: A scoured, but nevertheless well-performing "T-wall" levee section located near the north breach of the Lower Ninth Ward (J. Wartman, October 4, 2005).

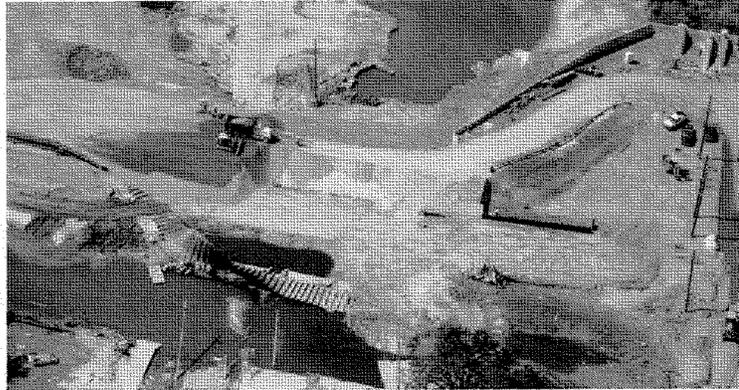
Figure 4.9 shows an aerial view of a 210 foot long levee breach located approximately 500 feet south of Florida Avenue. The breach initially resulted from the Hurricane Katrina storm surge in the IHNC. An emergency repair was made soon after. It is reported that unlike the south breach location, the north breach emergency repair was not overtopped in Hurricane Rita. The earthen portion of the I-wall levee system was almost completely destroyed and the I-wall was overturned and dragged inland by as much as 70 feet while remaining fully interlocked. In the most extreme case, the I-wall came to rest upside down, with the concrete portion at the bottom, and the toe of the sheeting pointing upward (Figure 4.10). The sheet pile separated from the concrete wall at the north end of the site by splitting the webbed section rather than tearing the interlock.

Figure 4.9: Aerial view of the north breach of the Lower Ninth Ward (L. Harder, October 14, 2005).

Figures 4.9 and 4.11 show the emergency repair, consisting of a core of large sandbags overlain by embankment fill. The sandbags were airlifted into place, while the stone was placed from land. Owing to the presence of standing water on the landside during a visit on October 4, it was not possible to determine if seepage was occurring through the repaired section.

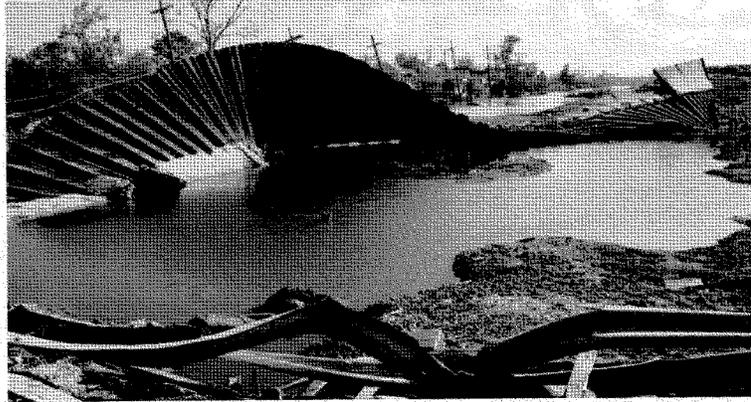
Figure 4.10: Overturned I-wall system at north breach of Lower Ninth Ward (J. Wartman, October 4, 2005).

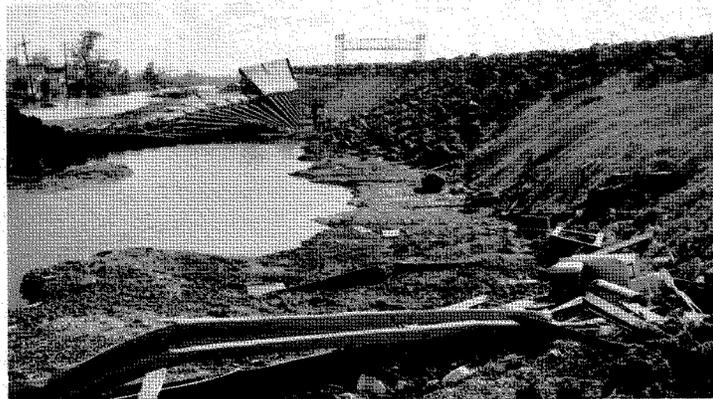
Figure 4.11: Looking south along the north breach repair at the Lower Ninth Ward (J. Wartman, October 4, 2005).

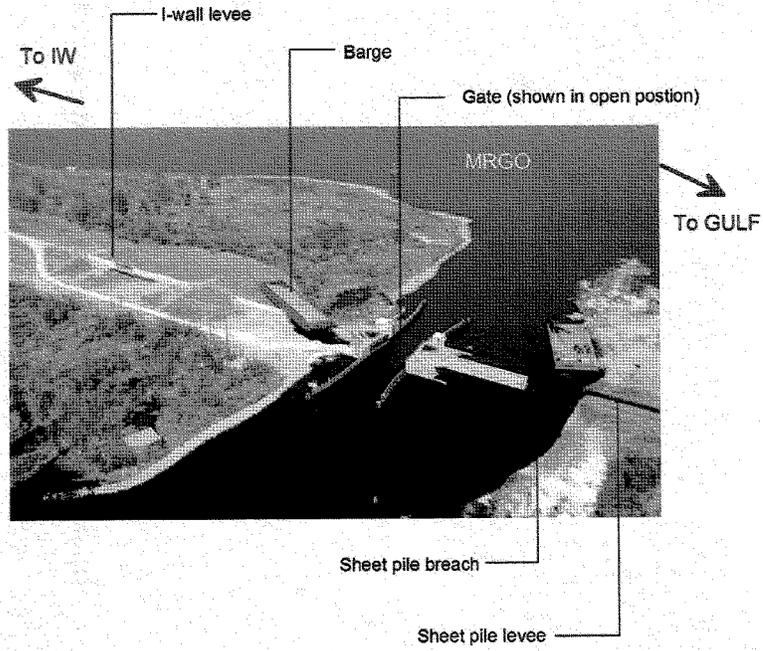
The flood protection system at the Bayou Bienvenue gate site is a complex levee-gate transition involving several different levee sections located as shown in Figure 4.12. These include (from northwest to southeast) an earthen levee, transitioning to an I-wall, transitioning to a gate structure, transition to a sheet pile section, which finally transitions again to an earthen levee along the MRGO.

Figure 4.12: Northwest facing aerial view of the Bayou Bienvenue Gate structure (L. Harder, October 14, 2005).

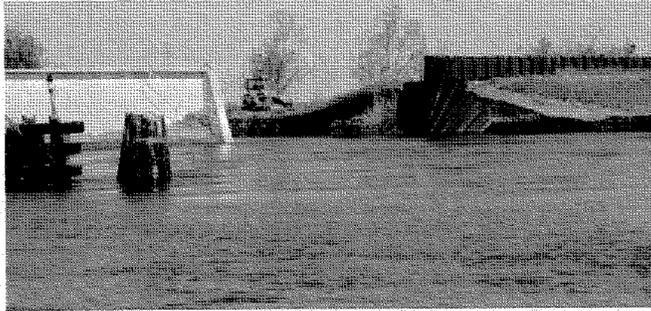
Figure 4.13: Sheet pile breach at the Bayou Bienvenue Gate (J. Wartman, October 5, 2005).

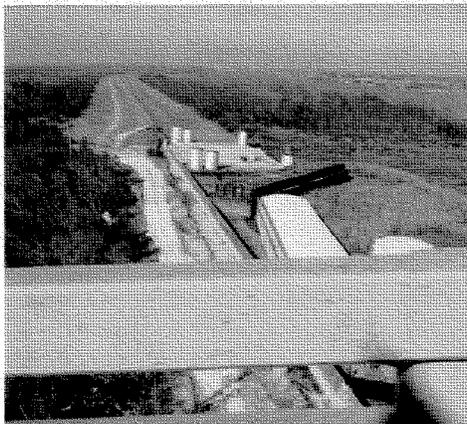
Figure 4.16: View of levee along the south bank of the Intracoastal Waterway from the Rt. 47 Bridge (Lee Wooten, October 6, 2005).

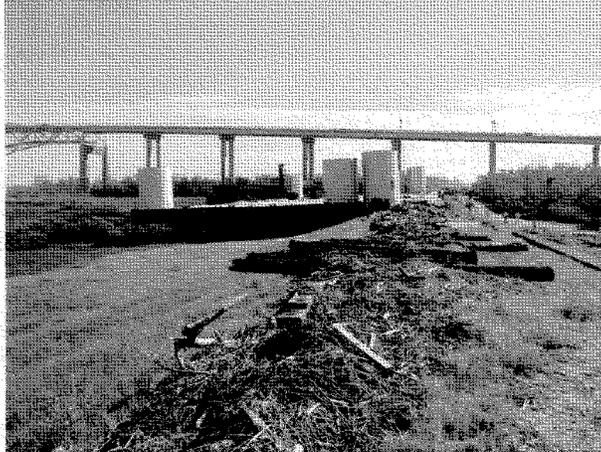
Figure 4.17: Debris line near levee crest just west of the Rt. 47 Bridge south abutment (L. Wooten, October 5, 2005).

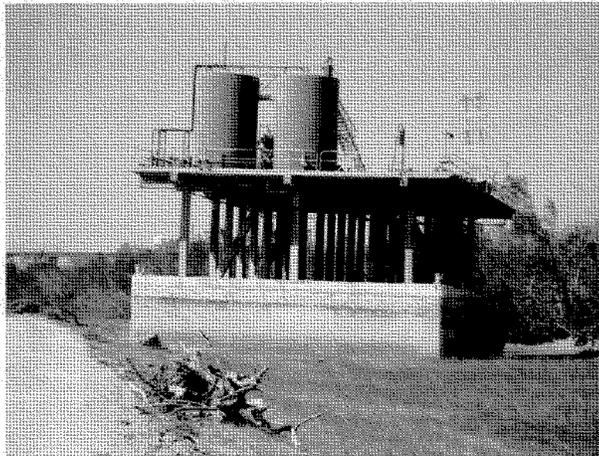
Figure 4.18: Various barges and other floating structures made contact with the earth levees without causing significant damage. Photo shows a gas processing barge (F. Silva, October 1, 2005).

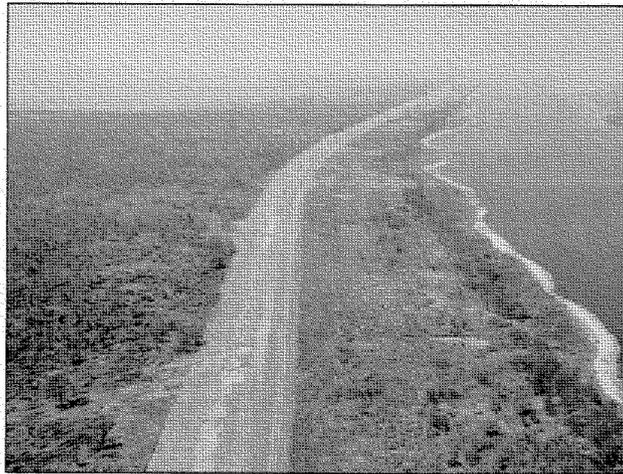
Figure 4.26: Aerial view of MRGO looking towards the city of New Orleans (L. Harder, October 14, 2005).

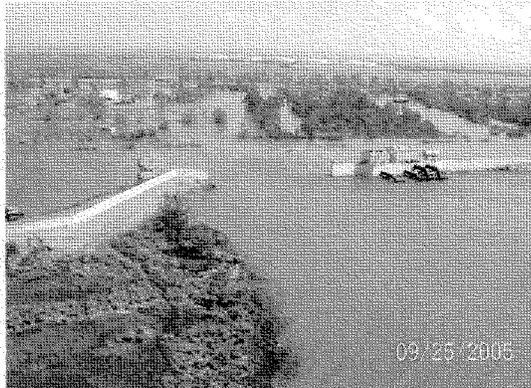
Figure 5.2: Aerial photograph of levee breach of hurricane (back) levee along western side of the Mississippi River near the community of Sunrise (September 25, 2005)

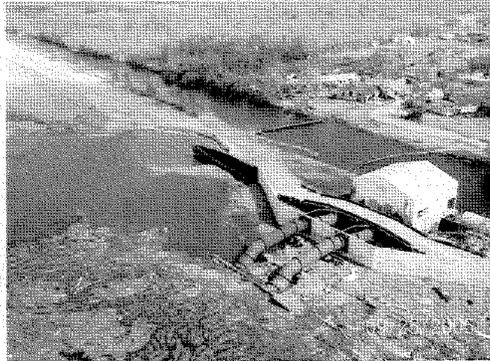
Figure 5.3: Aerial photograph of levee breach of hurricane (back) levee at levee transition near Hayes Pump Station (September 25, 2005)

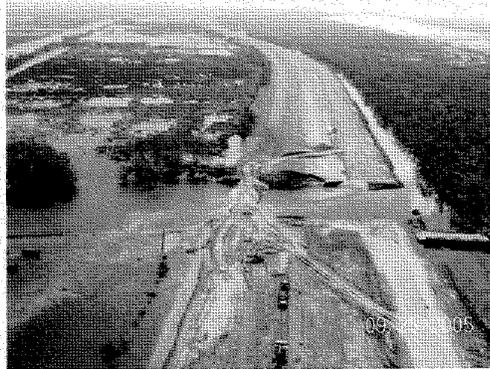
Figure 5.4: Aerial photograph of levee breach of hurricane (back) levee east of Pointe a la Hache (September 25, 2005)

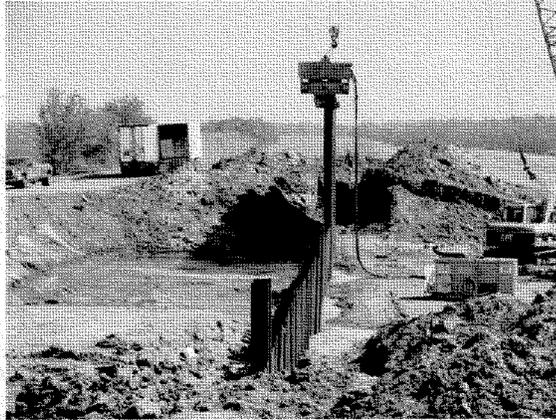
Figure 5.5: Photograph of sheetpile cutoff being placed into levee breach of hurricane (back) levee east of Pointe a la Hache (October 12, 2005)

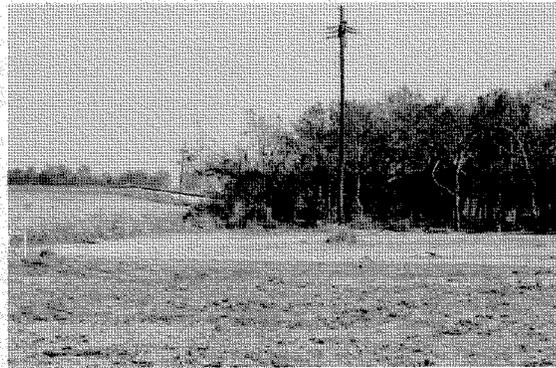
Residences in Pointe a la Hache were commonly inundated to depths of 12 to 15 feet (see Figure 5.6). Flooding was so great that water flowed across the community from the east

Figure 5.6: Photograph of flood elevation on trees landward of hurricane levee east of Pointe a la Hache – illustrating that flood water remained to large depths for extended periods (October 12, 2005)

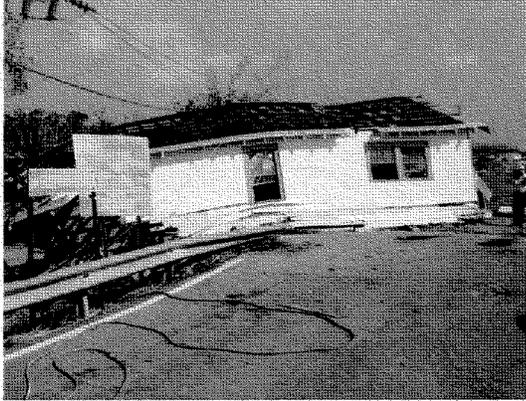
Like many New Orleans residences, the small wooden homes in Pointe a la Hache were commonly founded on cinderblock piers. As a result of the deep flooding and the flow towards the Mississippi River, homes in Pointe a la Hache were commonly picked up and floated away from their foundations. Many ended up being deposited on or across the Mississippi River Levee as a result of flood waters flowing into the Mississippi River (see Figures 5.7 through 5.9).

Figure 5.7: Photograph of Pointe a la Hache home deposited on Mississippi River levee crown after storm surges overtopped this levee from the east (left) towards the river – which is to the right in this photograph (October 12, 2005)

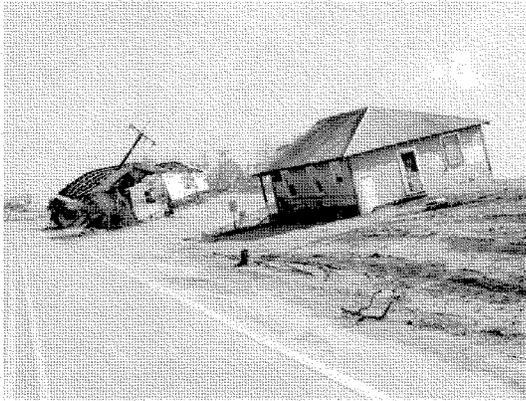
Figure 5.8: Photograph of Pointe a la Hache homes deposited on Mississippi River levee after storm surges overtopped the levee from the east (left) towards the river (right) (October 12, 2005)

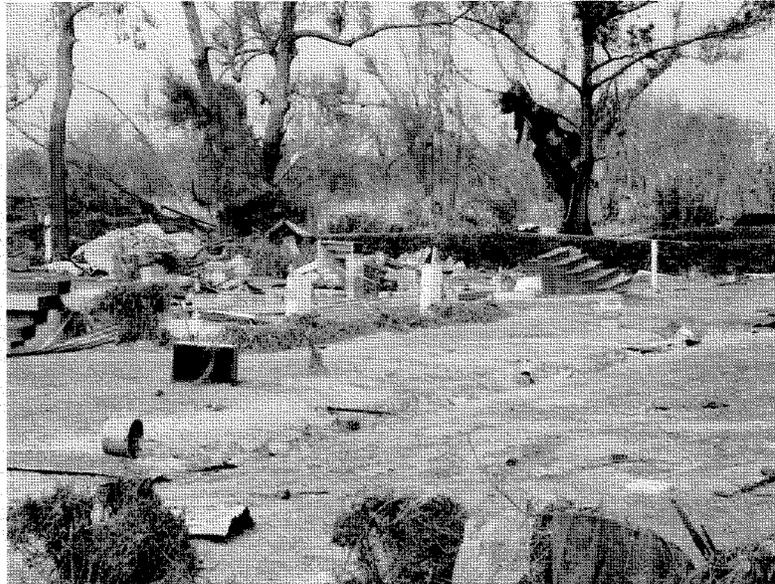
Figure 5.9: Photograph of Pointe a la Hache home site where wooden home was floated off of its cinderblock piers – note concrete stairs and black plastic sheet in tree illustrating the depth of flooding (October 12, 2005)

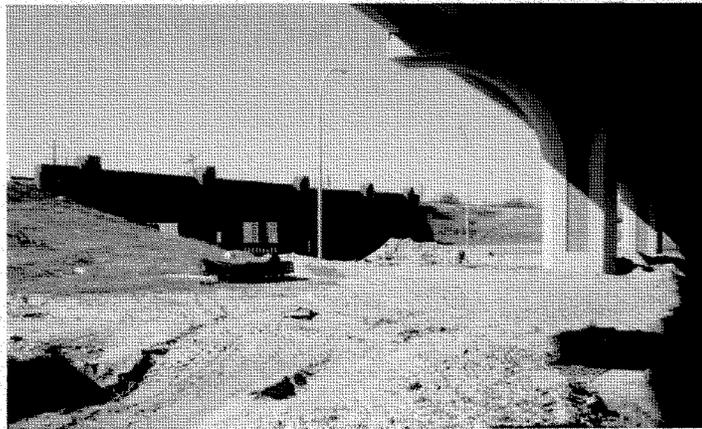
Another example of system vulnerabilities associated with the multiplicity of organizations occurred in the same area, near the lake front airport (Figure 6.3). The earth levee that paralleled the lake front defending the neighborhood to the south of the Lakefront airport had experienced some overtopping, but water had breached a section between the adjacent flood control structure (concrete, flood gate closed) and the earth levee (Figure 6.4). The earth levee was at an elevation that was lower than the flood control structure. Massive

Figure 6.4: This flood protection levee was overtopped and scoured, resulting in flooding of this lakefront residential area.

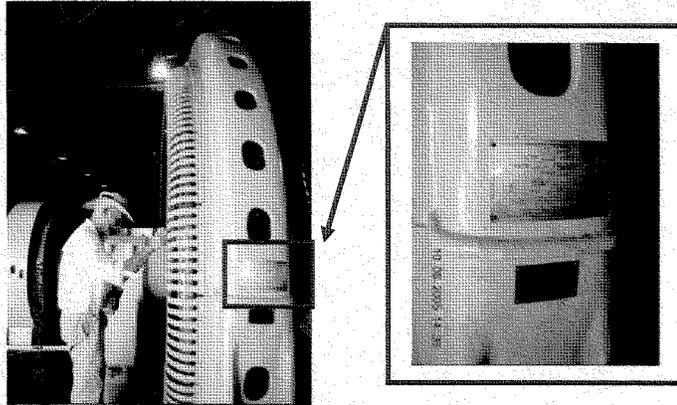
We visited one of the key pumping stations that are responsible for pumping water collected from within the city into the drainage canals, and thence into Lake Pontchartrain (Figure 6.5). These pump stations were put in service in the early 1900's, and many of the electrically driven pumps bore manufacturing identification plates that bore testimony to their age (Figure 6.6). The pumps were very old, and were obviously kept in service by tender loving care. While we were there, work was underway to dry out the pumps and associated electrical control equipment that had been submerged during the flooding - including the banks of stand-by batteries that are shown in Figure 6.7. Discussions with the pump station operators that had been present at the time of the hurricane disclosed how, as the water rose in the pump station, a decision was made to shut-down the pumps and evacuate the operating personnel by walking out on the adjacent 'elevated' railway. At this point in the storm, there was no hope of being able to pump water from the rapidly flooding city.

Figure 6.6: Original pump equipment at the Orleans Pumping Station from the early 1900s.

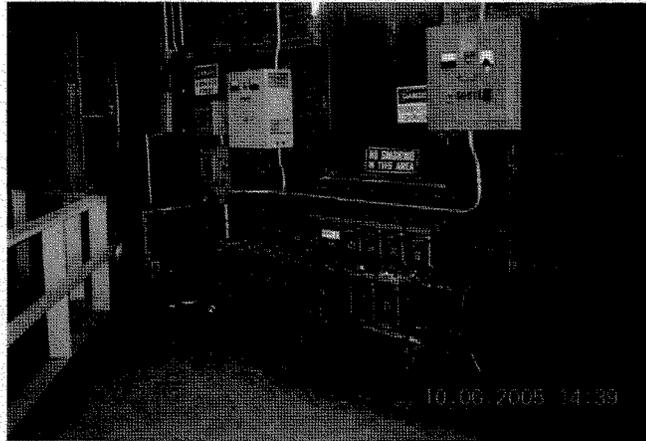
Figure 6.7: A battery bank in the pump station used for "emergency" power.

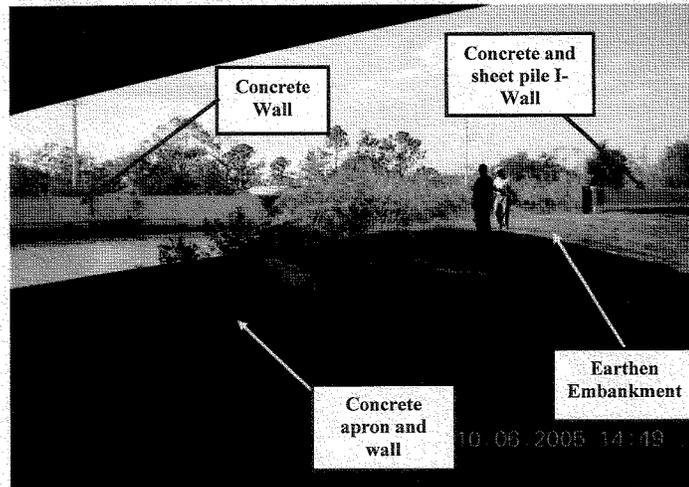
After touring the pump station, we surveyed the area immediately outside of the pump station to determine how the flood walls and other parts of the levee system had performed. We found that it had performed very well, with little signs of overtopping. However, as we toured the area we found that there were 5 different elevations of different parts of the levee system in a small area (Figure 6.8). A significant example of this occurs on the east bank where the floodwall on the earthen levee abruptly ends at a considerable distance (some 300 feet) before the levee reaches the pumping station, leaving a long, low gap where there should have been a contiguous, closed perimeter flood defense. A similar situation occurs on the west side where the floodwall transitions into a short stretch of sheet pile with a considerably lower elevation. Note that these gaps provide access of floodwater into the surrounding residential areas at a water level well below the flood protection system design level. Some overtopping had in fact occurred in both places, as reported by the pump station operator, who was onsite during Hurricane Katrina. Other variations in the elevations of the flood defense elements were correlated with the agencies that had responsibilities for various parts of this part of the system, (e.g. highway department determining the heights under the road overpass immediately adjacent and upstream of the pump station, Figure 6.9)).

Figure 6.9: At the Orleans Canal pump station, the flood protection system consisted of different components, each with a different "top of wall" elevation.

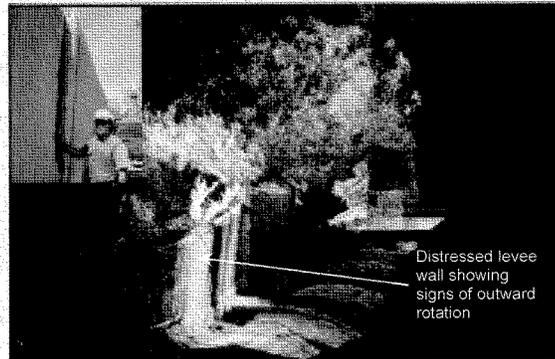
distress and lateral deformation associated with incipient failure of the levee. This movement is along a section of wall diagonally northeast of the west side breach across the canal. In Figure 7.13, an oblique image of the distressed wall can be seen from the south. The wall, preserved in incipient failure, leans toward the levee maintenance road and landside portion of the levee. In the right-hand background, is the bridge abutment on Robert E. Lee Blvd for reference.

Figure 7.13: Leaning I-wall of a distressed portion of the London Avenue Canal. The wall leans toward the levee maintenance road and landside portion of the levee. In the right-most background is the abutment of the bridge on Robert E. Lee Blvd. along with vegetation on the canal side of the levee.

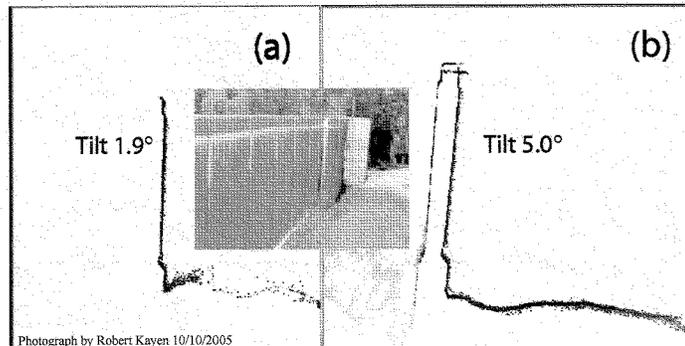
Considerable vegetation grows along the banks of the canal side of the levee that are less maintained for growth than the landside neighborhood-side of the levee wall. Thin slices of the point-cloud data orthogonal to the alignment of the levee wall (Figure 7.14) display highly accurate cross sections of the distressed I-wall at London Canal. Segment (a) is toward the south (left) of Figure 7.13 and has a modest 1.9 degree rotational deformation. Near a position of maximum distress, the I-wall has 5.0 degrees of rotational deformation toward the landside of the levee.

Figure 7.14: Cross sections through two segments of distressed I-wall at London Avenue Canal. Segment (a) is toward the south (left) of Figure 7.13 and has a modest 1.9 degree rotational deformation toward the landside of the levee. Near a position of maximum distress, the I-wall has 5.0 degrees of rotational deformation.

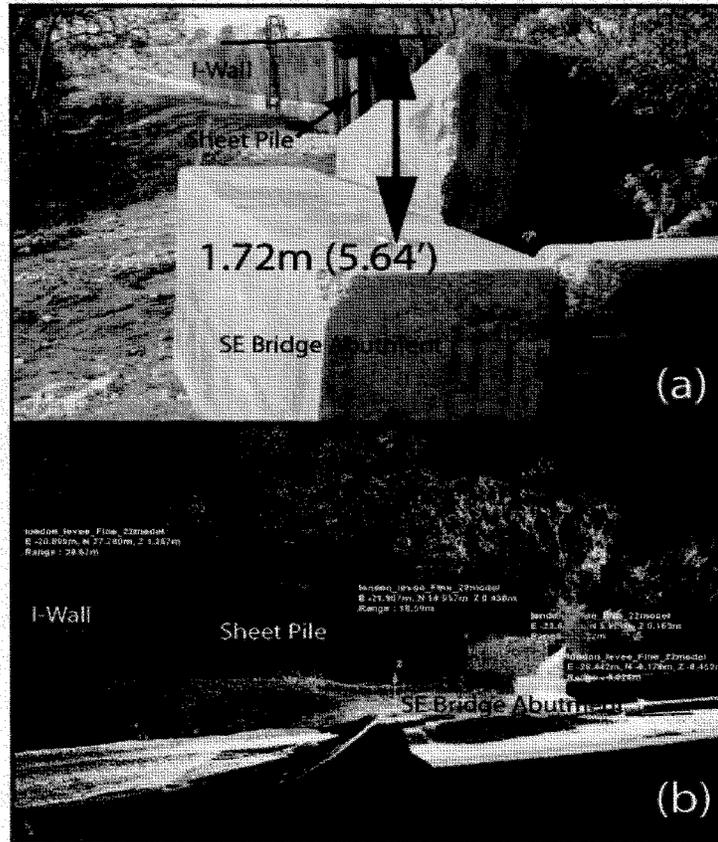
The London Canal levee failure (west side) and distressed wall (east side) are both immediately south of the bridge crossing at Robert E. Lee Boulevard. A significant gap in height between the lower un-walled bridge abutment and I-wall prevents water from overtopping these levees. The height gap differs slightly between the walls located north and south of the bridge, due either to differing design heights or differential settlement following construction. At the distressed I-wall section on the southeast corner of the bridge, LIDAR surveys and visual inspection indicated the gap at this location was approximately 1.7 meters (5.6 feet). Therefore, water rising in the canal would overtop the bridge abutment and begin to flood the surrounding community when the water level was 1.7 meters (5.6 feet) below the top of the I-wall. Figure 7.15 shows this considerable wall gap, as well as moderate scour at the southeast edge of the bridge abutment (Figure 7.15a). On the northeast corner of the bridge abutment near the north levee wall, LIDAR surveys indicate the gap at this location to be approximately 1.51 meters (5.0 feet). Figure 7.16 and 7.17 show this gap, as well as a scour trench at the base of the northeast abutment (Figure 7.17a).

Figure 7.15: Photograph of the southeast abutment of the London Avenue Canal bridge at Robert E. Lee Blvd (a), and LIDAR scan of the same location (b). New soil and rock apparently fills scour and sink hole erosion beneath the abutment. The relative height gap between the bridge abutment and the flood wall is 1.72 meters (5.6 feet).

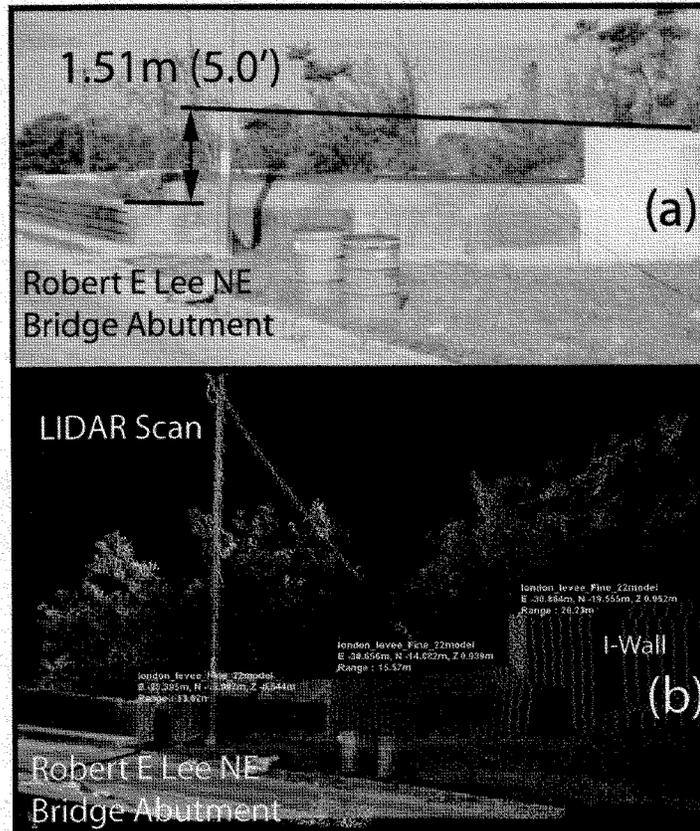
Figure 7.16: The northeast abutment of the London Avenue Canal bridge on Robert E. Lee Blvd. in photograph taken from the lower portion of the bridge approach-fill embankment (a), and corresponding LIDAR scan (b). The wall gap here is 1.51 meters (5.0 feet).

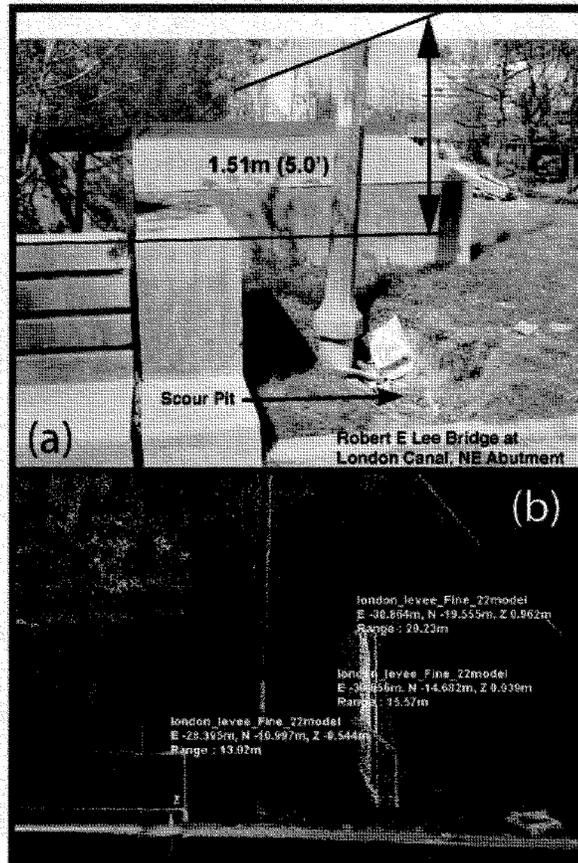
There was no evidence of overtopping of the levee walls or erosion scour anywhere along this section of the canal except at the gap at the bridge. The LIDAR and scour evidence therefore indicate that the floodwalls along the London Canal section, south of the Robert E. Lee Boulevard Bridge were not overtopped prior to failure of the levee wall.

Figure 7.17: Photograph taken directly south and adjacent to the northeast abutment of the Robert E. Lee Bridge (a), and corresponding LIDAR scan of the same location (b). A scour trench is clearly visible beneath the abutment. The wall gap here is 1.51 meters (5.0 feet).

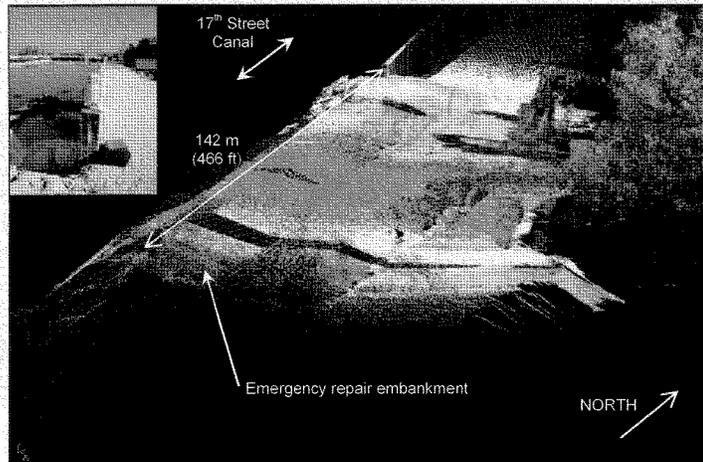
Figure 7.19. An oblique close-in image of the as built replacement levee at the 17th Street Canal breach from the south. The remaining I-wall is visible on either side of the earthen embankment.
