**HURRICANE KATRINA:
WHY DID THE LEVEES FAIL?**

COMMITTEE ON
HOMELAND SECURITY AND
GOVERNMENTAL AFFAIRS
UNITED STATES SENATE

NOVEMBER 2, 2005

Chapters 2 through 5 of this report present a summary of observations and preliminary findings to date associated with protective levee system performance in the (2) Orleans East Bank, (3) Ninth Ward/St. Bernard Parish, (4) New Orleans East, and (5) Plaquemines Parish protected areas, respectively. Chapter 6 briefly addresses observations regarding pumping and dewatering systems, and other aspects of the overall regional flood protection system. Chapter 7 describes LIDAR imagery data sets taken to capture three-dimensional representations of detailed ground surface conditions and configurations at a number of key sites. Finally, Chapter 8 summarizes a number of preliminary overall observations and recommendations.

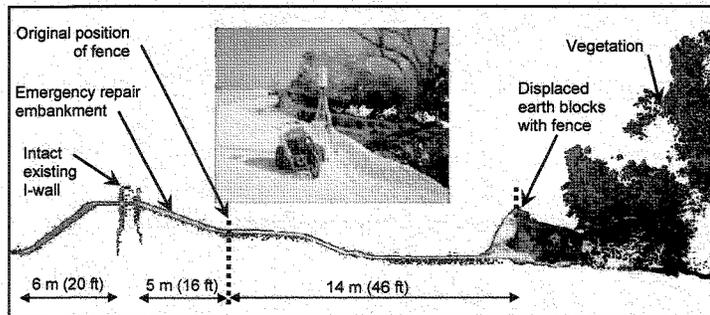
displacement of several earth blocks that moved away from the levee break during failure. While forensic work on the original positions of the earth blocks is still ongoing, the LIDAR data shows that blocks translated approximately 14 meters (46 feet) as measured from the existing alignment of the cyclone fence line to its new position within the displaced blocks. From the perspective shown in Figure 7.20, it can also be seen that the width of the 17th St. Canal has been reduced about 6 meters (20 feet) by the placement of the earthen embankment.

Figure 7.20 Cross-section of the 17th Street Canal breach looking northward. Measurement of the lateral translation of the landside soil levee from its original position is approximately 14 meters (46 ft). The I-wall in this image is offset (out of the page) from the slide block.

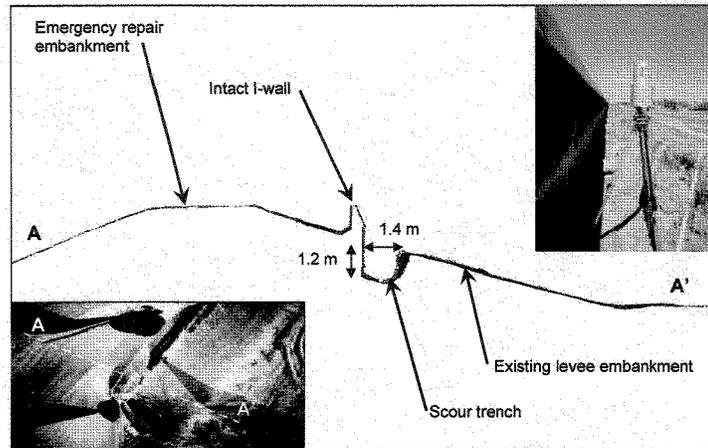
Figure 7.21: Measurement of scour trench dimensions at the IHNC – South site.
