michigan's  
demonstration  
erosion control  
program

update evaluation report - august, 1975

Prepared by  
The University of Michigan

Coastal Zone Laboratory

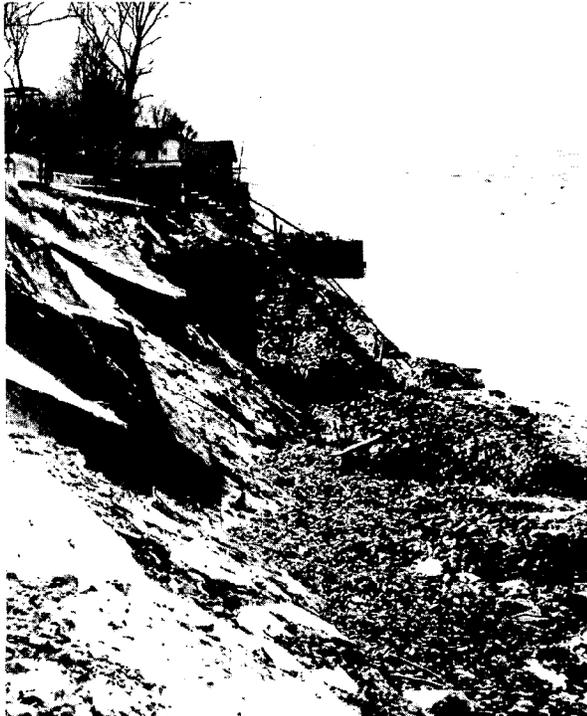
Diagram #1  
Typical Cross Section

Condition. Diagram #1 shows the condition of the structure at this site on December 10, 1974. The first sign of problems with the structure appeared in the fall of 1974 when undermining of the toe of the revetment occurred in a few small areas. At that time it was also evident that surface runoff from the roads was concentrating at one or two locations, causing local undermining. A survey made after a fairly heavy November storm showed that the revetment had settled in some places. Photo #1 illustrates the condition of the revetment after the November storm. After the snow and ice disappeared in the spring of 1975, however, the revetment was still in quite good condition. Settlement had lowered the top edge about a foot in some places.

Design Modifications. A number of changes could be made in the design and construction of this type of revetment to improve its performance. First, the rocks should be larger and more uniform in size so that all rocks are in the 8 to 12 inch range. This would improve the depth of asphalt mastic penetration into the rock. The incorporation of a more massive section at the lower edge might reduce undermining at the toe. A deeper layer of rock with an underlayer of smaller rock (1 to 3 inch size) might provide a path for seepage under the revetment and, thus, reduce undermining due to overtopping. Points of surface runoff drainage and drains should be placed in or beneath the revetment to accommodate storm runoff. If a single layer of rock and asphalt mastic was added to the main portion of the revetment, the increased elevation could eliminate overtopping, but the costs would also be increased.

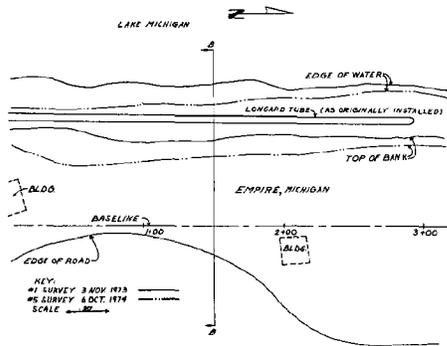
Diagram #2  
Plan View of Site

Condition. Diagrams #2 and #3 and Photo #6 are included for reference and also to provide information obtained during the final survey of this site.

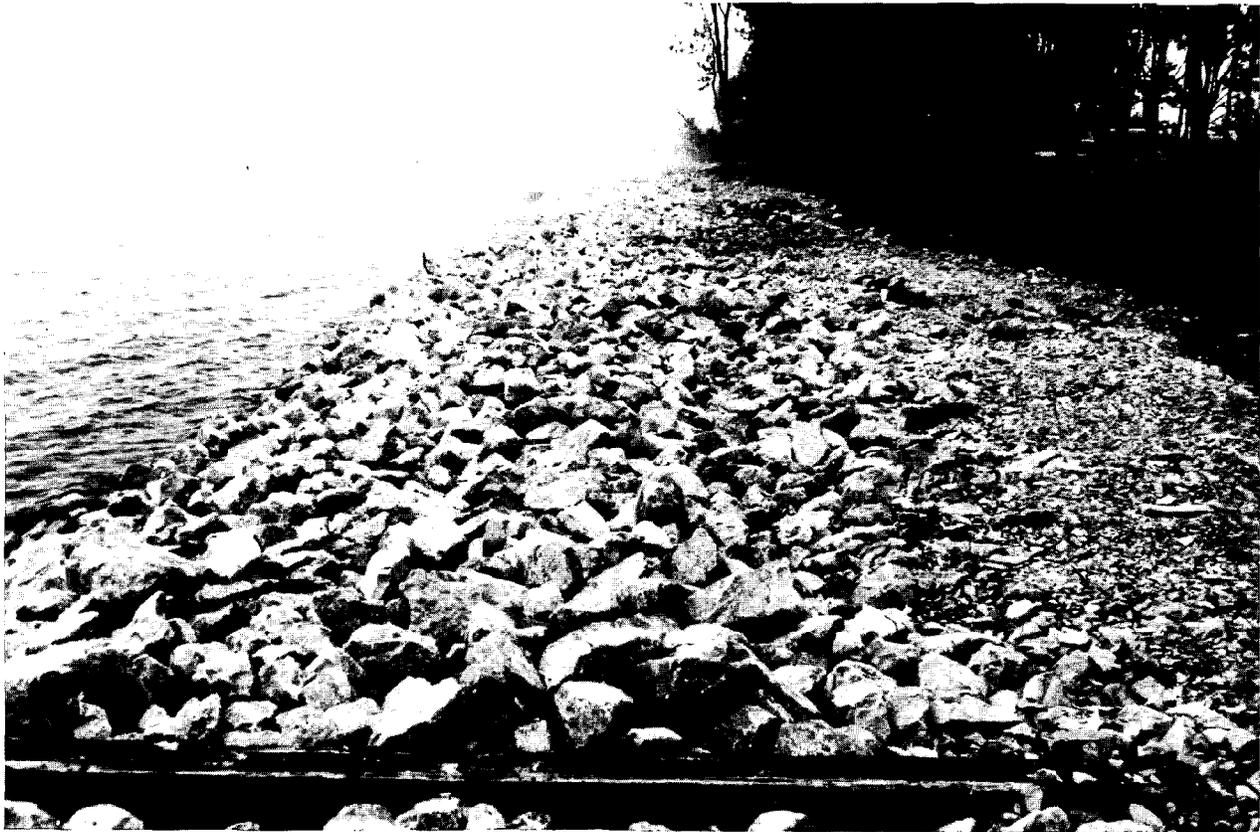
Photo #15 June 18, 1975

Condition. Photo #15 shows the condition of the site. The use of the groins in conjunction with the rock revetment are shown in their present state in the park area.

A groin was used in conjunction with rock revetment at this site.

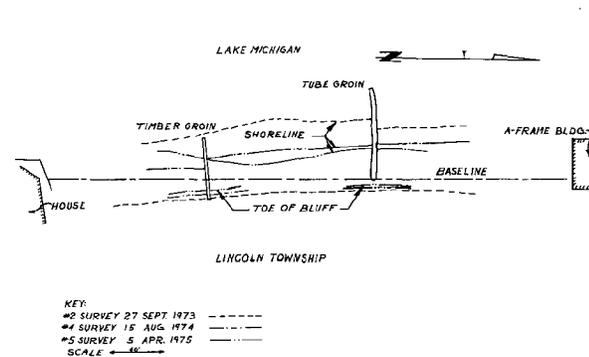
Diagram #11  
Plan View of Site

Condition. Diagrams #11 and #12 and Photo #17 show the condition of the tube. It has continued to settle, but its rate of settlement has dropped off substantially. In spite of total settlement (which has amounted to as much as 3 feet at the outer end since installation) the tube is still trapping sand and offering protection. The rip in the structure which was observed earlier does not seem to have caused much loss of sand.

Condition. Diagrams #11 and #13 and Photo #17 show the condition of the structure. The groin has remained stable since its installation, with no deterioration or other adverse effects being detected. Substantial amounts of sand have been trapped and a protective beach has been built.

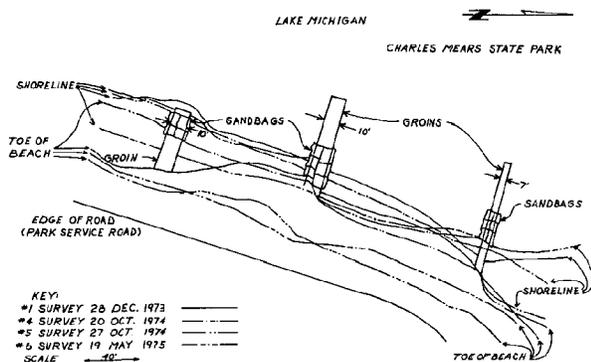
Diagram #14  
Plan View of Site

**Condition.** Diagrams #14 and #15, along with Photos #18 and #19 show the condition of this site. The groins seem relatively stable, although some shifting and settlement has been detected in the sand bags. Compared to the other sand bag installations, however, this movement has been insignificant. Each of the groins has lost one or two bags at the outer ends, yet considering the location of these structures on park land, which is open to the public where the potential for vandalism is high, it is amazing that most of the bags are still intact.

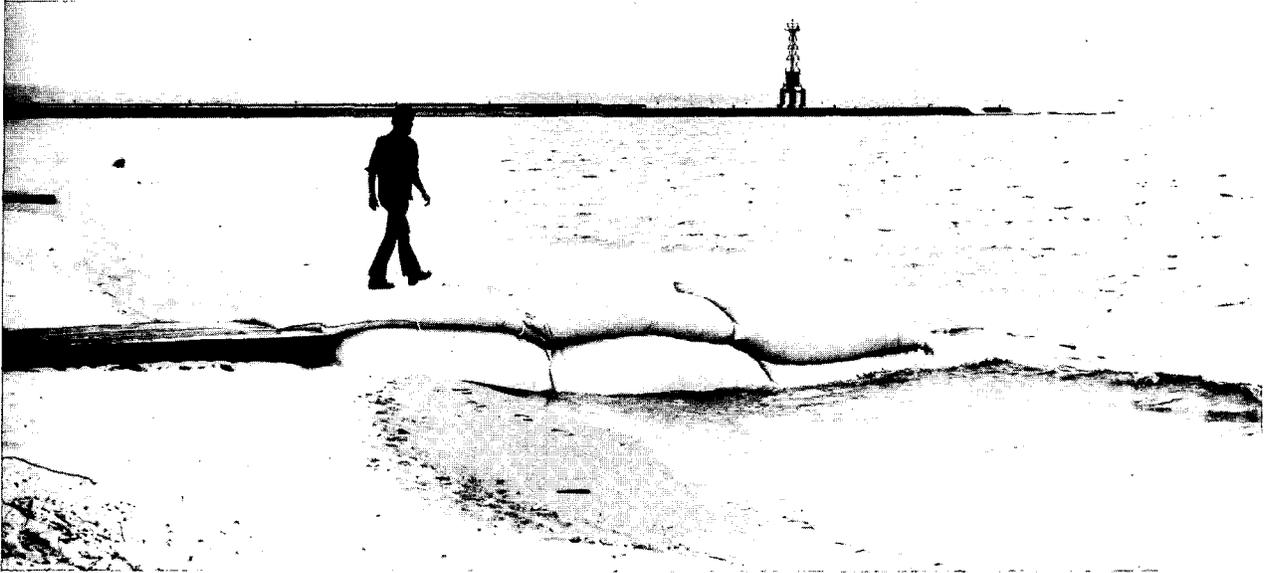
Photo #19 May 19, 1975

The shoreline has remained relatively stable at this location. Periodic sand replacement has been required.

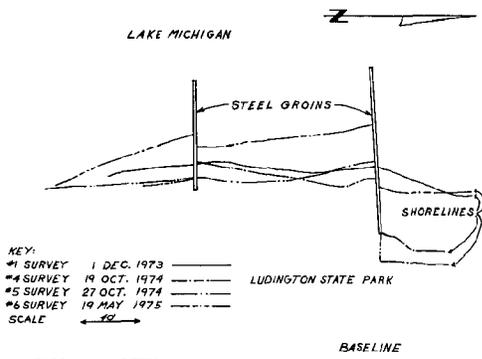
Diagram #16  
Plan View of Site

Condition. Photo #20 shows the condition of the site in late October 1974. Photo #21 shows the same site as it appeared in mid-May 1975. Some of the field data recorded at this site is included in Diagrams #16 and #17.

Design Modifications. Changes in the design and construction of these groins might include the addition of rubble along the ends of the groin to prevent scour, or the use of longer piles to help prevent scour damage to the groin. The use of longer groins to provide better "anchorage" into the existing back shore could also be implemented.

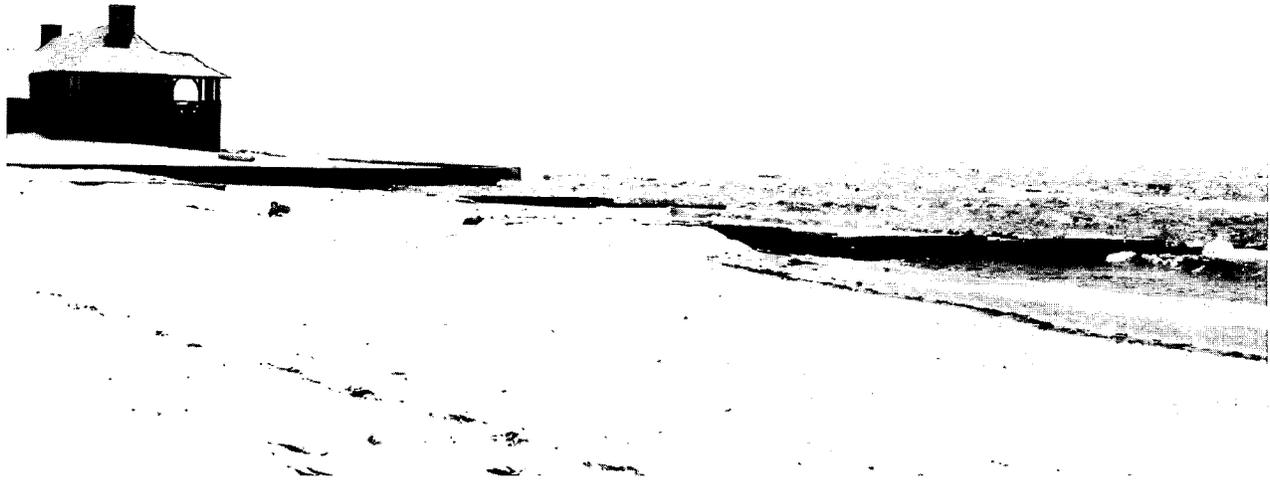
Photo #21 May 19, 1975  
A view of the groins looking south.

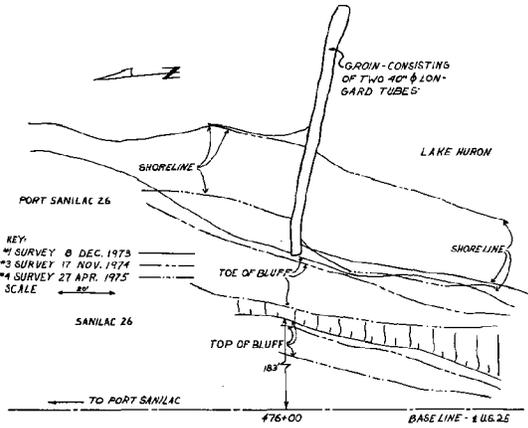
Diagram #18  
Plan View of 40'' Diameter Longard Tube

Condition. Both of the tubes are essentially intact and properly placed. Some settlement has occurred in both tubes (see Photo #22), especially in the southern (down drift) tube (see Photo #23), but this movement has been minor and has not hindered the performance of the groin. Diagrams #18 and #19 depict the conditions described above.

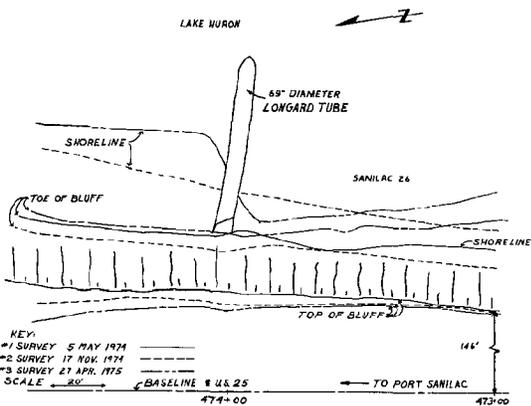
Diagram #21  
Profiles Along Centerline  
of 69" Diameter Longard Tube

The recession of the bank behind this tube cannot be attributed to poor performance of the structure at this time since factors other than wave attack may be responsible.

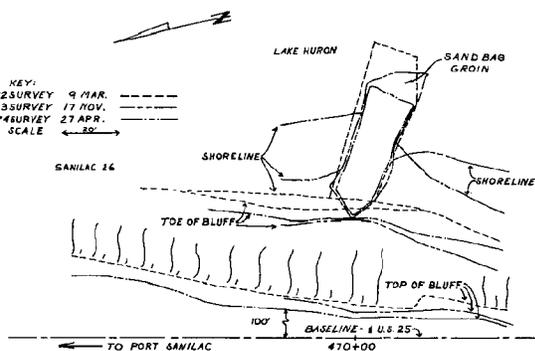
Diagram #22  
Plan View of Sandbag Groin

General Observations. In spite of the loss of bags in this structure, it appears to be trapping substantial amounts of sand. In the November 1974 report it was recommended that this means of shore protection be considered temporary. Now, after further study (with mild storm activity), this statement should be revised to read that these bags should not be counted on for as much permanence as other structures. With provisions made to help eliminate the ripping and tearing of bags, and with some annual replacement of damaged or lost bags, this type of structure might be expected to trap sand for a period of about two to three years, under mild wave attack.

Design Modifications. Some provision should be made to hold the sand bags in the structure together in a more efficient manner. Presently, the bags are "held" in place because of their weight and by being tied together with the nylon leaders to be found at the corners of each bag. This does not appear to be an adequate method. Some means of armoring the structure or providing a tear (rip) resistant coating for the bags is also required.

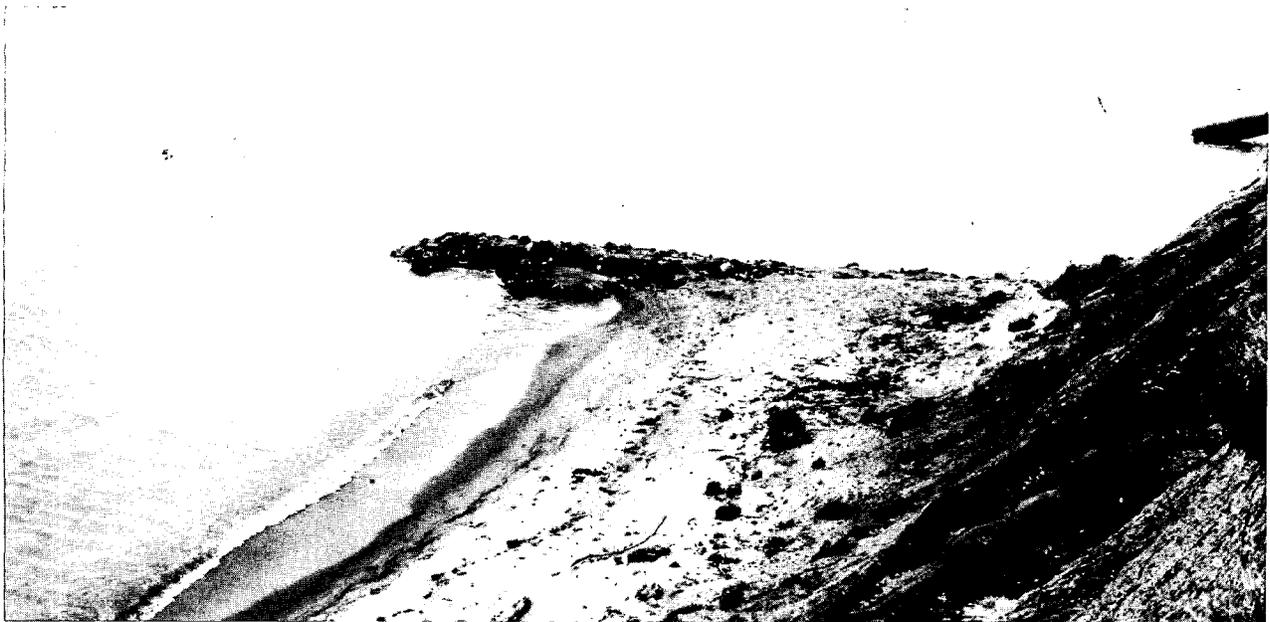
Photo #26 April 27, 1975

The rock mastic groin has remained relatively stable. Trapped sand has built a beach.

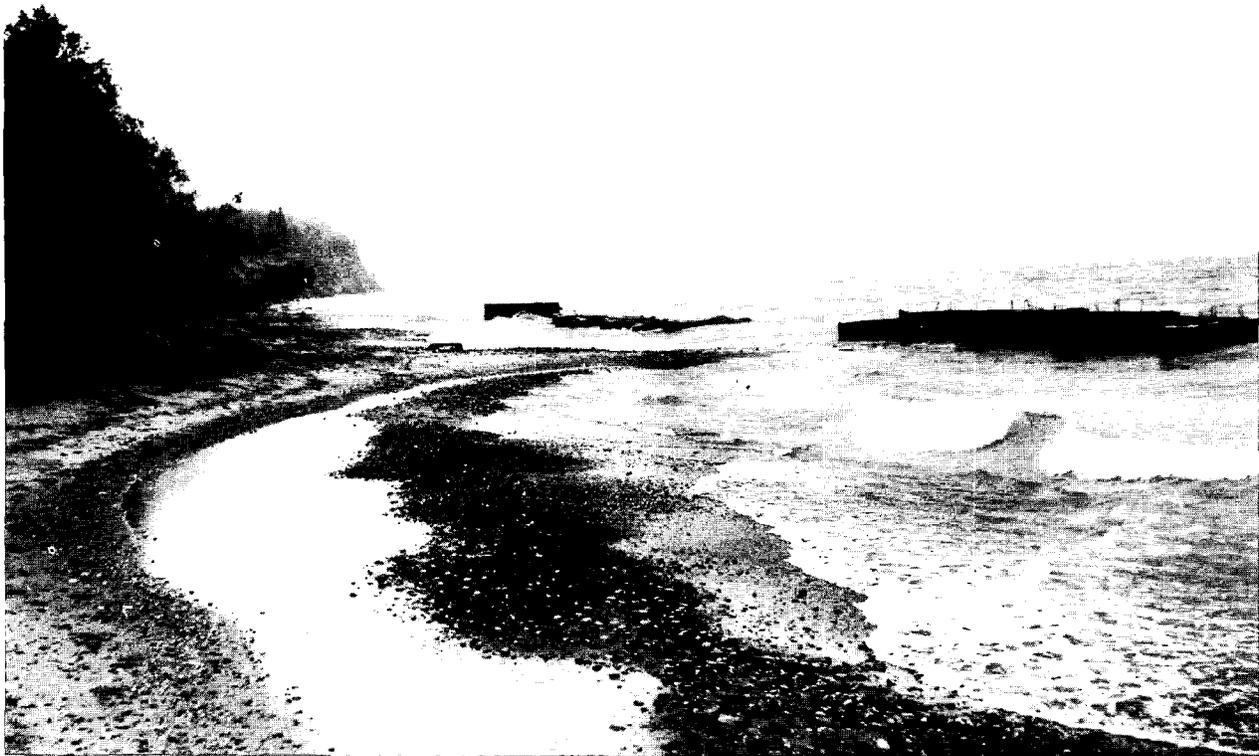
Condition. Diagram #28 and Photos #29 through #34 show the condition of the site. Major recession of the bluff has occurred during this second year of study, with as much as 30 feet of bluff being lost. A bath house, located immediately behind this breakwater system, which the breakwater system was to protect, was lost when the bank eroded. At least one foot of settlement has been detected in the breakwater. The center structure (the first to be built) has lost one module (2 panels), and the north structure has settled at least two feet and has been severely damaged. At least one module has been damaged and lost during this period of study.

Photo #29 October 20, 1974  
This photograph shows all three units of the breakwater system.

Maintenance. The desired procedure to maintain these structures would be to remove them from the water, repair them and replace them at higher elevations on rubble foundations. However, the cost and field difficulties involved in such an operation make this recommendation somewhat unfeasible under the constraints of this program. One of the breakwaters is now so low that it is of virtually no benefit.

Design Modifications. In order to use these zig-zag walls as a suitable offshore breakwater system some design changes must be implemented. Based on this study, it would be desirable to shorten the gaps between structures. A 30' gap between 70' walls might be more successful.

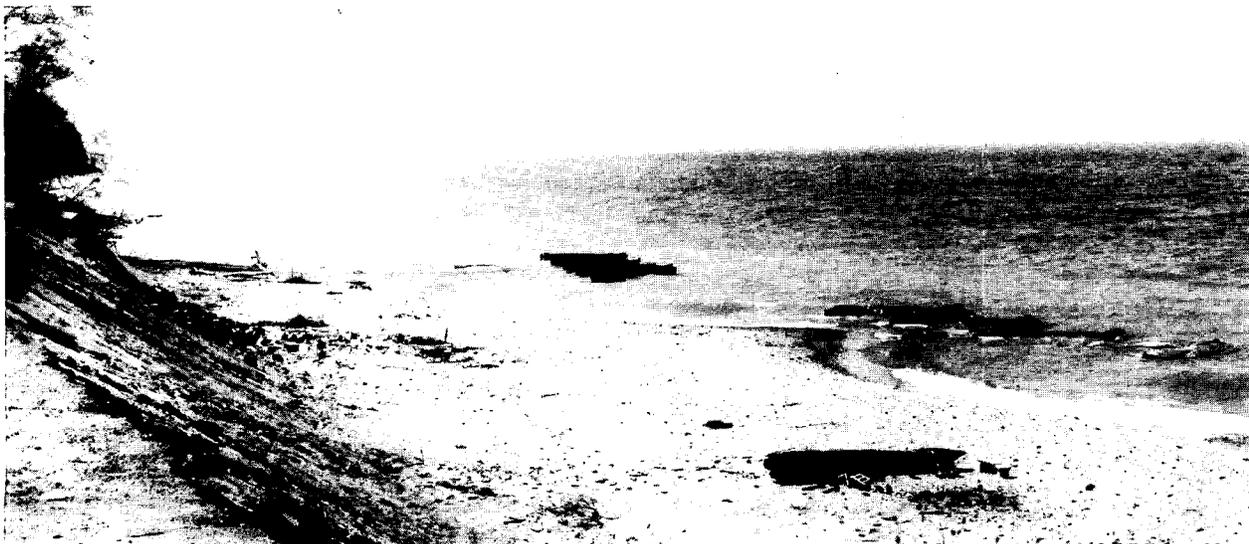
Photo #32 May 19, 1975

The south and center units are shown here. Some of the blocks from the destroyed bathhouse can be seen on the beach.

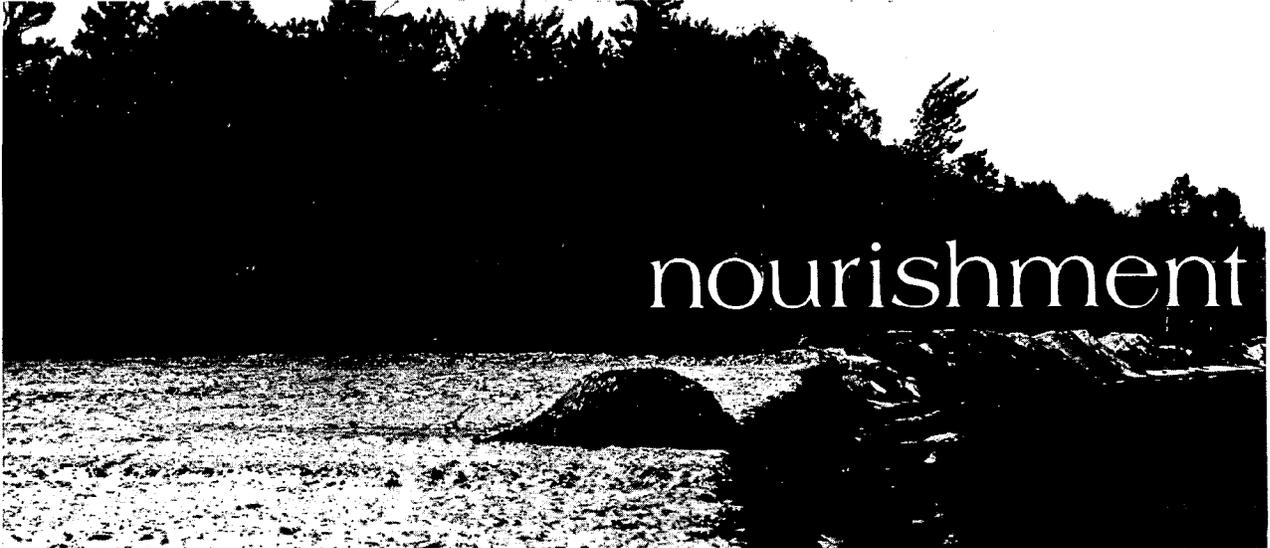
Photo #35 May 6, 1975  
Sand has covered all but small portions of the tube. The structure is no longer needed and is not functioning as a shore protection device.

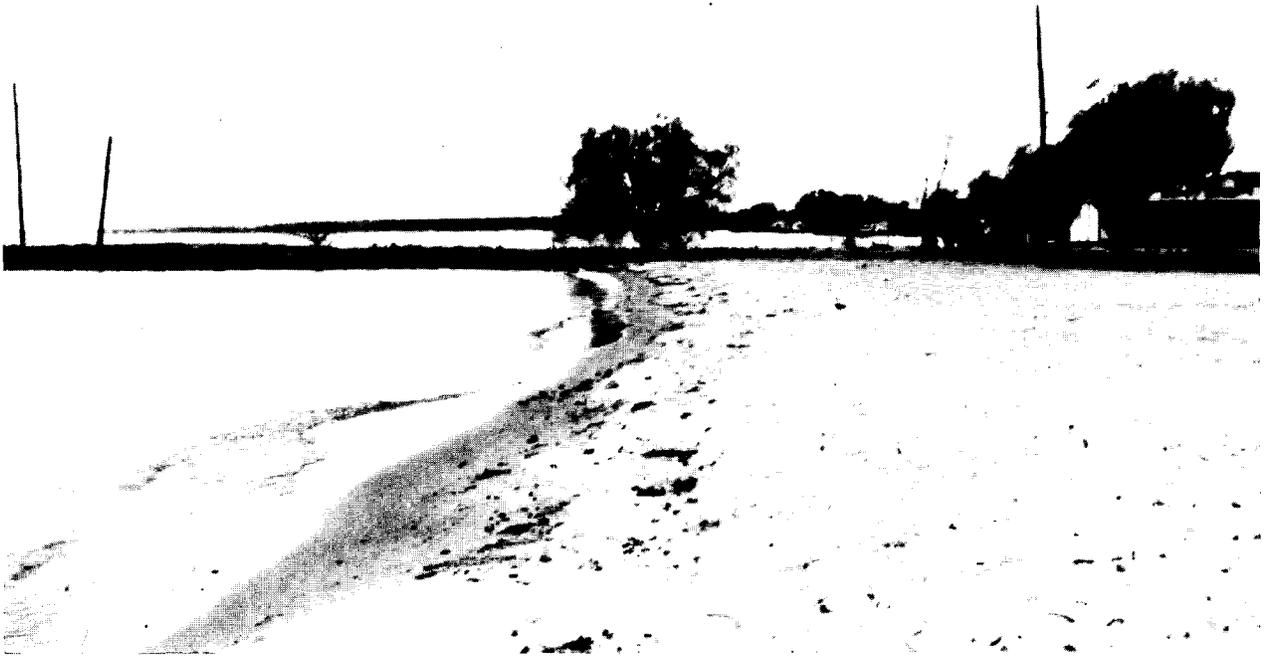
Photo #36 October 20, 1974  
Compare the relatively straight shoreline shown in this photograph with the curved appearance of the shoreline in Photo #37.

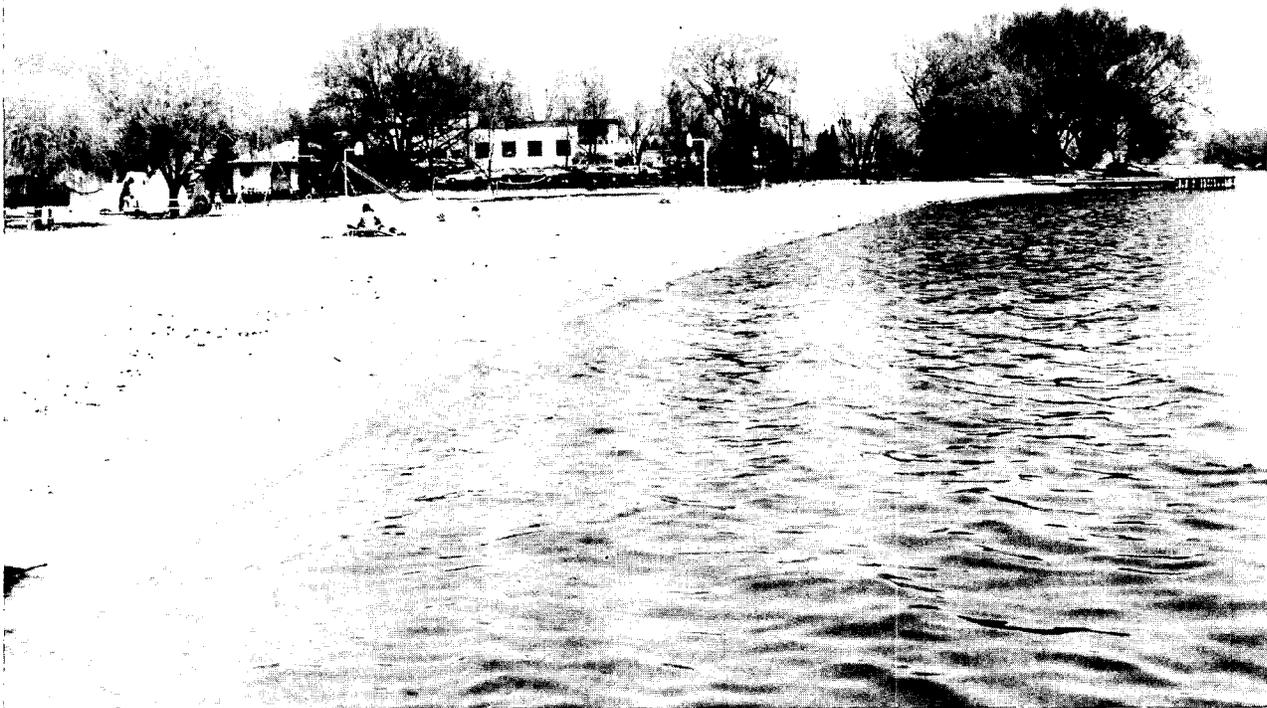
Photo #37 May 17, 1975  
 Only slight sand movement  
 has been detected at this  
 site.

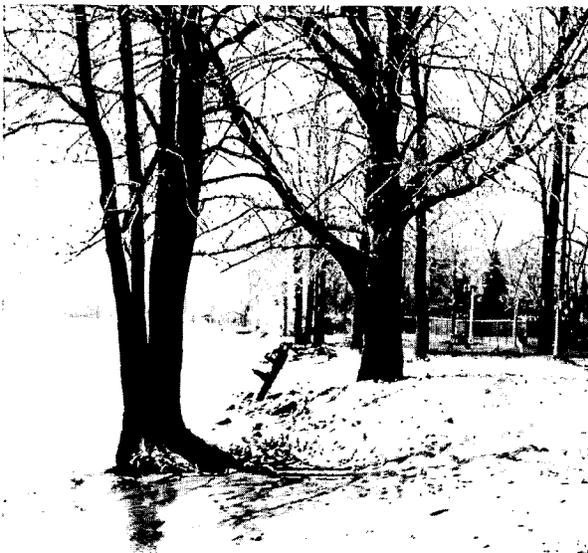
Photo #41 May 17, 1975  
 Another view of the sand fill and small rock revetment.
