SUMMARY: This amendment supersedes Airworthiness Directive (AD) 75-23-08 R5, which currently requires repetitively inspecting and replacing or repairing the exhaust system on certain Cessna Aircraft Company (Cessna) 300 and 400 series airplanes. The requirements of this AD replace the inspections and replacements that are required by AD 75-23-08 R5 with inspections and replacements containing new simplified procedures for all 300 and 400 series airplanes (models affected by the current AD plus additional models). This AD also revises the inspection intervals and requires replacing certain unserviceable parts and removing the exhaust system for a detailed inspection. This AD is the result of numerous incidents and accidents relating to the exhaust systems on Cessna 300 and 400 series airplanes dating from the middle 1970's to the present, including six incidents since issuance of AD 75-23-08 R5 where exhaust problems were cited. The actions specified by this AD are intended to detect and correct cracks and corrosion in the exhaust system, which could result in exhaust system failure and a possible uncontrollable in-flight fire with pilot and/or passenger injury.

Appendix to Docket

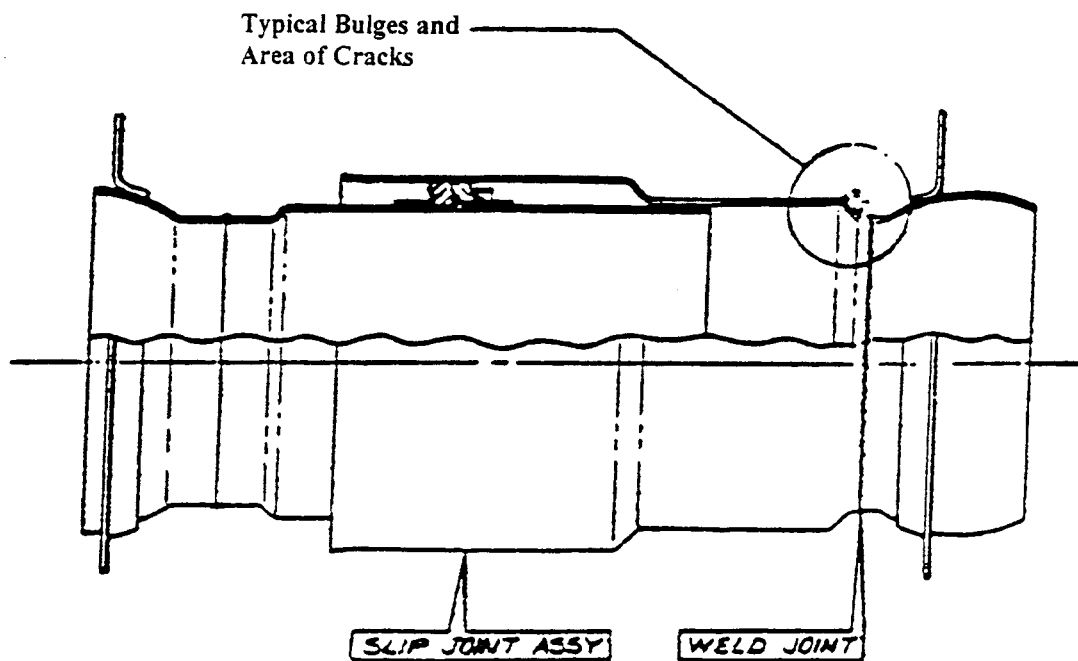
FIGURE 1 to the Appendix

(3) Visually inspect the exhaust joint springs for correct compression. If the joint is disturbed or if the springs are obviously loose or frozen, proceed with the following inspection (see Figure 1 of this Appendix).
