NISTIR 7809

Metallurgical Investigations into Corrosion Damage in Homes Constructed with Problem Drywall

R. E. Ricker
D. J. Pitchure
M. E. Williams
S. A. Claggett

Report prepared for the
U.S. Consumer Product Safety Commission
Directorate for Engineering Sciences
Bethesda, MD 20814

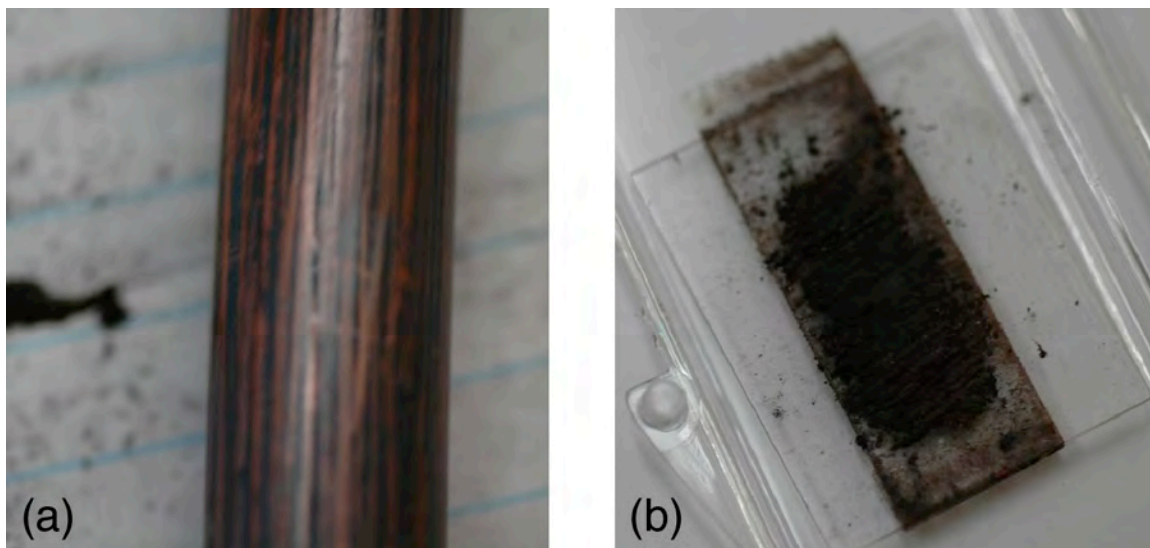
The black substance observed on the surfaces of the copper components was identified by X-ray diffraction. This was accomplished by scraping the black substance from the surface of one of the samples of copper natural gas line tubing using a razor blade. The powder removed in this manner was placed on double stick tape and attached to a glass slide, as shown in Figure 5. A powder diffraction pattern was then obtained from this sample of scrapings using a Siemens D500 X-ray diffractometer with a Cu K_{α} radiation source operated at 40 kV (kilovolts) and 30 mA (milliamperes) using a step size of 0.03 degrees, and a dwell time of 5 seconds (s).

Figure 5 – Photographs of the scraped copper natural gas supply line (a) and the slide holding the sample for X-ray diffraction (b).

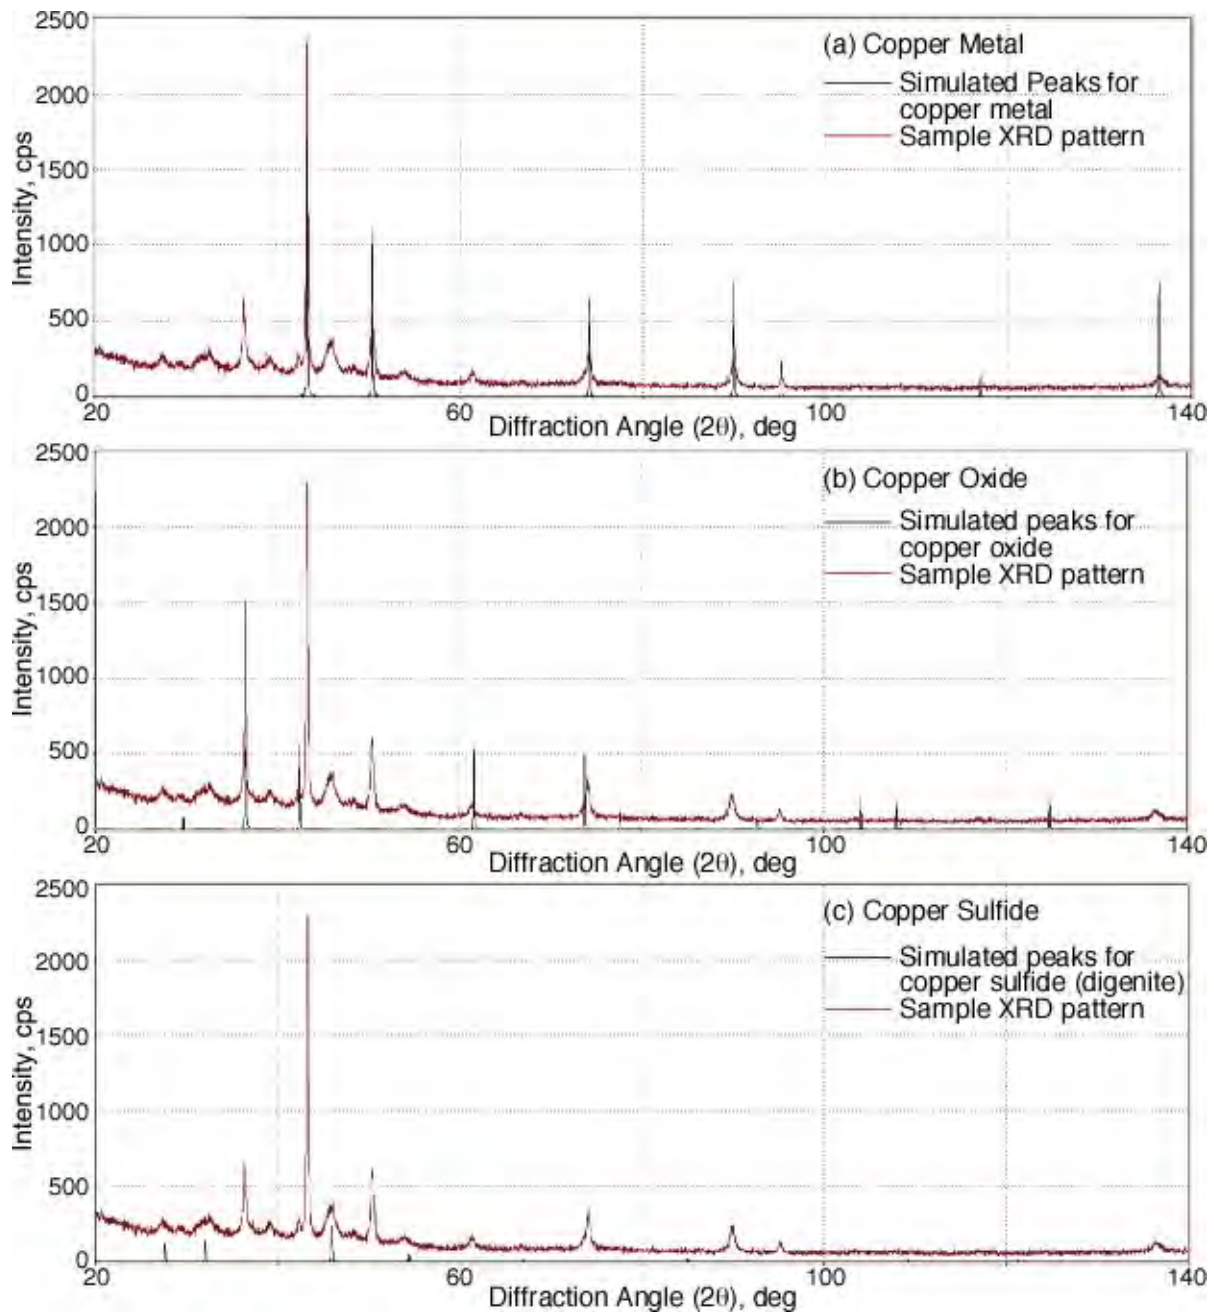
Figure 6 shows the results of these measurements in red along with the peak locations in black for copper metal (Figure 6a), copper (I) oxide (Figure 6b) and copper (I) sulfide (Figure 6c) as listed in the International Crystal Structure Database (ICSD) for the phase of copper sulfide known as digenite ($Cu_{1.80}S$ or Cu_9S_5). This figure shows that peaks corresponding to all three of these phases are present in the sample of scrapings from the surface of the copper natural gas supply line. Given that the sample was collected by scraping the surface of copper metal with a sharp razor blade, the peaks for copper and copper oxide were expected because copper is a soft metal compared to the steel of the razor blade, and it will normally form copper oxide when exposed to air. The third phase, copper sulfide (Cu_2S), is not a typical atmospheric corrosion product because the concentration of the reduced sulfur species, such as H_2S , required to form this product, is usually very low under normal indoor atmospheric conditions.^{1, 3-5} Figure 7 is a summary of the XRD results showing that all but two small peaks, indicated by question marks, are accounted for by these three phases.

Figure 6 – Measured X-ray powder diffraction patterns for the sample of corrosion products scraped off a Cu natural gas supply line in red compared with simulated patterns for specific structures in black (simulated peaks do not contain background noise): (a) Cu metal, (b) copper (I) oxide (ICSD #38233), and (c) the copper (I) sulfide phase digenite (Cu_9S_5) (ICSD #95395).

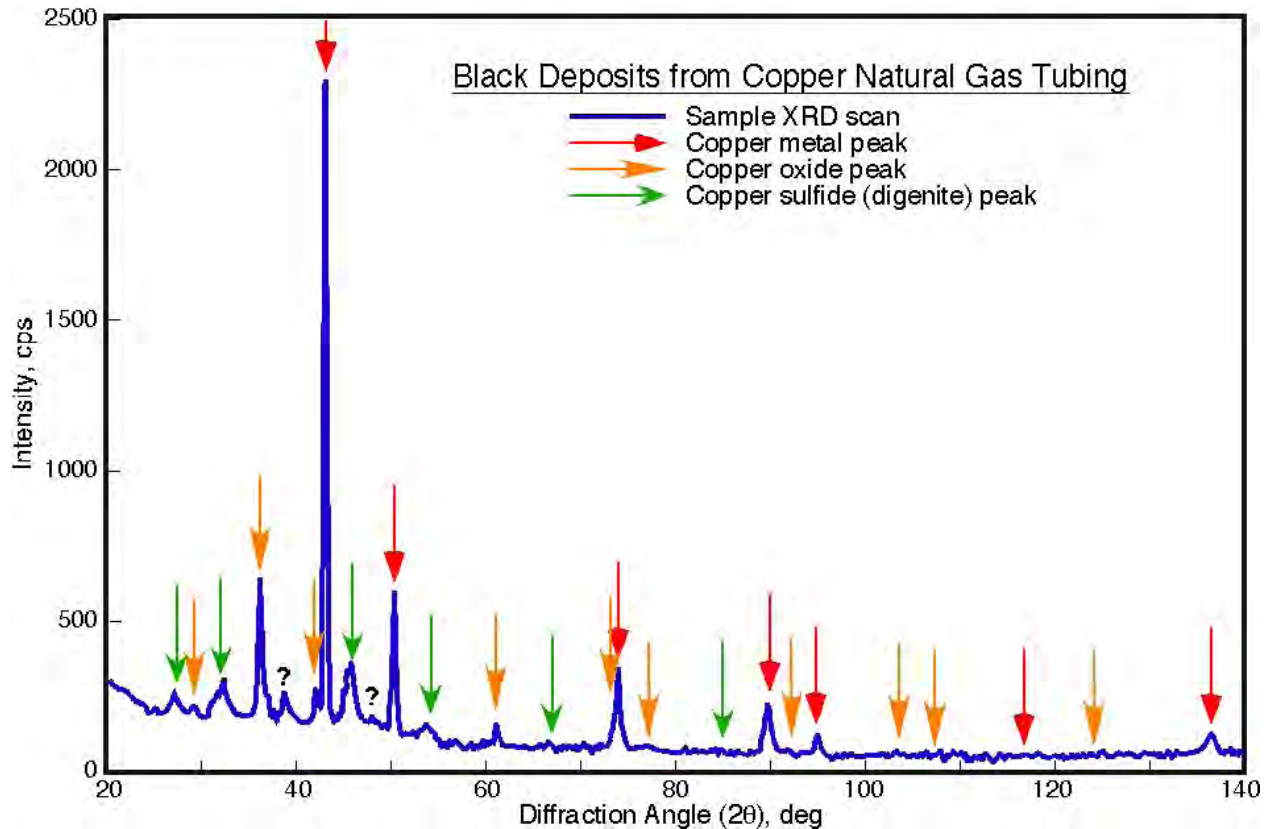
Figure 7 – Summary of peaks found in the corrosion product sample and their identification for showing that only two small peaks were unidentified by the three phases.

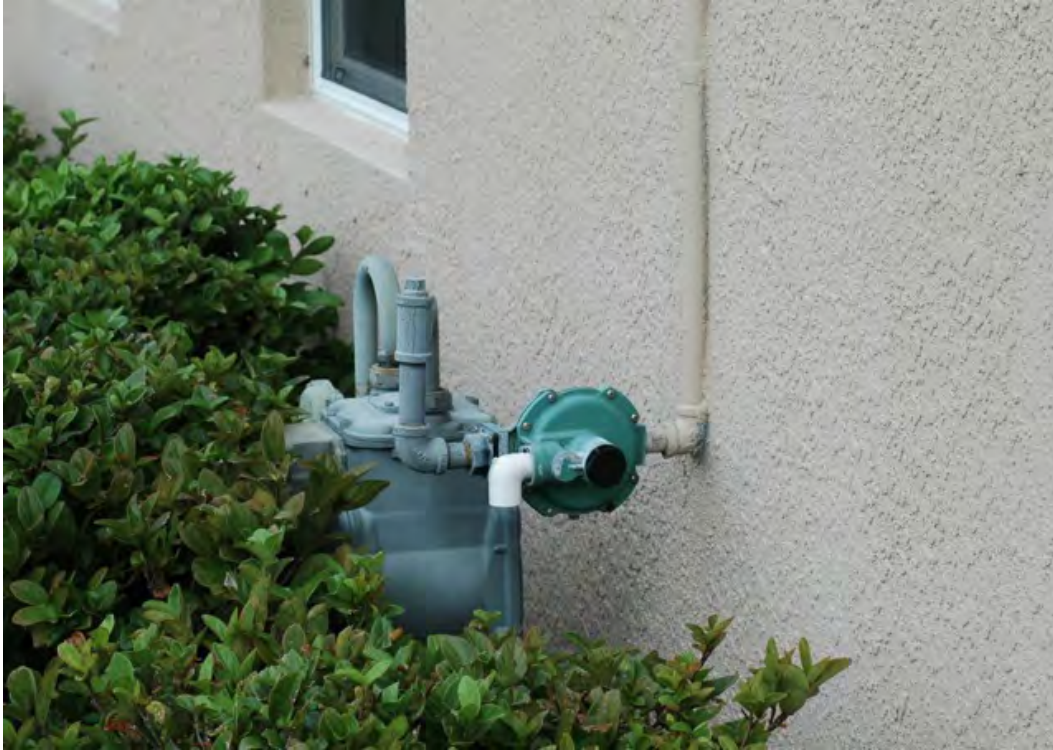
Because the emphasis was on safety-related systems, the natural gas supply systems and appliances were examined first. Figure 10 shows the natural gas meter and inlet on the outside of one of the homes. No evidence of any corrosion damage beyond that normally expected for exposure to the outdoor atmosphere in Florida can be seen in Figure 10. Figure 11 shows the stainless steel flex tube used to connect the water heater to the gas distribution pipe. The Figure shows very little evidence of corrosion, while the outside of the brass fitting on the end is covered with a dark corrosion product. The brass visible on the inside of this fitting indicates the original color of this fitting. Figure 12 shows one of the wall electrical receptacles. As is typical in homes made with problem drywall, the bare copper ground wire is covered with a thin uniform black film of corrosion products that is so uniform that it almost appears as if the wire were painted black or is covered with a thin layer of electrical insulation. Figure 13 shows the HVAC evaporator coil in a garage after removal of the side cover, and Figure 14 shows the corrosion damage in the attic unit from the same home. Both units show considerable discoloration of the copper tubes, indicative of the reaction of copper with a reduced sulfur species similar to that shown in Figures 6 and 7.

Figure 10 – Gas meter on the outside of a problem drywall home.

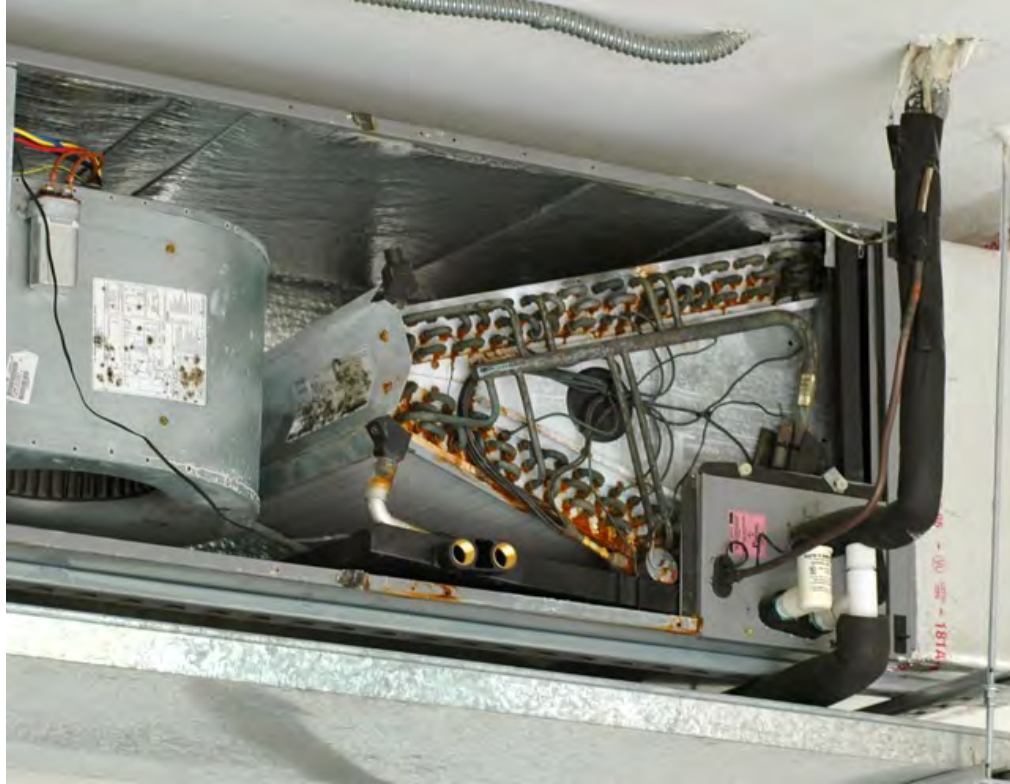
The homebuilder told NIST staff that both homes had experienced trouble repeatedly with the HVAC systems, which HVAC service providers attributed to loss of coolant pressure due to corrosion of the evaporator coil (A-coil). It was also reported that total replacement of the evaporator coil frequently was employed as a remedy and that both of the homes examined had their evaporator coils replaced at least once. However, these reports and the operational history of these units could not be documented, and the actual working status of the systems at the time of the NIST inspection could not be determined unequivocally. The evaporator coil shown in Figure 13, suspected to have failed in service, was tagged and shipped to NIST for laboratory examination. At NIST, the coil was pressurized and leak-tested, as shown in Figure 15. No evidence of leaking was detected, and no loss of pressure was observed. Therefore, it is concluded that either: (i) this unit was not leaking in service, or (ii) the leak was not in the evaporator coil but in a connection or section of the pressure boundary not included in this sample. Therefore, no further examinations were conducted on this unit.

Figure 13 – HVAC unit in the garage of a problem drywall home.

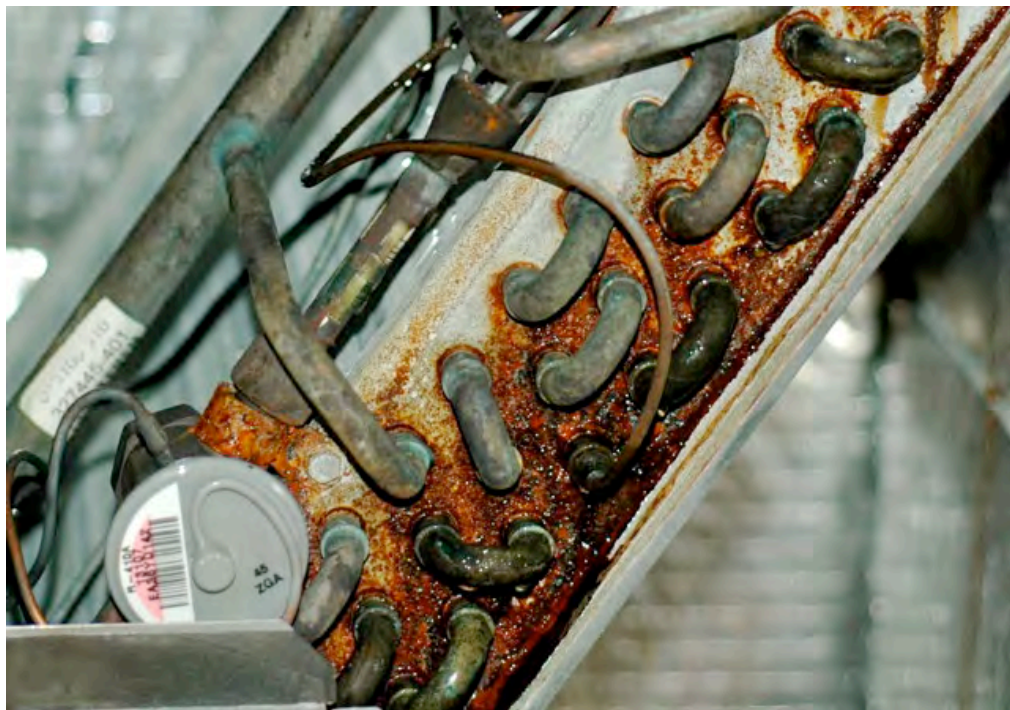
Figure 14 – HVAC unit in the attic of a home with problem drywall.

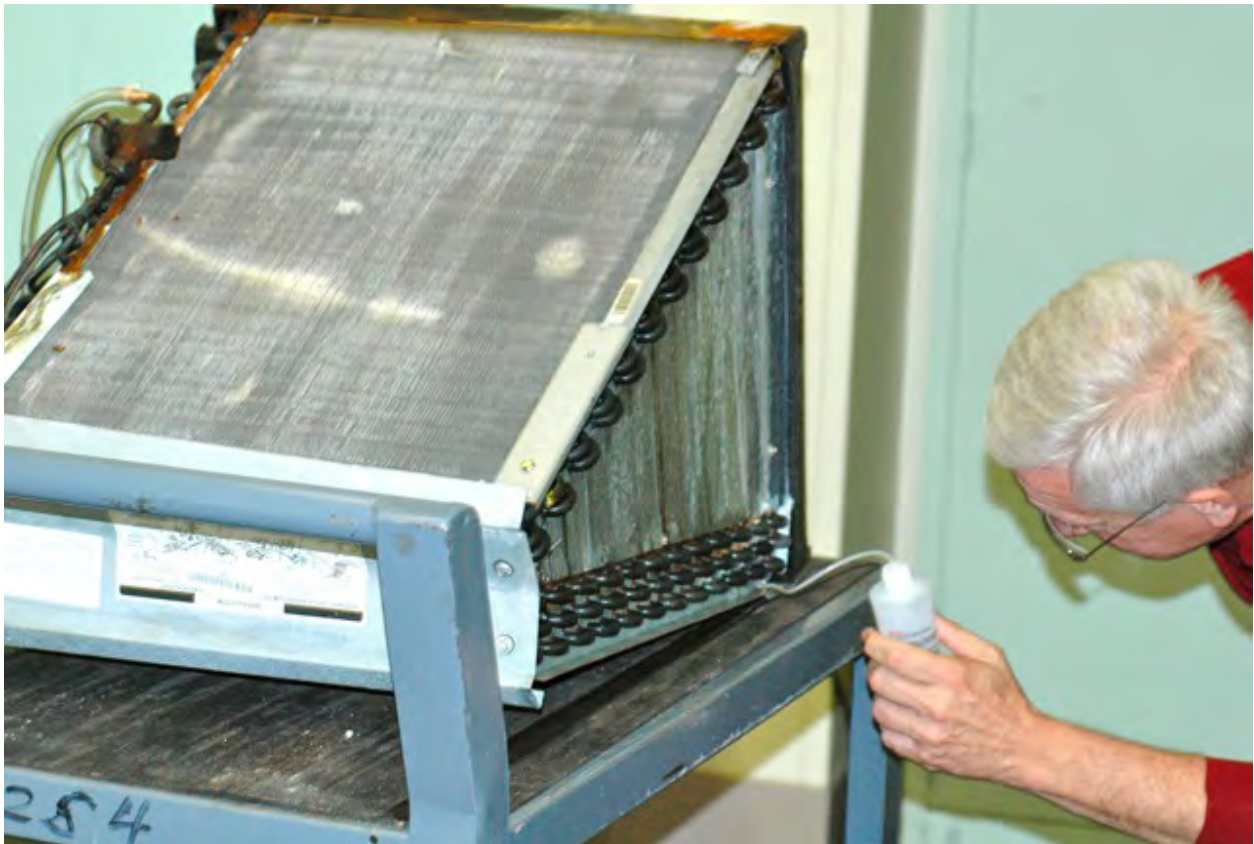
Figure 15 – The garage HVAC unit shown in Figure 13 undergoing leak testing in the metallurgy laboratory at NIST.

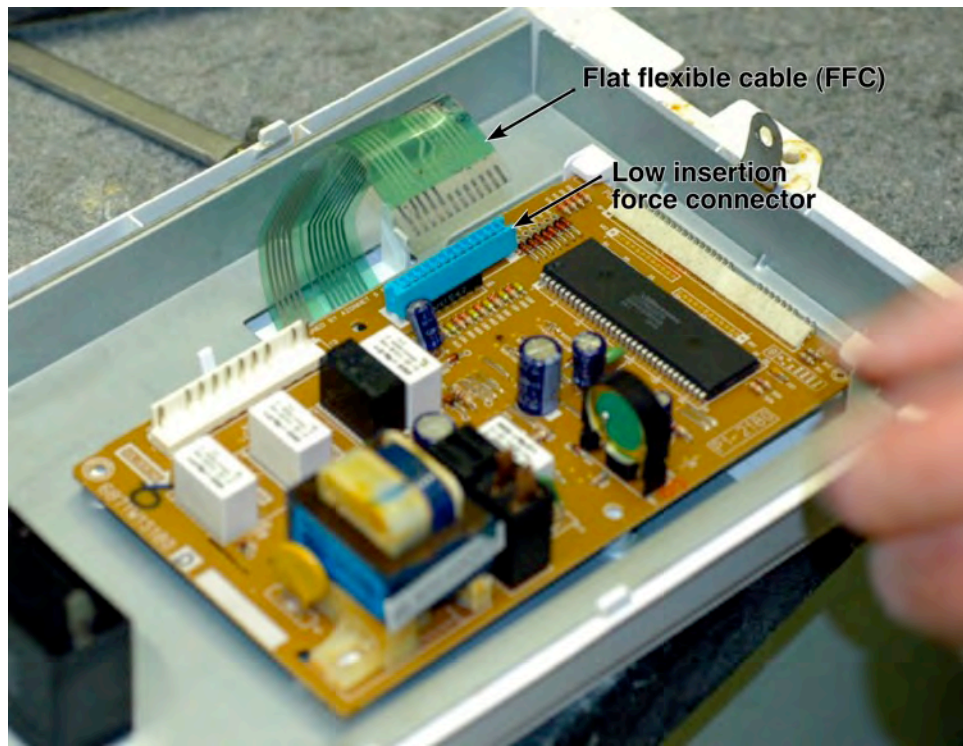
Figure 16 – Removal of the control module of the microwave oven.

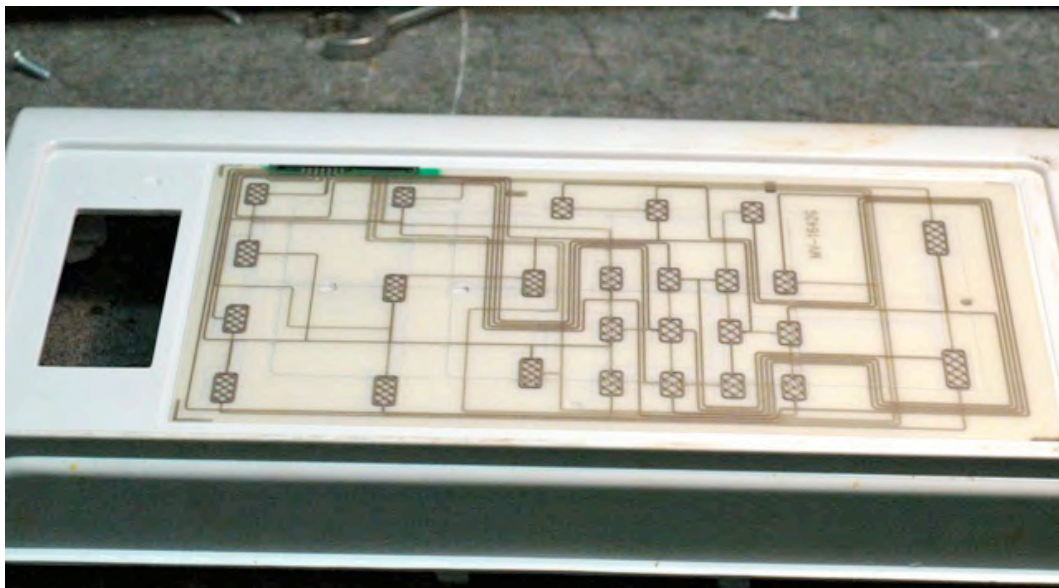
Figure 17 – Pushbutton controls with cover removed.

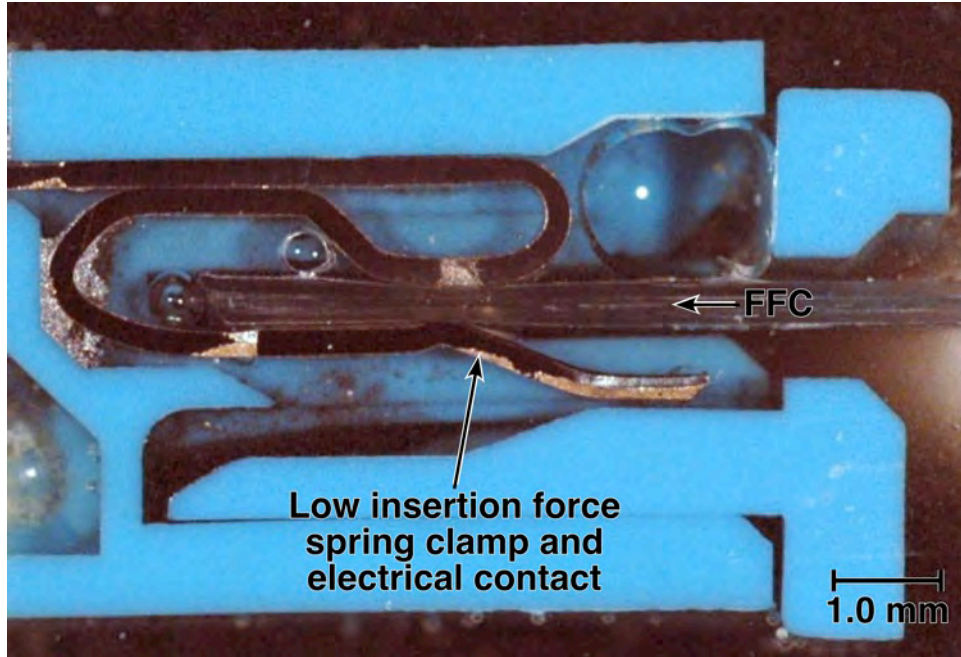
Figure 20 – Flat, flexible cable plug in low-insertion force connector mounted in clear epoxy, cross sectioned, and polished for microscopic examination.

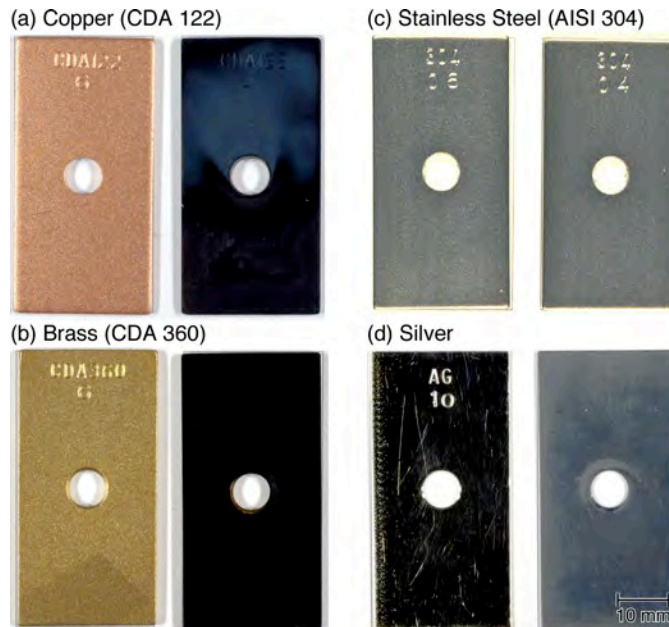
(2) Optical Examination Results. Figure 23 shows photographs of the five flat coupon samples of each alloy after exposure to the accelerated test environment at SNL. Figure 24 shows a photograph of a representative sample of each alloy, after exposure, next to a sample that was not exposed to the accelerated test environment. By comparing these photographs, it can be seen that the alloys that contain copper formed very dark deposits that appear to be thick due to the dark opaque color of these deposits. The silver samples are also significantly altered

by this exposure, although the change seems to be more of a case of loss of luster rather than the development of a corrosion product. No evidence of general or localized attack was observed on any of the stainless steel coupons. Similar deposits were found on the U-bend coupons, but no evidence of any form of localized corrosion, pitting, or stress corrosion cracking was found on any of the samples.

Figure 24 – Unexposed samples (left side) compared to samples of the same alloy after 60 days of exposure to the accelerated testing environment at SNL (right side). The unexposed silver sample appears dark because its mirror-like surface is highly reflective.

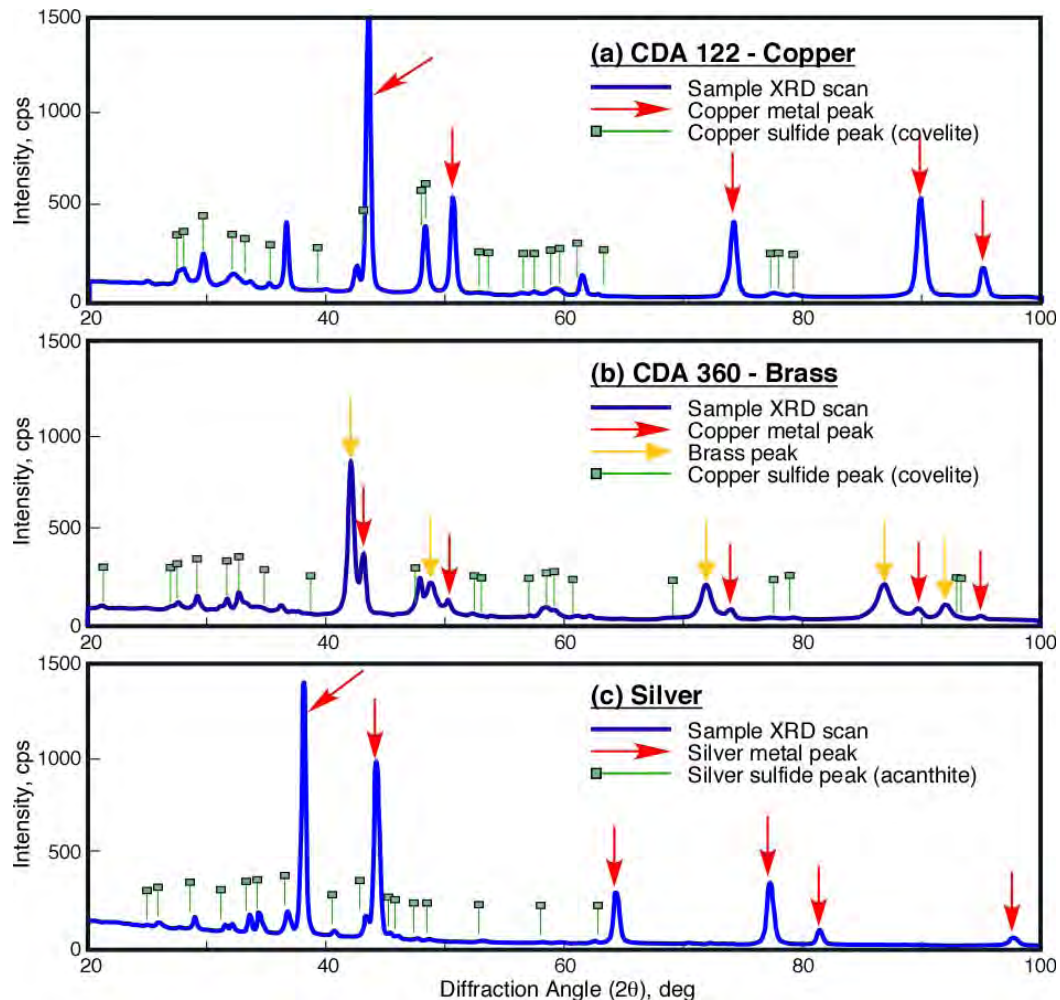
(3) X-ray Diffraction Results. The corrosion product scales on the accelerated test coupons were analyzed by X-ray diffraction for comparison to the scales found on samples removed from homes with problem drywall. This also enabled the use of corrosion product stoichiometry in the analysis of the coupon mass change measurements. A commercial diffractometer with a Cu K-alpha radiation source and a gas-filled 2D area detector at a 15 cm sample-to-detector distance with a field of view of 35 degrees was used. The X-ray beam spot size was 0.5 mm x 1.5 mm in lateral dimensions. Three consecutive scans were performed over the 2-theta range from 20 degrees to 100 degrees. Table II shows the results of this analysis, and Figure 25 shows powder diffraction scans, one each obtained from a sample of copper (CDA122), brass (CDA360) and silver. It should be noted that the X-ray diffraction results show that the accelerated testing environment with its greater concentrations of reactants, including H₂S, altered the corrosion product on the surface of copper and brass from the digenite phase (Cu₉S₅) found on samples removed from homes with problem wallboard to the covellite phase (CuS). The deposit on the silver sample was found by X-ray diffraction to be acanthite (Ag₂S). A similar analysis was not performed on samples from problem drywall homes, but silver has only one sulfide phase that is stable at ambient temperatures.

Figure 25 – X-ray powder diffraction scans from samples of three alloys after exposure to the accelerated testing atmosphere for 60 days. Table II summarizes the findings.

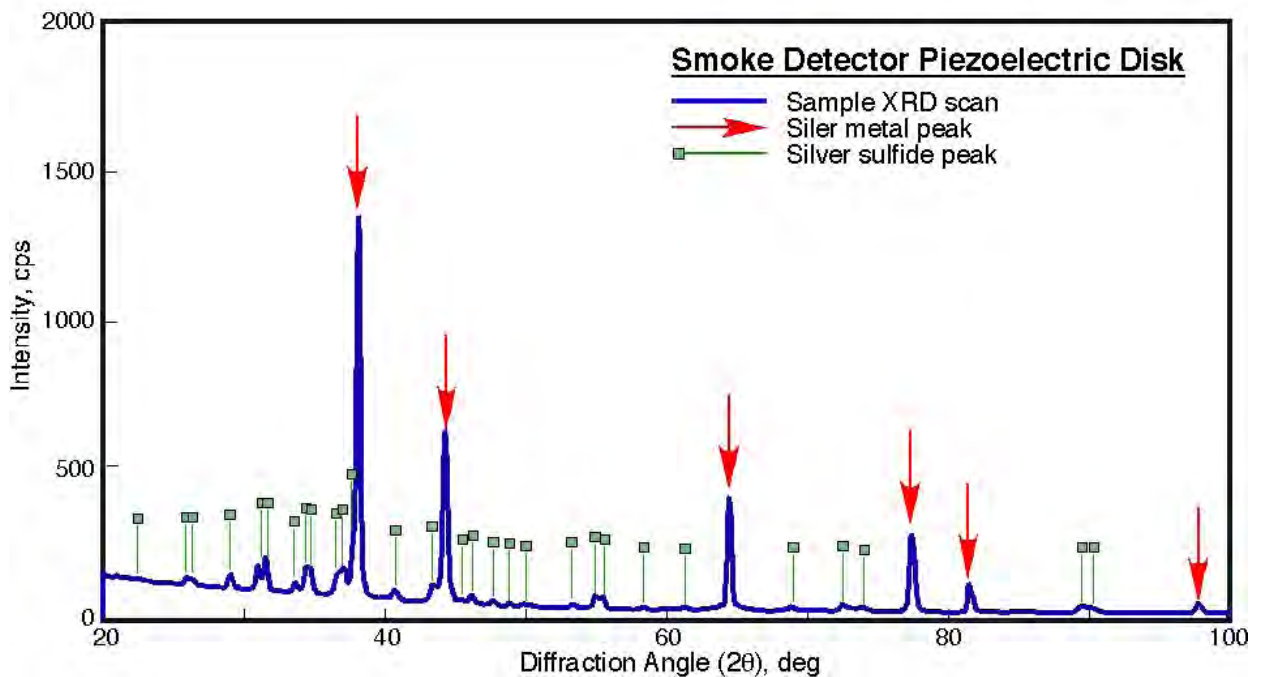
Figure 30 – X-ray powder diffraction scan showing peaks for silver and silver sulfide obtained from the surface of the piezoelectric buzzer disc shown on the left in Figure 29.

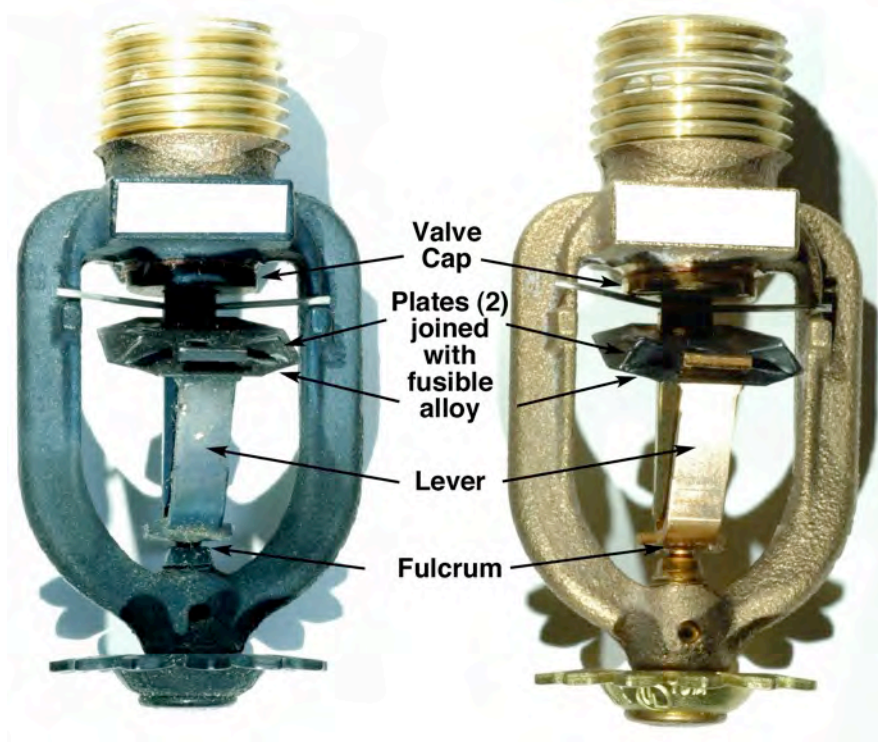
(2) Fire Sprinkler Results: Figure 31 shows the sprinkler that failed to activate in the NIST plunge test on the left and a sprinkler of the same design that has not been exposed to the accelerated corrosion test environment on the right. From this figure, it can be seen that exposure to the accelerated corrosion testing environment turned all of the copper and brass parts of the sprinkler a dark black color. The thin black plate slightly inclined to the viewing angle near the middle of both units is the fusible link. It is actually two plates fused together with a low melting point alloy. The copper strip in the middle is the lever that is held in place by the fusible link. When a heat source melts the fusible alloy, the two plates separate, allowing the lever to move, which releases the strut behind the lever holding the valve cap in place. Figure 32 is a close-up of the fusible links in the same units, and this figure shows how the fusible link holds the lever and the strut together, allowing the strut to keep the valve cap, shown above it, in place. The two plates fused together are similar in shape, except that opposite sides of the plates have their corners turned up in a “dog eared” fashion. As a result, this view also allows a view of the fusion zone between the two plates; however, examination of this figure indicates that a black coating of some type has been applied by the manufacturer to limit access of the external environment to the plates of the fusible link or to the low melting point alloy. Figure 33 shows two views of a fusible plate from a sprinkler that successfully activated in the plunge test at NIST. The surface that mated the plate of the opposite side and the remains of the low melting point alloy can be seen on the surface of this plate. In addition, the lip left by the fracture of the coating when the plates separated can be seen in the plane view; the oblique angle of the second photo makes it clear that this substance came over and covered the fusible alloy. Chemical analysis of this coating and the fusible alloy is beyond the scope of the present work.

Because corrosion could alter the contact of the pivot and lever mechanism, the force applied to the fusible link by the lever of the unit that failed to activate was measured by suspending weights from the lever and determining the mass that freed the fusible plate from the lever. The force the lever placed on the fusible link of the unit that failed to activate was estimated at $3.03 \text{ kg} \pm 0.05 \text{ kg}$ and this compares to $4.84 \text{ kg} \pm 0.06 \text{ kg}$ for a similar unexposed unit. While this is a large enough difference for one to detect by hand, 3 kg of force should still be enough force to separate the plates if the low melting point alloy between the plates melted and the plates were free to move.

Figure 31 – A comparison between a lever-type, fusible-link fire sprinkler head after exposure to the accelerated corrosion test environment at SNL (left) and another one from the same batch that has not been exposed to this environment.

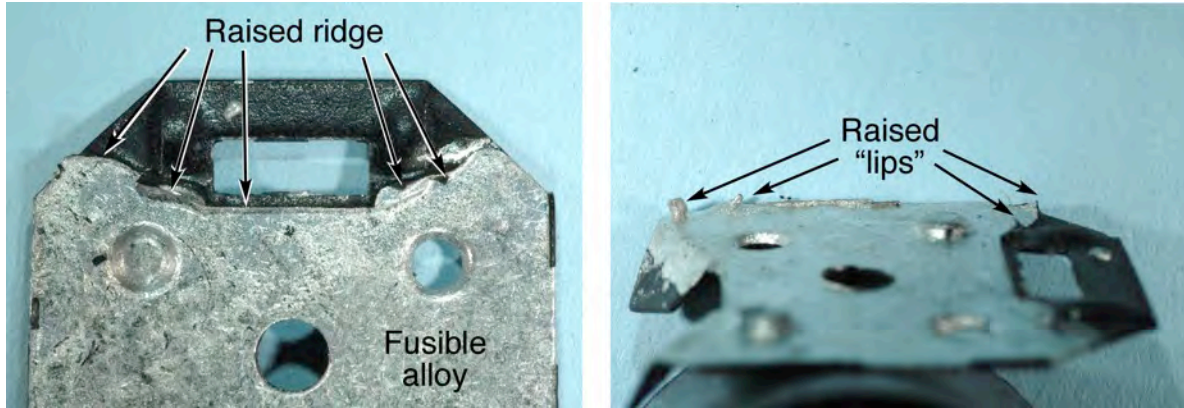
Figure 33 – Two macro photographs of the plate from a fusible link plate from a sprinkler that activated in the plunge test at NIST. The remains of the fusible alloy are the silver-colored substances in the fusion region of the plate, and the remains of the black coating can be seen to form a lip on the edge of the fusion zone.

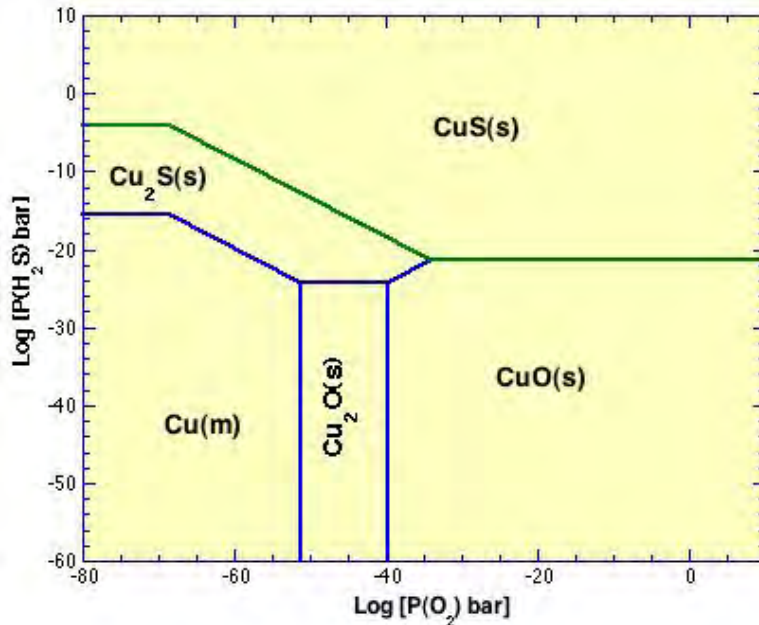
Figure 34 is a diagram of the stable phases of oxygen and hydrogen sulfide, at different partial pressures, on the surface of copper (concentration or activities). This diagram was created from the assembled list of postulated chemical reactions in Appendix A. The free energy change was calculated using the data of Wagman et al.,¹⁷ and the equilibrium line determined for the reaction with respect to variable oxygen and hydrogen sulfide partial pressures. For these calculations, it was assumed that the total gas pressure was 1 barr (approximately atmospheric pressure) and the relative humidity was assumed constant at 31.6 percent (where $\text{Log}_{10}[\text{H}_2\text{O}] = -0.5$). By examining this figure, it can be seen that copper sulfide and copper oxide are stable-to-very low concentrations of these gasses in an atmosphere. The relative position of the Cu_2S and the CuS phase fields in this diagram indicates that increasing the hydrogen sulfide concentration (as measured by partial pressure in the diagram), causes the stoichiometry of the stable phase to shift to a lower Cu/S ratio. Wagman et al.¹⁷ provide thermodynamic data for only two of the copper sulfide phase that can form. Fourteen different phases have been identified in the Copper-sulfide system,¹⁸⁻²⁰ but the composition of these lie between these two extremes. Copper sulfides are non-stoichiometric compounds that will exchange ions with the atmosphere to equilibrate at intermediate concentrations of hydrogen sulfide. Therefore, it is not too surprising that a different phase of copper sulfide was found on the laboratory samples, as compared to that found in the homes with problem drywall. The greater concentration of hydrogen sulfide used in this environment to accelerate the test just moved the stoichiometry of the corrosion product to one of the lower Cu/S ratio sulfides.

Figure 34 – Diagram of the stable phases on copper metal as a function of the oxygen and hydrogen sulfide partial pressures (concentrations). This diagram assumes that the activity of water vapor in this atmosphere is constant at 31.6 percent relative humidity.
