NATIONAL BUREAU OF STANDARDS REPORT

7489

PERFORMANCE OF ROOFING IN PUERTO RICO

20 April 1962

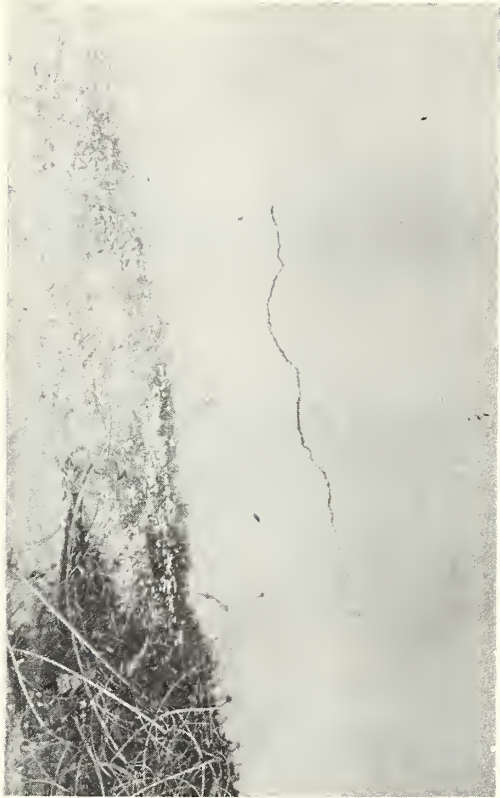
12

This method consisted of applying a cement grout directly over the crack, as illustrated in Figure 13. Our observations indicated that this method was not effective due to the poor adhesion to the dense concrete deck. On the other hand, if proper adhesion was obtained it is predicted that the crack in the substrate would soon be transferred to the patching compound due to its relatively poor elasticity.

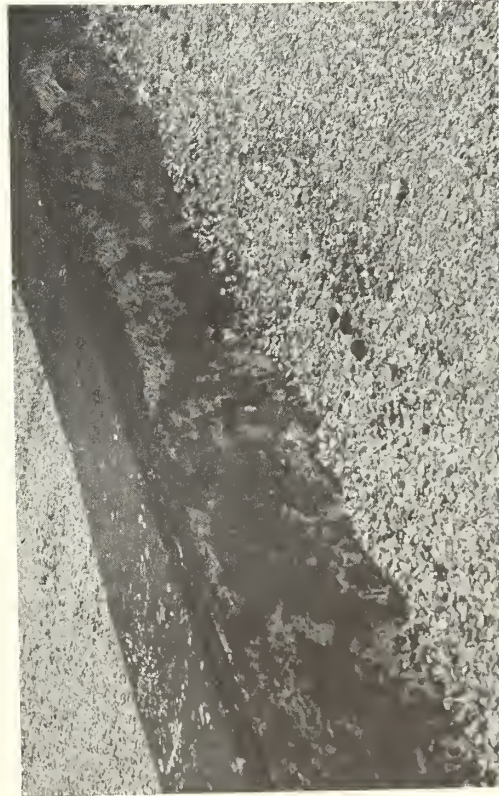
19

The appearance of this roof was good after about 20 years exposure, as shown in Figure 18. An examination of the asphalt showed it to be very hard and brittle even at the high temperature of the roof. However, there were no other signs of deterioration and it was apparently performing its basic function. The only defects observed were a number of bare areas where the felts were exposed. Some 41 leaks were reported in this roof. However, our observations indicated that most, if not all, of the leaks resulted from defective flashings, as shown in Figure 19. Obviously such deficiencies could be prevented by adequate and timely maintenance.
