THE APOLLO 13 ACCIDENT

HEARINGS
BEFORE THE
COMMITTEE ON
SCIENCE AND ASTRONAUTICS
U.S. HOUSE OF REPRESENTATIVES
NINETY-FIRST CONGRESS
SECOND SESSION

JUNE 16, 1970

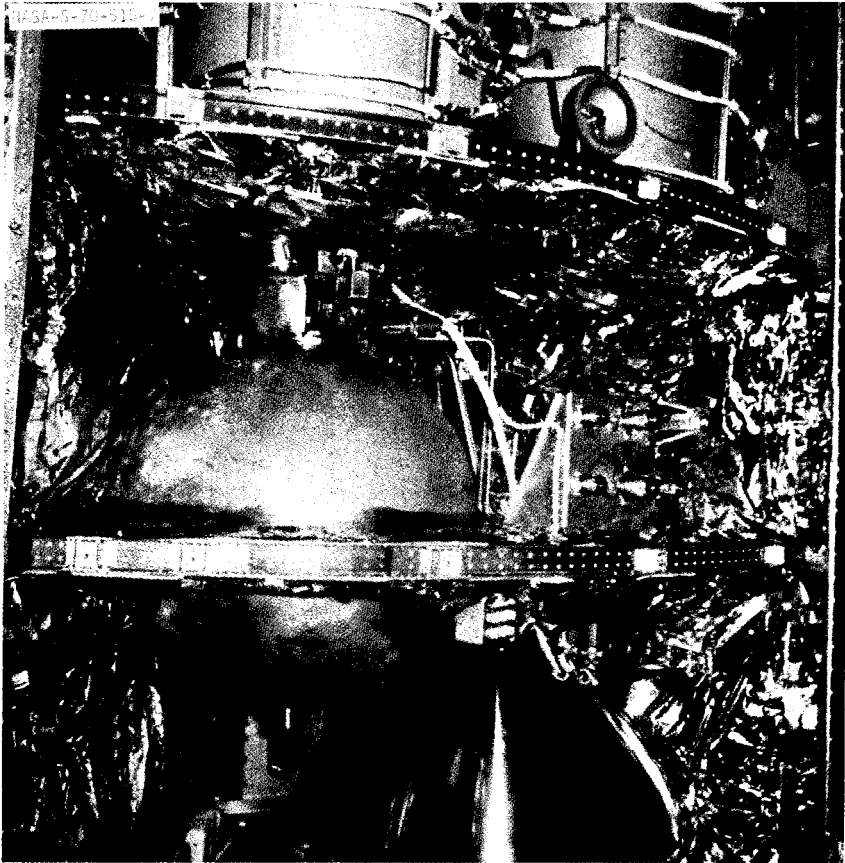
The tanks supply oxygen to the environmental control system (ECS) for the astronauts to breathe, and oxygen and hydrogen to the fuel cells. The fuel cells generate the electrical power for the command and service modules during a mission. The next slides (Nos. 5, 6 and 7) are photographs of Bay 4 of the service module for Apollo 13, showing the major elements and their interconnection. Slide 7 shows the oxygen tank #2 in place.

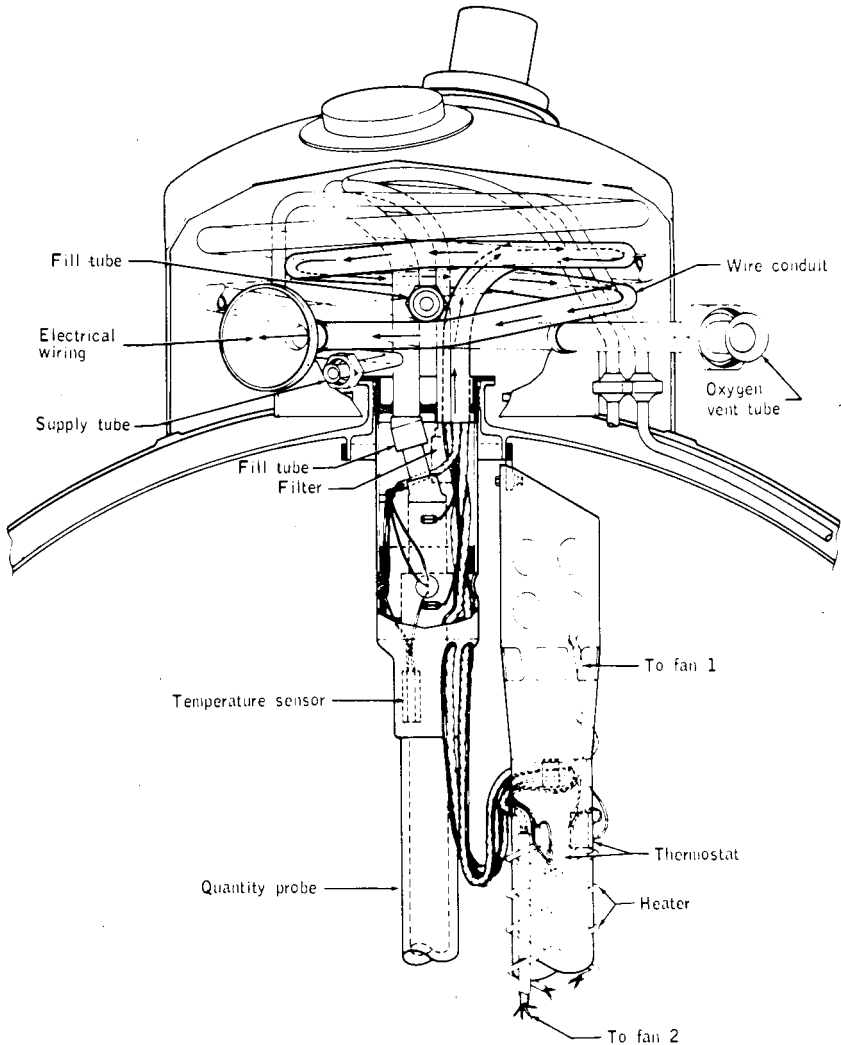
Figure 4-2.- Oxygen tank wiring and lines.

There is a pressure switch on this line, a pressure transducer to measure the pressure, and a relief valve in the event this pressure gets too high. This relief valve actually opened during the course of the accident.

A temperature rise of not too much would make it fail at the 1,000 pounds per square inch pressure it was then experiencing. Probably the penetration cap came out at that time.

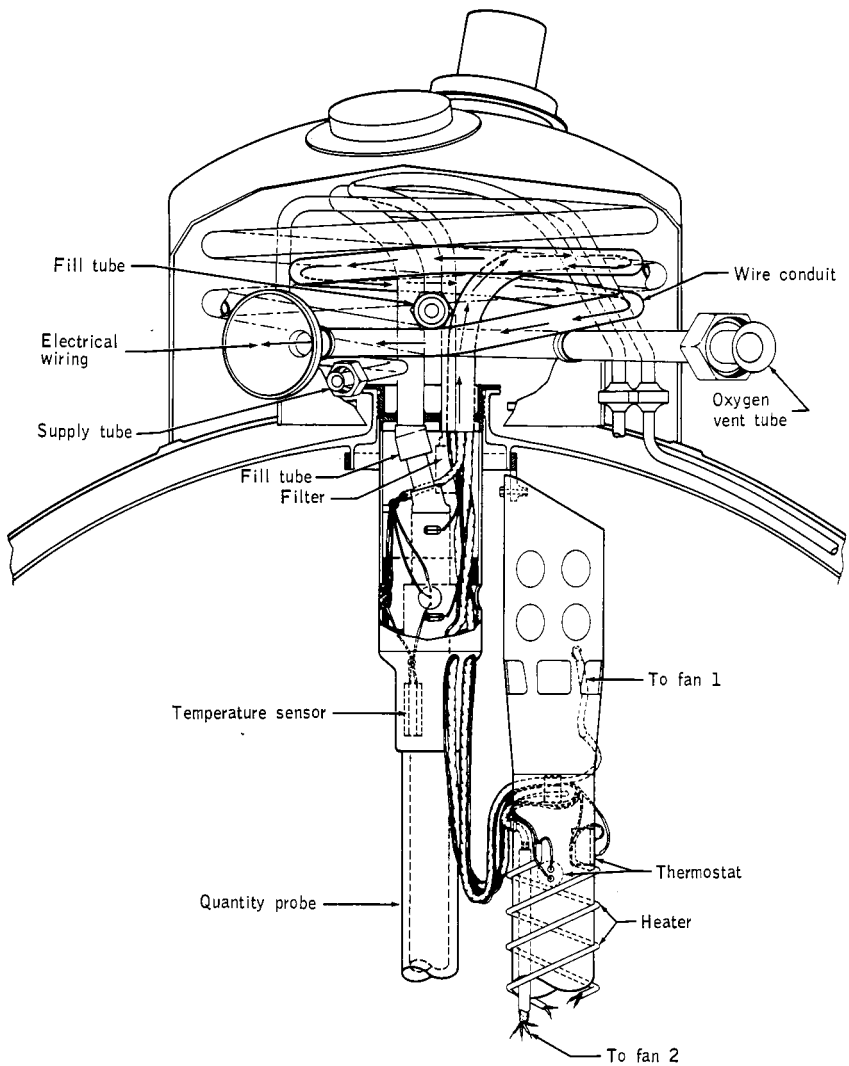
Figure 4-2.- Oxygen tank wiring and lines.

As shown in figure 4-2, the fill line from the exterior of the SM enters the oxygen tank and connects to the inner cylinder of the capacitance gage through a coupling of two Teflon adapters or sleeves and a short length of Inconel tubing. The dimensions and tolerances selected are such that if "worst case" variations in an actual system were to occur, the coupling might not reach from the fill line to the gage cylinder (fig. 4-3). Thus, the variations might be such that a very loose fit would result.

As noted earlier in this chapter, and shown in figure 4-2, each heater is protected with a thermostatic switch, mounted on the heater tube, which is intended to open the heater circuit when it senses a temperature of 80° F. In tests conducted at MSC since the accident, however, it was found that the switches failed to open when the heaters were powered from a 65 V dc supply similar to the power used at KSC during the detanking sequence. Subsequent investigations have shown that the thermostatic switches used, while rated as satisfactory for the 28 V dc spacecraft power supply, could not open properly at 65 V dc. Qualification and test procedures for the heater assemblies and switches do not at any time test the capability of the switches to open while under full current conditions. A review of the voltage recordings made during the detanking at KSC indicates that, in fact, the switches did not open when the temperature indication from within the tank rose past 80° F. Further tests have shown that the temperatures on the heater tube may have reached as much as 1000° F during the detanking. This temperature will cause serious damage to adjacent Teflon insulation, and such damage almost certainly occurred.

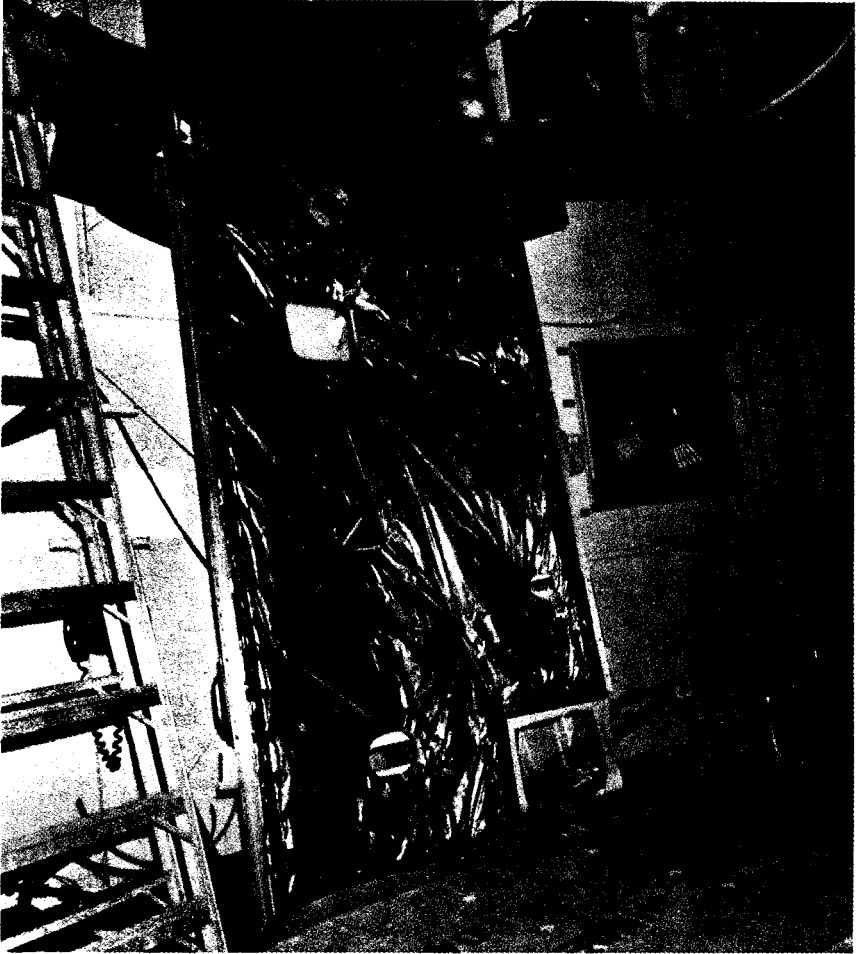
4-8.-
Figure ~~XXX~~ Inside view of panel covering bay 4.

of the Apollo 13 service module (SM 109) at the North American Rockwell plant prior to shipment to KSC. Figure 4-5 shows the fuel cell shelf, with fuel cell 1 on the right, fuel cell 3 on the left, and fuel cell 2 behind cells 1 and 3. The top of oxygen tank no. 2 can be seen at the lower left. Figure 4-6 shows the oxygen tank shelf, with oxygen tank no. 2 at left center. Figure 4-7 shows the hydrogen tank shelf with hydrogen tank no. 1 on top and hydrogen tank no. 2 below. The bottom of the oxygen shelf shows some of the oxygen system instrumentation and wiring, largely covered by insulation. Figure 4-8 is a photograph of the bay 4 panel, which was missing from the service module after the accident.

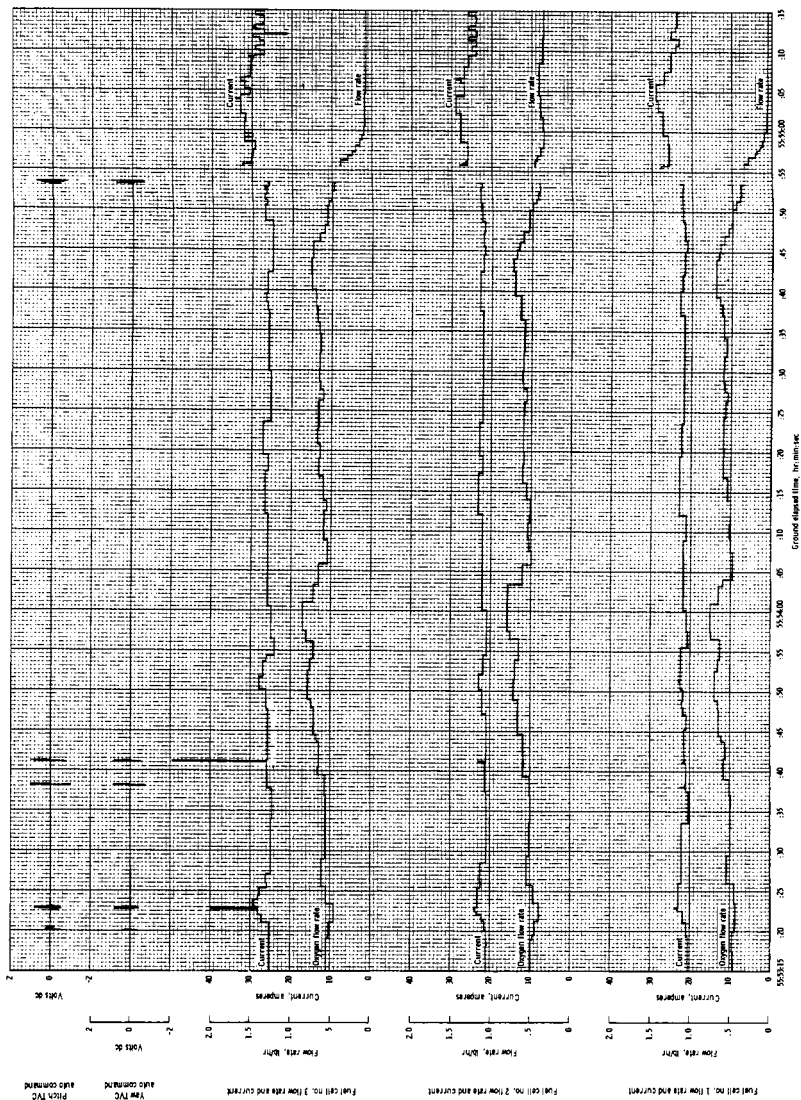
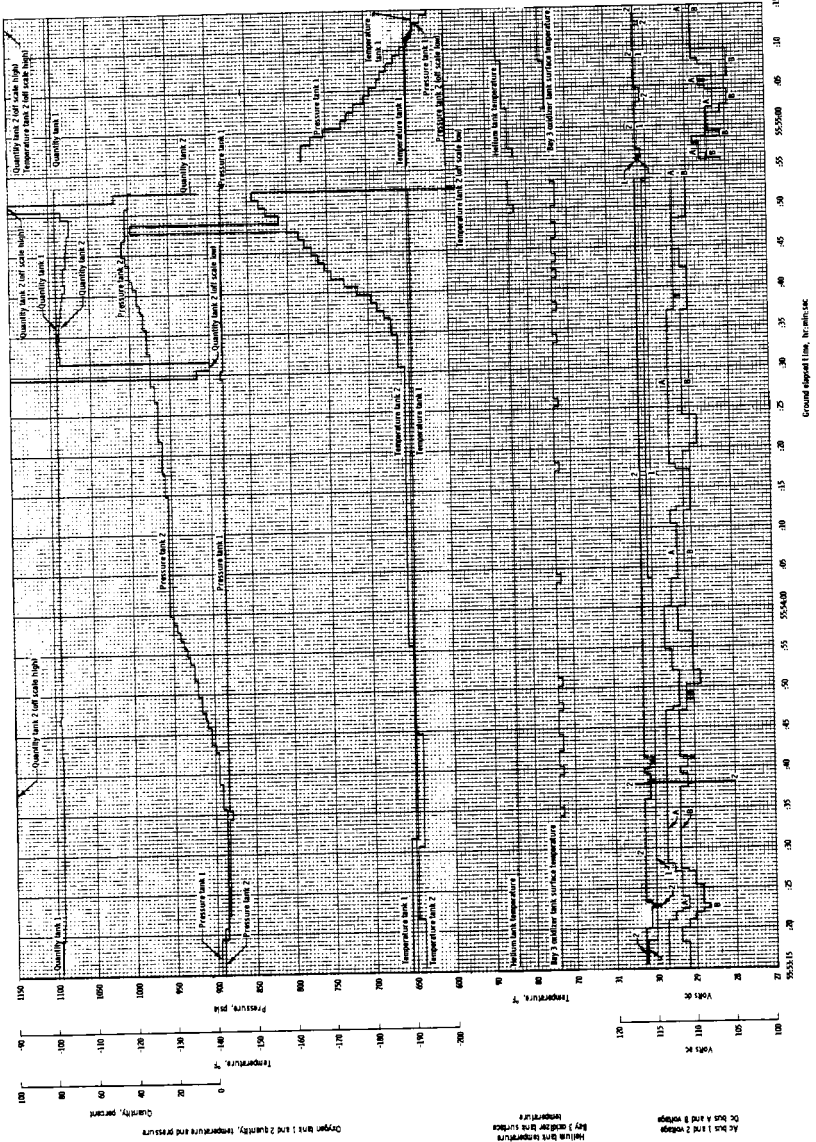
Figure 4-10.- Telemetry record.

The various telemetered parameters of primary interest are shown in figure 4-10 and listed in table 4-11.
