# APOLLO 13 MISSION REVIEW

HEARING  
BEFORE THE  
COMMITTEE ON  
AERONAUTICAL AND SPACE SCIENCES  
UNITED STATES SENATE  
NINETY-FIRST CONGRESS  
SECOND SESSION

JUNE 30, 1970

## CHAPTER 5—FINDINGS, DETERMINATIONS, AND RECOMMENDATIONS

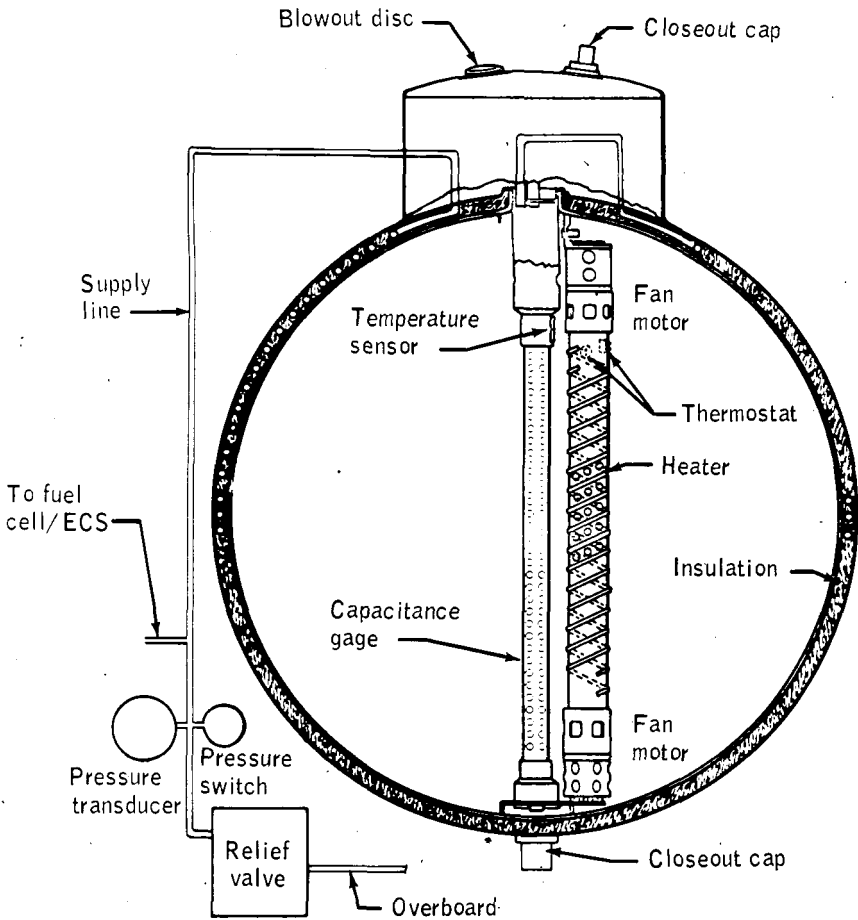
FIGURE 12

As the simplified drawing in the next slide indicates (see figure 12) each oxygen tank has an outer shell and an inner shell, arranged to provide a vacuum space to reduce heat leak, and a dome enclosing paths into the tank for transmission of fluids, and electrical power and signals. The space between the shells and the space in the dome are filled with insulating materials. Mounted in the tank are two tubular assemblies. One, called the heater tube, contains two thermostatically protected heater coils and two small fans driven by 1800 RPM motors to stir the tank contents. The other assembly, called the quantity probe, consists of a cylindrical capacitance gage used to measure electrically the quantity of fluid in the tank. The inner cylinder of this probe is connected through the top

The oxygen tank, as designed, contained materials, which if ignited will burn in supercritical oxygen. These include Teflon, used, for example, to insulate the wiring, and aluminum.

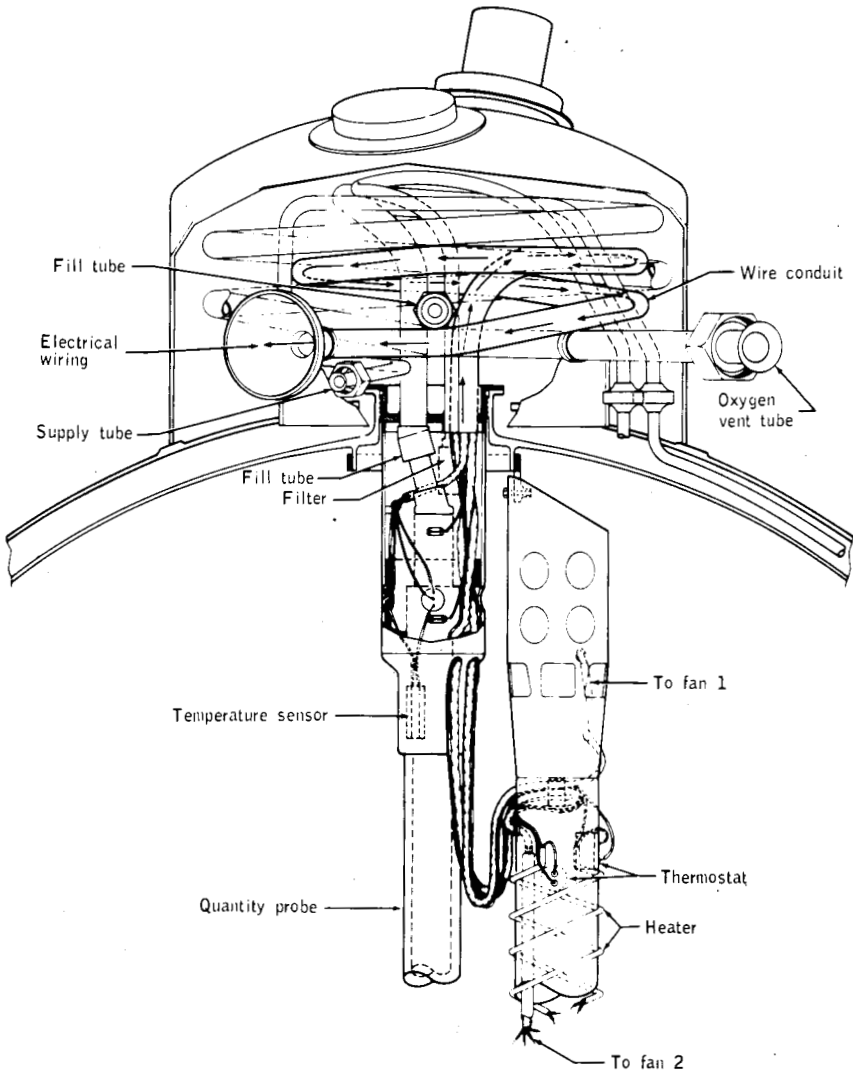
FIGURE 13

As shown in figure 13, each heater coil is protected with a thermostatic switch, mounted on the heater tube, which is intended to open the heater circuit when it senses a temperature of 80°F. As I will point out later in tracing the Board's conclusions as to the cause of the accident, when the heaters were powered from a 65 volt DC supply at KSC during an improvised detanking procedure, these thermostatic switches, because they were rated at only 30 V DC, could not prevent an overheating condition of the heaters and the associated wiring. Tests conducted for the Board indicate that the heater tube assembly was probably heated to a temperature of as much as 1000°F during this detanking procedure.

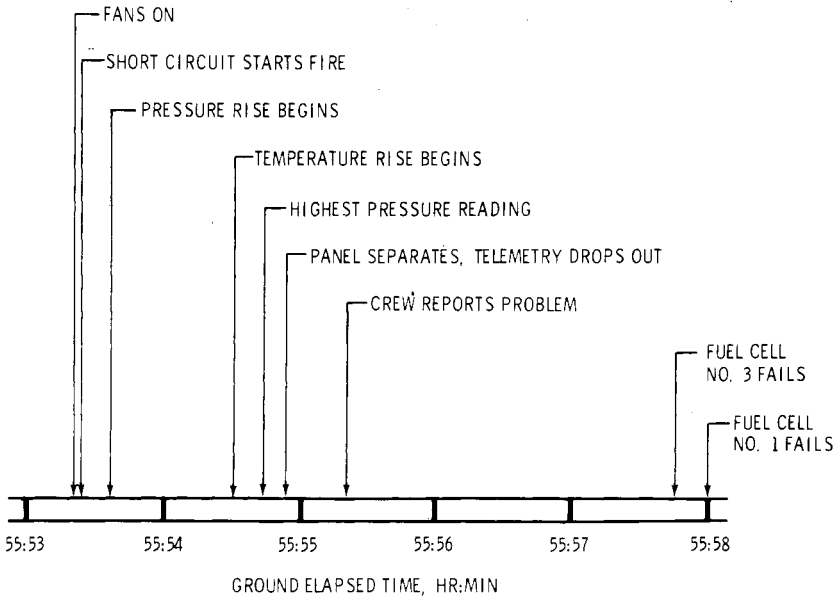
FIGURE 15

The following discussion treats the accident in its key phases: initiation, propagation and energy release, loss of oxygen tank No. 2 system integrity, and loss of oxygen tank No. 1 system integrity. Figure 15 shows the key events in the sequence.
