APPENDIX I
91-21-01

[Docket No. 96-NM-111-AD; Amendment 39-9664; AD 96-12-21]

Airworthiness Directives; McDonnell Douglas Model DC-9-80 Series Airplanes, Model MD-88 Airplanes, and Model MD-90 Airplanes

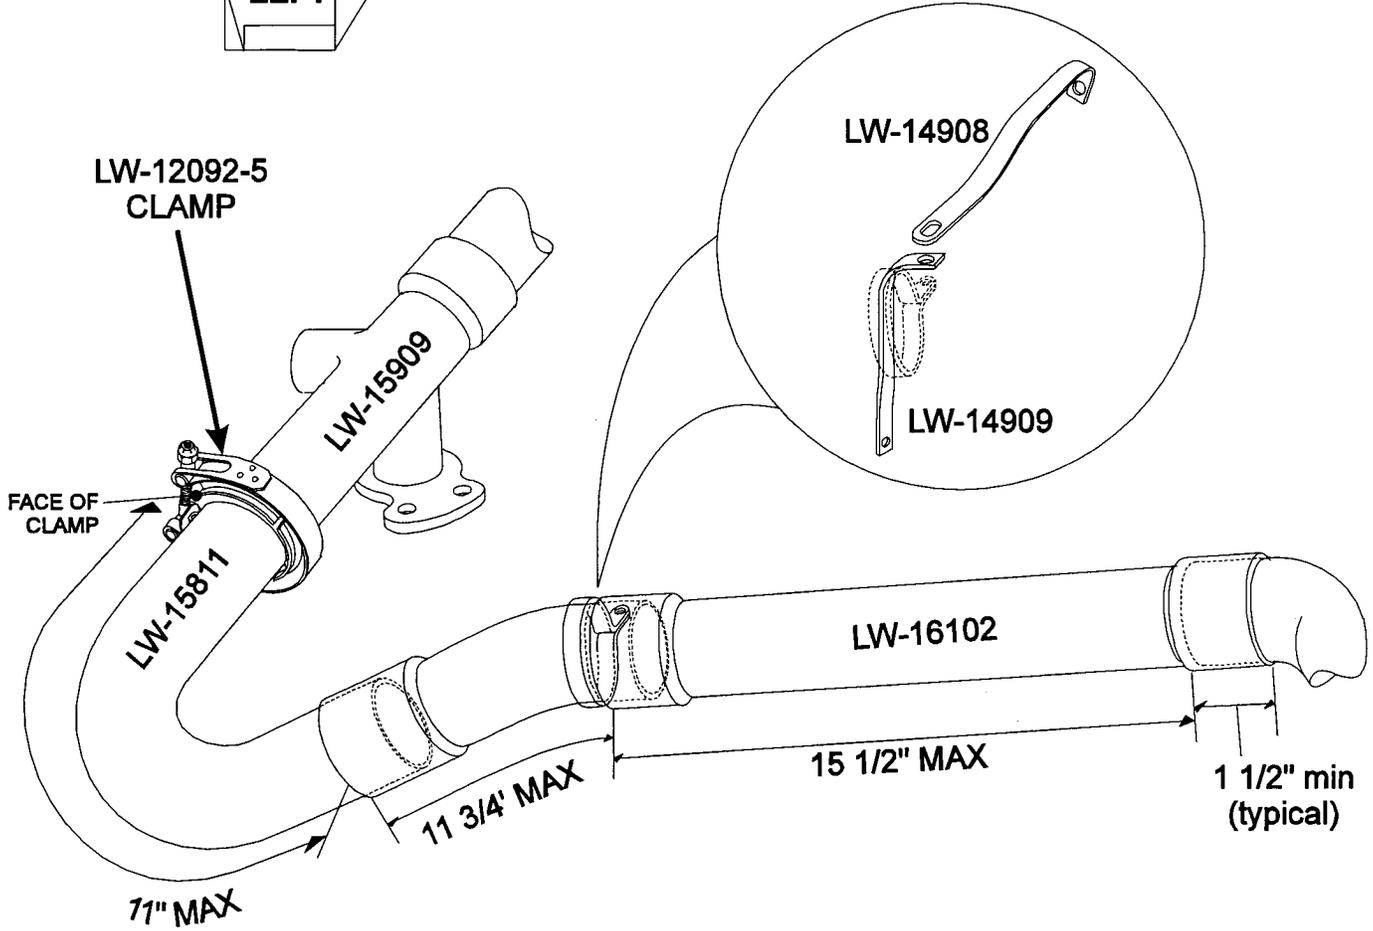
VIEW-AFT LOOKING FORWARD
ON TOP OF ENGINE

NOTE: ALL DIMENSIONS TAKEN ON OUTSIDE
OF TUBE BENDS
